Project **FORTH REPLACEMENT CROSSING**

**AIR QUALITY MONITORING REPORT
FEBRUARY 2018**

Document number	Rev
REP-00352	00

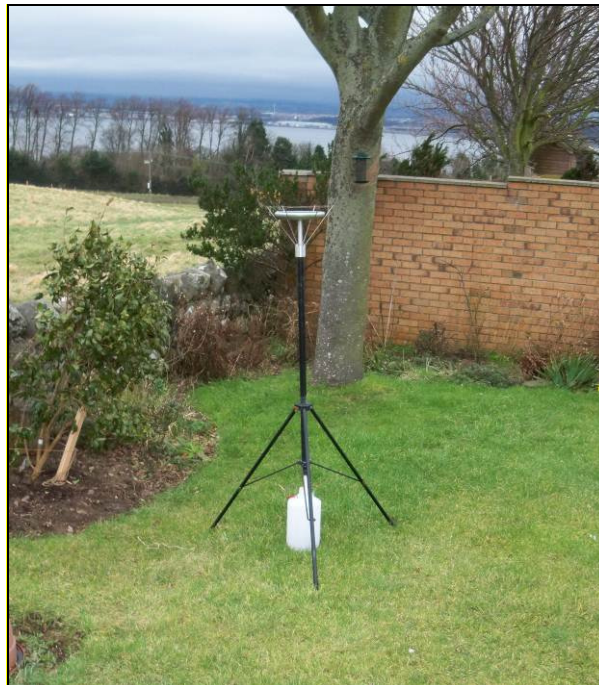
Figure 1: Example of an Installed Frisbee Gauge Meter

2.1. Air quality is being monitored on site using both automatic light scatter dust meters and Frisbee gauge dust deposition monitoring. Four Frisbee gauges are currently set up at sensitive locations across the site to measure dust deposition rates (Figure 1). Three automatic light scatter meters are installed at sensitive locations near the south abutment of the Queensferry Crossing to measure real time particulate matter (PM₁₀) concentrations and the Total Suspended Particle (TSP) concentrations (Figure 2). These meters are calibrated annually. Table 1 lists the air quality monitoring equipment present at each monitoring location, including the date it was installed.

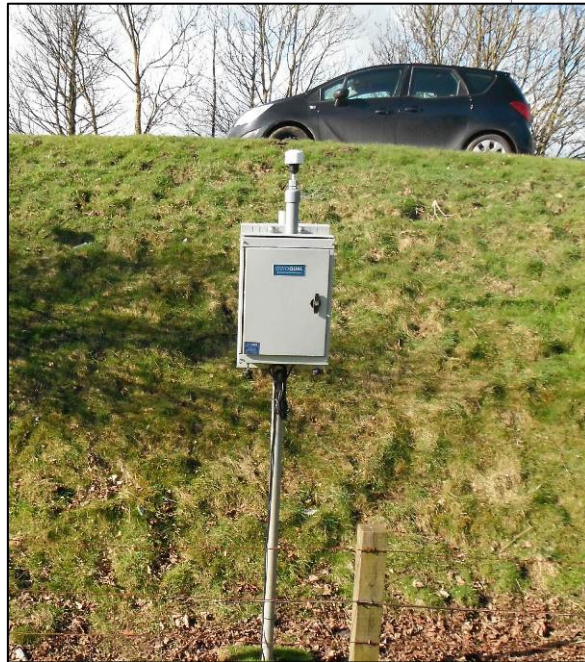
Figure 2: Example of an installed Automatic Light Scatter Dust Meter

2.2. Light scatter type monitoring equipment have been selected as a site monitoring tool to create a live network which assesses the levels of fugitive particulate matter, principally airborne dust. These monitors require less space, maintenance and power than other real time monitors such as a Tapered Element Oscillating Microbalance (TEOM) which is used and designed to measure particulate levels to exceedingly high standards, including measuring long-term compliance to statutory limits. Light scatter meters are more practicable to deploy. However, the meters do generally record levels higher than those measured by the TEOM. The meters can also be affected by atmospheric moisture content which further increases reported levels. Accordingly, any elevations of statutory limits should be treated as precautionary exceedances. The monitors are reliable for on-site monitoring and the establishment of action thresholds to ensure unforeseen activities generating significant dust are identified and suitably controlled. Light scatter meters are becoming the construction and waste industries norm for particulate dust monitoring.

2.3. In association with air quality monitoring across the site, temperature and relative humidity are also continually measured by the light scatter meters at Inchgarvie Lodge and Clufflat Brae.
