Appendix A10.1

Peat Stability Risk Assessment

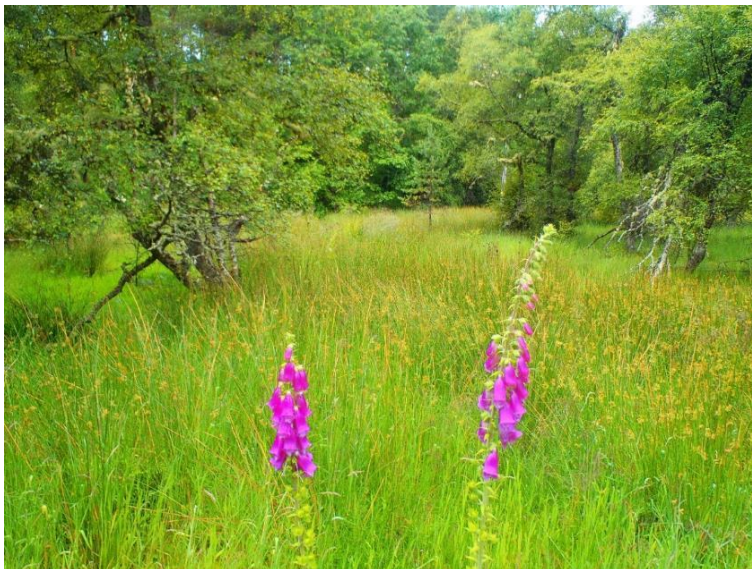
- 2.3.4. Illustration 1 shows Tomatin Junction at 281mAOD looking west towards the existing A9 road. The area features primarily deciduous woodland which is boggy underfoot. There are isolated areas of deeper peat up to 2.1m in depth. Typical slope angles are less than 6 degrees.

Illustration 1: Boggy Woodland South-east of Tomatin Junction, Low Gradient with Areas of Deep Peat (NH 8009 2974)

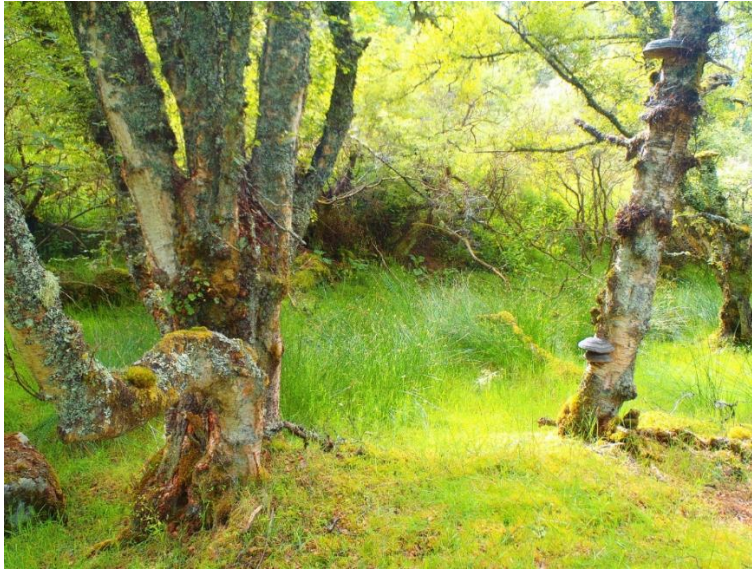
- 2.3.5. Illustration 2 shows woodland adjacent to the Dalmagarry Burn at 274mAOD looking west towards the existing side road. The area features upland birch wood, which is boggy in places. There are isolated deeper areas of peat up to 2.2m in depth. Typical slope angles are between 6 and 12 degrees.

Illustration 2: Woodland South of Dalmagarry Burn Facing North, Featuring Small Defined Areas of Peat (NH 7920 3197)

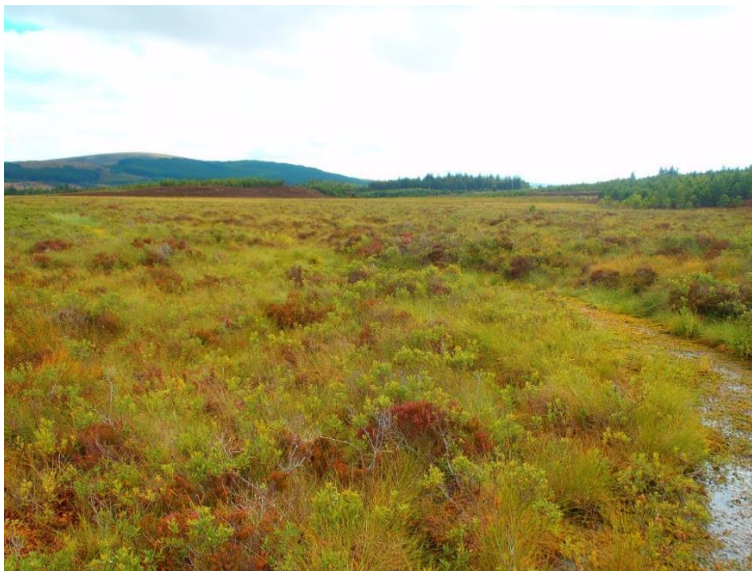
- 2.3.6. Illustration 3 shows blanket bog within the Class 1 Priority Peatland area located south of the existing A9 at 302mAOD, facing east towards Lynebeg. This area of blanket bog features a number of artificial drains primarily running west-east, with peat depths of up to 5.6m in the centre of the peatland. Typical slope angles are less than 1 degree.

Illustration 3: Class 1 Peatland Facing East Towards Lynebeg, with Artificial Drains. Very Low Gradient Area and Wet Underfoot with Limited Peat Erosion (NH 7564 3427)

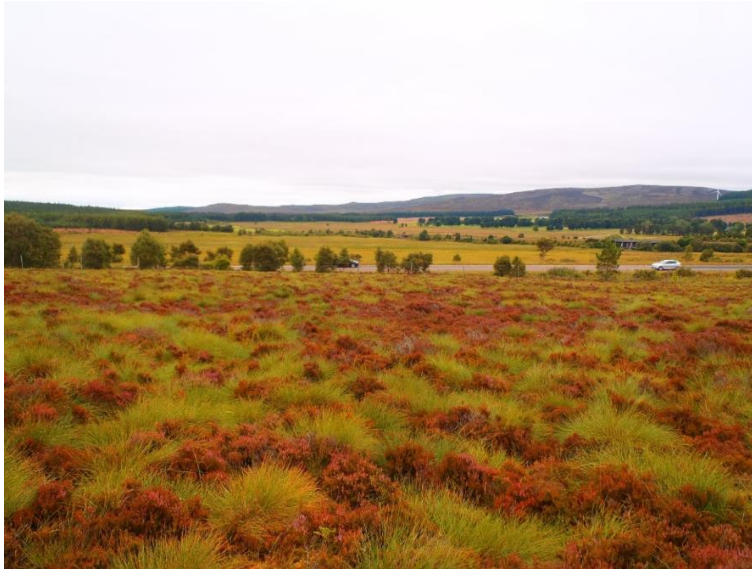
- 2.3.7. Illustration 4 shows a mix of blanket bog and upland heathland looking north towards the Allt Creag Bheithin, with the existing A9 crossing north-west to south-east. This area features moderate peat depths of up to 1.75m in defined areas. Slope angles are typically less than 6 degrees, with a gentle downward slope towards the north.

Illustration 4: Class 3 Peatland West of Moy, Facing North and Downslope Towards Existing A9 and Allt Creag Bheithin (NGR 7565 3450)

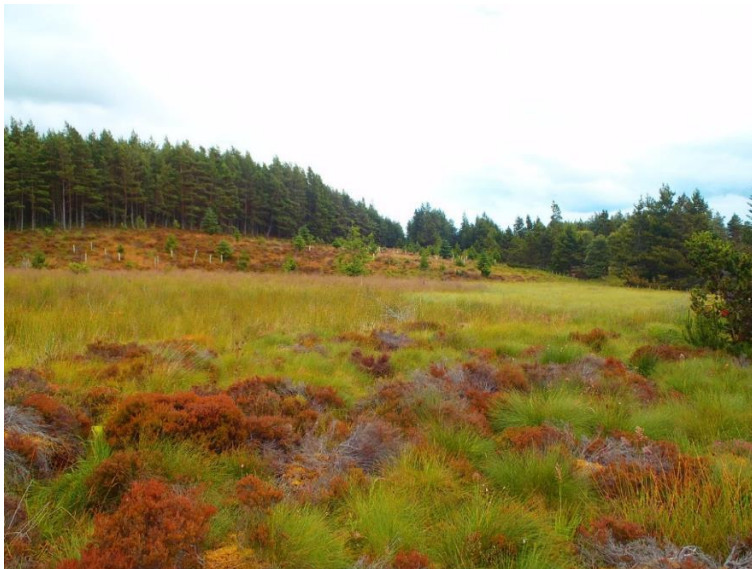
- 2.3.8. Illustration 5 shows an area of flush/bog ground adjacent to the existing A9 facing east, west of Moy and located north of the existing A9 road. This grassland area is boggy underfoot, with conifer woodland located upslope. This area is small and well defined with maximum peat depths of 1.5m towards the centre of this area. Slope angles are very low within the area of bog, typically less than 5 degrees.

Illustration 5: Upland Flush Area Adjacent to Existing A9 (NH 7416 3475)

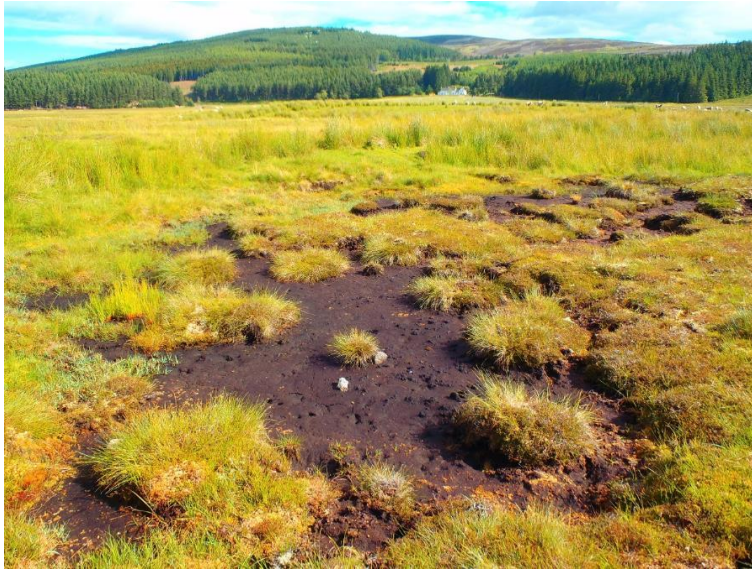
- 2.3.9. Illustration 6 shows eroded peat north of Dalmagarry Farm, east of the existing A9. The area features low slope angles, and a number of artificial drains and areas of eroded and exposed peat. Maximum peat depths of 3.9m were recorded within the scheme footprint and slope angles are typically less than 6 degrees.

Illustration 6: Exposed Peat Facing East from Dalmagarry Farm Towards the Funtack Burn, Area Used for Grazing (NH 7836 3280)

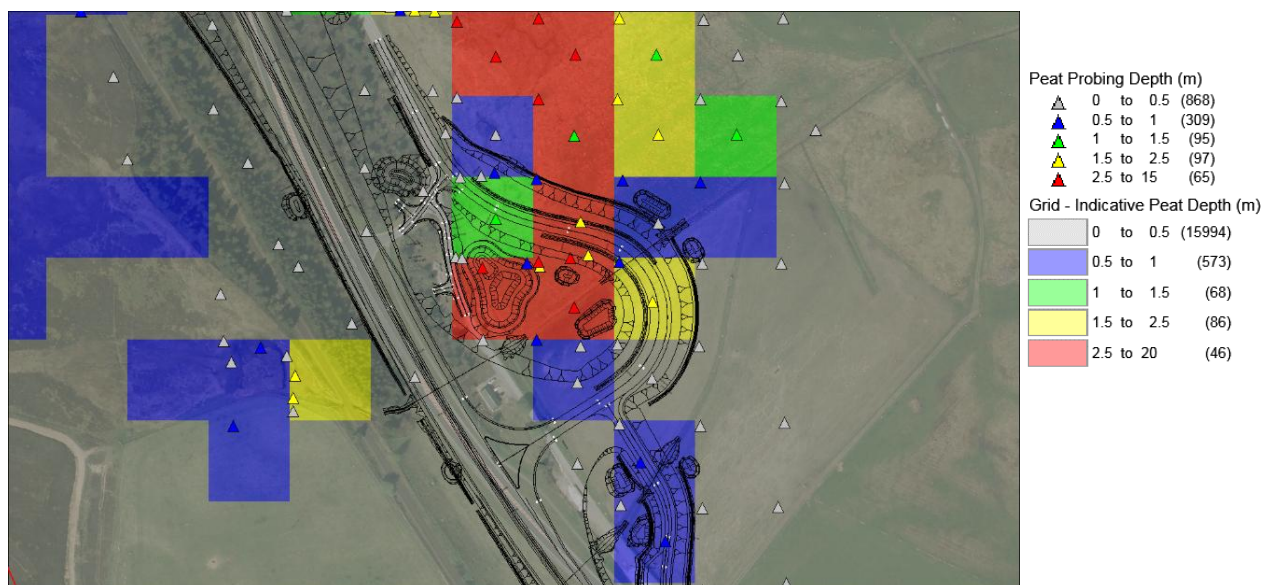
Illustration 7: Sample of Indicative Peat Depth Map

- 2.4.17. Illustration 7 shows an enlarged portion of the peat depth mapping. Each cell is 50m x 50m with areas of shallower than 0.5m (no peat) coloured grey, shallow peat coloured blue, moderate depth peat coloured green, deep peat in yellow and very deep peat coloured red. The full indicative peat depth map is included in Figure A10.1.1.

- 2.4.19. As can be seen from Illustration 7 and Figure A10.1.1, where a cluster of peat probing points are all within the same peat depth category this has been taken as a good indication of the general peat depth in the surrounding area and the indicative peat depth map has been coloured accordingly. However, where clusters of peat probing points have returned depths in a wide range of depth categories a precautionary approach has been taken, with the indicative peat depth map being classified in line with the deepest category of peat found in the area. This leads to a conservative indicative peat depth map.

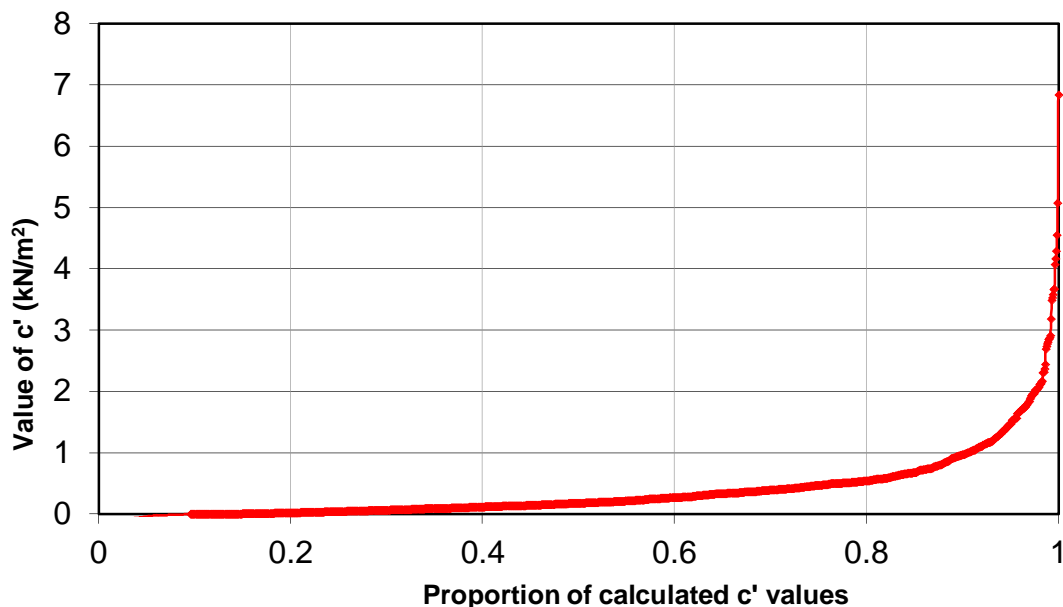
- 2.4.36. Each peat probing location visited is known to have been stable at the time of the visit and therefore must have a FoS of at least 1. If we assume conservatively that $F=1$ and use values for the other parameters as discussed above, the FoS equation can be rearranged to allow derivation of a value for c' at each probing location. Slope angles for the probing points are generated from the DTM. It is important to note that the value of c' calculated for each location represents the minimum cohesive strength necessary for the peat to be stable at that location. In fact, the shear strength may be, and in most cases probably is, considerably higher.

Illustration 9: Estimate of Minimum Cohesive Strength, c'

- 2.4.37. Within the study area, 1,434 locations have been surveyed during the different phases of fieldwork, c' values for each of these have been calculated and the distribution of these values is shown in Illustration 9. For example, reading from the graph, 0.8 (or 80%) of the probing locations required a c' value of 0.54kN/m² or less to be stable and retain peat on the slope.

- 2.4.38. From this work it is possible to state, with confidence, that across the site as a whole the shear strength of the peat is unlikely to be less than 3.65kN/m² as this is the value of the 99.5th percentile point on the graph. The basis for making this statement depends upon:
