Appendix 12.5

Bats

Transport Scotland

August 2018

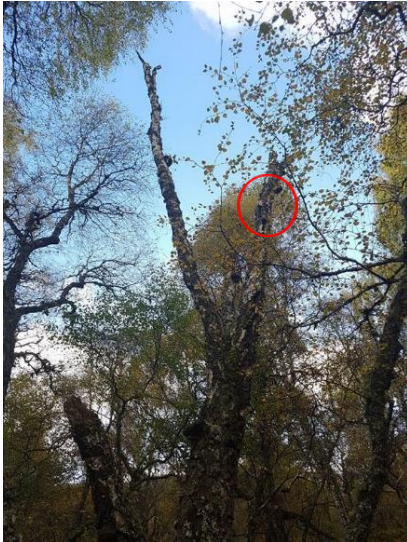
ID	Description of Tree and Roost Location	Photographs of Tree
TR71	<p>Silver birch located at NH 90135 15627. Co-dominant stem with bracket fungus, two holes, one at 4m and one at 3m above ground. On a dawn activity survey on 18/07/2017 one <i>Myotis</i> sp. bat was seen to enter the upper hole and roost (see picture).</p>

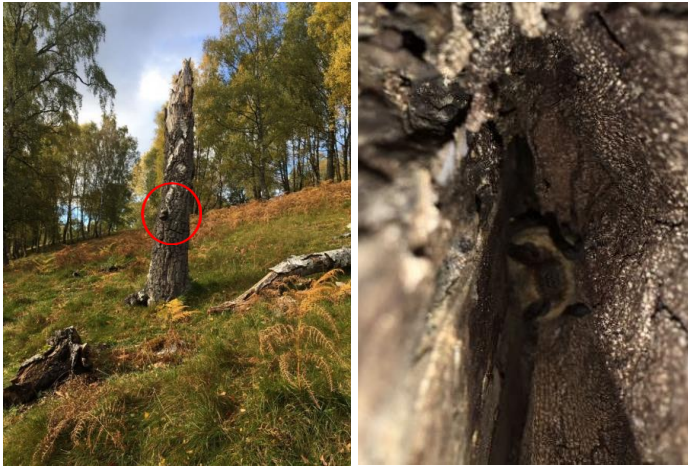
TR95	<p>Dead stump (unknown species) at NH 87472 10470. Cavities were found behind loose bark on the north face at 1m above the ground (circled in picture), and during the ground inspection on 31/08/2017 one pipistrelle bat was seen behind the bark (see second picture).</p>

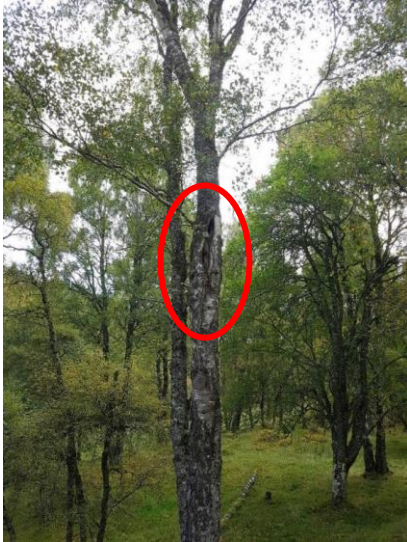
TR678	<p>Silver birch tree located at NH 89770 15246. A rot hole extends upwards on the south face at 4m above ground (circled in picture). During the aerial inspection on 03/10/2017 one bat was identified within the cavity, through use of the endoscope. It wasn't possible to identify the bat to species level due to its position in the roost.</p>

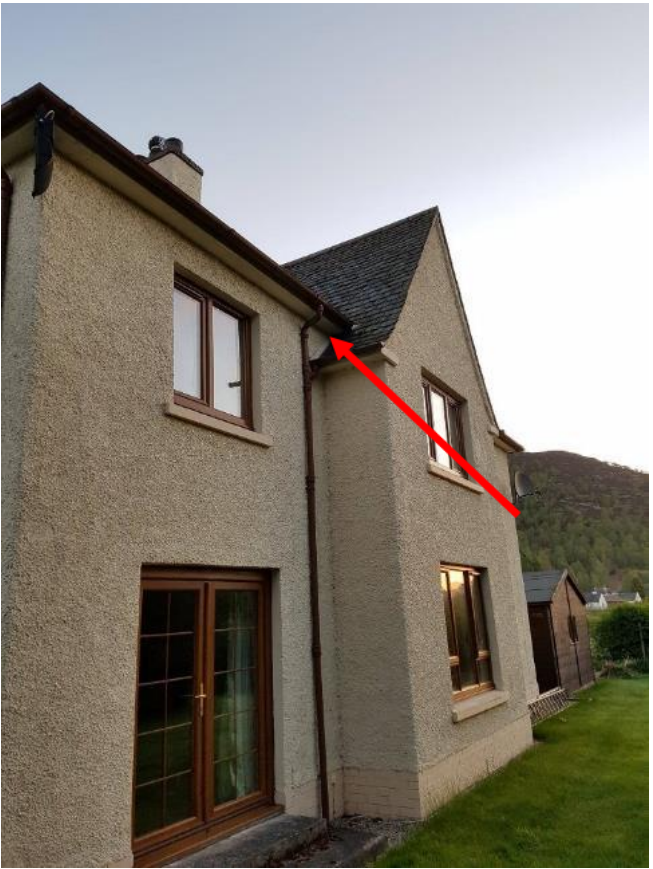
Description of Structure/ Building and Potential Roost Location	Photographs of Structure/ Building	Roost Locations and Hibernation Roost Potential
<p>ST01 - Lynwilg Farmhouse</p> <p>The house is constructed from brick with a render covering, and is two storeys with a pitched slated roof. There are two chimneys on the roof. The loft has a light in it and is floored. There is a timber garage to the north of the house although there appeared to be no Potential Roost Features (PRFs) in it.</p> <p>The slates on the roof all appeared old and irregular shaped so there were gaps underneath them. The ridge tiles were raised in various places. There were cavities under the flashing around the chimneys and in the valleys. The wallheads were generally tight so there were few access points associated with those.</p>

<p>Photograph 1</p>	<p>A large amount of bat droppings and two dead brown long-eared bats were found in the loft during the PRA. One confirmed brown long-eared bat entered a roost at the rear (south-east face) of the house at the red arrow (first photo), between the wall and the pitch of the roof on 17/05/2017.</p> <p>On 19/06/2017 one soprano pipistrelle and five brown long-eared bats emerged from the same point as shown in picture one. In addition, a common pipistrelle emerged from under a slate on the south facing pitched roof and another emerged from the east corner under the gutter (no picture). One soprano pipistrelle entered a roost on the east side near the satellite dish (no picture).</p> <p>On 19/07/2017, 11 brown long-eared bats entered the roost shown in the first picture while a common pipistrelle entered above the gutter (picture two) and an unidentified pipistrelle entered adjacent to that (picture two). Three common pipistrelle and two soprano pipistrelle entered roosts on the south-west side of the building as shown in the third picture.</p> <p>Roost Classification:</p> <p>Brown long-eared – Maternity Common pipistrelle – Non-breeding Soprano pipistrelle – Non-breeding</p> <p>Hibernation Roost Potential - Moderate</p> <p>There are numerous areas for potential roosting including under slates, at wallheads, within the loft and within cracks in stonework. Due to the house being inhabited it will have a certain level of heat throughout the winter which means a hibernation roost of high conservation significance is less likely, but there is the opportunity for smaller numbers or individual bats to roost.</p>

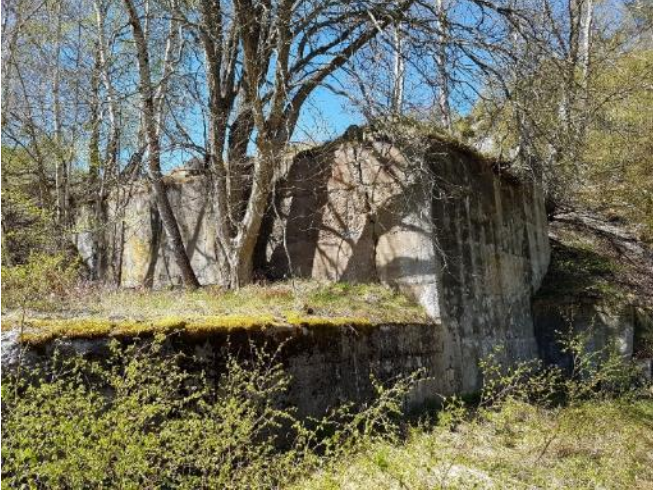
Description of Structure/ Building and Potential Roost Location	Photographs of Structure/ Building	Roost Locations and Hibernation Roost Potential
<p>ST02 – Quarry Building</p> <p>This is a concrete structure with only two sides visible (it may be solid concrete so there is no internal access). There is a deep vertical crack on the south-east face. The crack extended deep into the structure and although there was unlikely to be a high conservation status roost present there were a number of cavities evident and the surrounding habitat was good for foraging and commuting.</p> <p>BRP – Moderate</p>

<p>Photograph 4</p>	<p>No roosts were recorded during the surveys.</p> <p>Hibernation Roost Potential – Low</p> <p>The crack present on the concrete extends deep into the structure, although it may not provide a suitable level of protection from the elements and water and/or frost may inundate in winter. It is unlikely therefore to be suitable for regular use or use by large numbers of bats.</p>

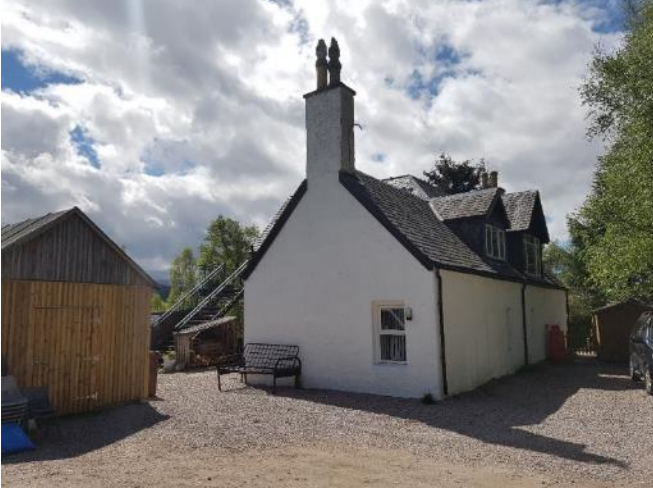
<p>ST03 – Kinakyle</p> <p>This is a two-storey stone building with multiple pitched slated roofs and two chimneys. There is one dormer on the south pitch and two on the north pitch, and a skylight on the east pitch. The stone walls are rendered on the north and east sides. The west side has a small entrance way of wooden construction with a small slated pitched roof; there is a glass conservatory on the west. There are soffit boxes on the west side and any gaps between the box and the wall look to have been filled. The building is split into two flats and the</p>

<p>Photograph 5</p>	<p>No roosting bats were seen during the first (21/06/2017) or second (11/07/2017) surveys. During the dawn survey on 16/08/2017 two roosting locations were identified. Two brown long-eared bats entered a roost on the south-east corner of the house (red triangle in the second picture) and one common pipistrelle entered under a slate near the dormer window on the south-east face (circled in picture two).</p> <p>Roost Classification:</p> <p>Brown long-eared – Non-breeding Common pipistrelle – Non-breeding</p> <p>Hibernation Roost Potential – Moderate</p> <p>There are numerous areas for potential roosting including under slates, at wallheads, within the loft and within cracks in</p>

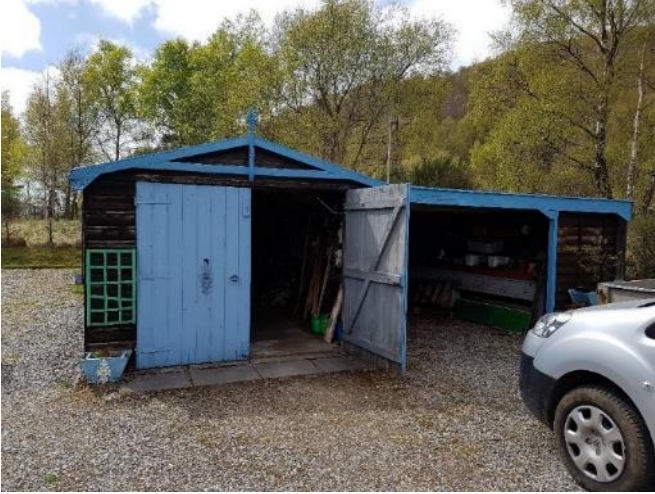
<p>Photograph 8</p>	<p>would be unlikely to give the required level of protection to bats in winter.</p>

Description of Structure/ Building and Potential Roost Location	Photographs of Structure/ Building	Roost Locations and Hibernation Roost Potential
<p>western-most shed is constructed of wood with a plyboard clad interior, and a corrugated metal roof. The shed closest to the house is made of wood, with a pitched felt roof secured with wooden batons.</p> <p>There were gaps under the wooden cladding on the gable ends of the house which may extend upwards. The front edge of the house had occasional gaps under barge boards. There were gaps around the porch window lintel and gaps where the wooden cladding meets the brick of the chimney on the south-east facing gable. There was also damage to the wooden sleepers on that gable end. On the rear of the house there were gaps where the wooden cladding met the fascias above the sunroom. There were a number of gaps around the exterior of the building which would allow bats access although there was unlikely to be a cavity wall due to the construction of the building.</p> <p>The only area of potential on the summerhouse was on the rear (south-east corner) at an area of raised roofing. The outbuildings had PRFs including holes around the doorways and gaps on the interior between the wooden construction and plyboard cladding. There was evidence of nesting birds from a previous year in the shed at the west.</p>

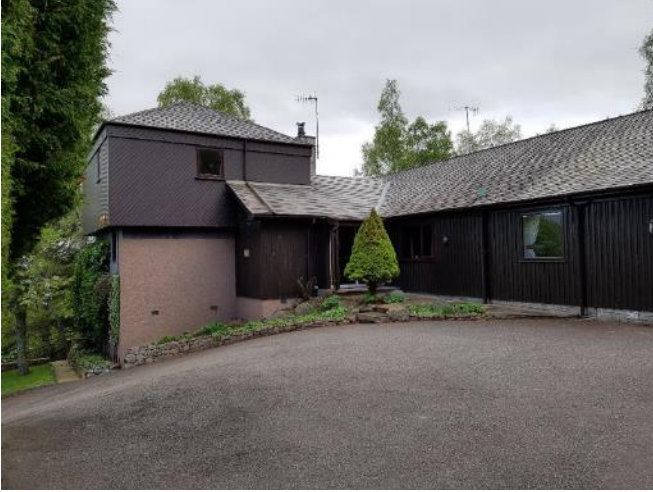
Description of Structure/ Building and Potential Roost Location	Photographs of Structure/ Building	Roost Locations and Hibernation Roost Potential
<p>ST07 – High Range House</p> <p>High Range House was built as a kit house around 30 years ago; it is wooden clad on a block base with both single and two storey sections. The roof is pitched and tiled. There is a floored loft above the single storey part of the house, running the full length of it with windows at each end. The two-storey section has a small, cleaner loft. There is a single storey triple garage to the north-west of the house, of wooden construction with a pitched roof. A small garden shed lies to the south-west of the house.</p> <p>There were occasional areas of potential under some of the roof tiles, but no gaps under the wallheads or on the cladding at the gable ends. There were no PRFs on the garage or the shed. The BRP was assessed as low as the house had very few PRFs which could only be used by a small number of bats.</p> <p>BRP – Low</p>

<p>Photograph 9</p>	<p>No roosts were found during the surveys.</p> <p>Hibernation Roost Potential – Low</p> <p>There are very few areas which could be accessed by bats throughout the building, and so this means that likelihood of hibernation is low.</p>

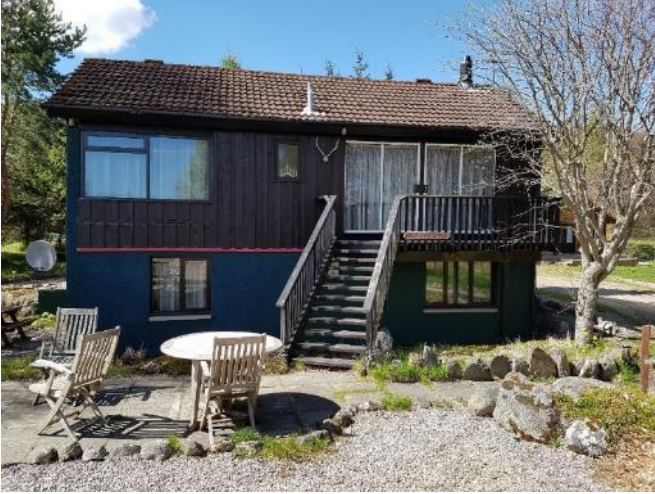
<p>Photograph 10</p>

Description of Structure/ Building and Potential Roost Location	Photographs of Structure/ Building	Roost Locations and Hibernation Roost Potential
<p>ST08 – Red Stag Lodge</p> <p>The main lodge is a two-storey building with a brick base and wooden clad upper. There is a pitched tiled roof with dry verge system on the roof at the front (east). The roof at the rear (west) is pitched with pan tiles. There are soffit boxes around the roof line. The garage (to the north-west of the house) is of brick construction with a corrugated metal roof. The summer house building north of the garage is of wooden construction with a pitched felt roof.</p> <p>On the main house, there were gaps at the lower end of all of the cladding boards leading in to the space behind, and gaps at the top of the walls where the fascias met the soffits. There were crevices on the north-east facing gable end where the fascias met the soffits. There were very few gaps in the summerhouse except a potential hole on the rear wallhead. The garage had a few gaps around the wallheads and the corrugations of the metal roof, and cavities at the apex on the side nearest the summer house, and where the soffit box has come away from the wall.</p> <p>The BRP was classed as high. There were numerous features around the exterior of the main</p>

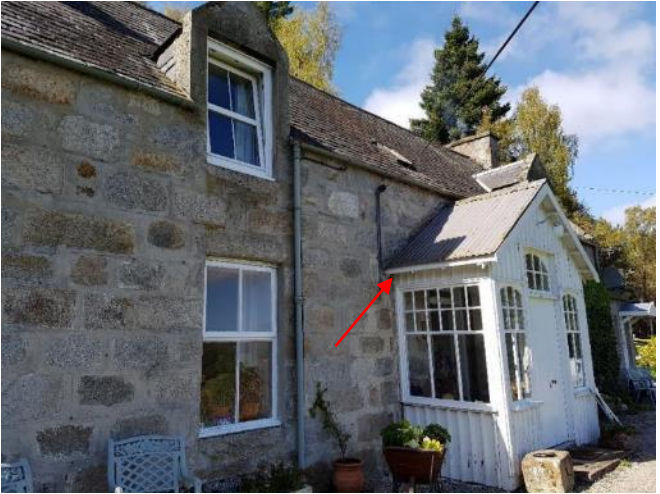
<p>Photograph 13</p>	<p>Roost evidence at was found at the north end of the loft in the form of droppings which were DNA tested and found to be common pipistrelle. The main concentration of droppings was against the stone wall of the chimney, and gaps visible at the apex of the gable (daylight seen from within loft) where bats could access. There was a known roost (identified by the owner) at the front porch, at a gap where the porch adjoins house and three droppings were seen on the south side (the owner regularly cleans droppings from the windows of porch). These droppings were also DNA tested as common pipistrelle. There were also gaps under slates around the whole house and raised slates adjacent to the chimney stacks. There was a possible gap on the south gable wall under the cope stone of chimney, and a crevice at the wallhead along most of the length of the building at the front and rear.</p> <p>A common pipistrelle maternity roost was located within the building. A large number of bat droppings were found within the north end of the loft. The roost emerged from under slates and flashing around the north chimney, as shown by the labels on the photos. There was also a common pipistrelle roost entrance where the porch wall joins the main house of the east face, and a roost at the apex of the gable of the porch, again east facing. Access points are shown by the red arrows (see also photo below).</p> <p>Roost Classification:</p> <p>Common pipistrelle – Non-breeding Common pipistrelle – Maternity</p> <p>Hibernation Roost Potential – Moderate</p>

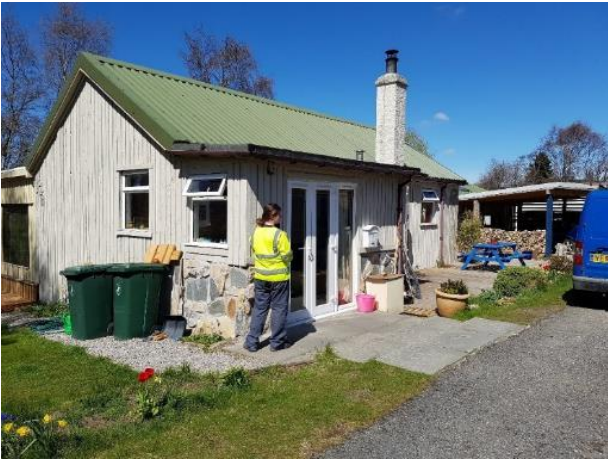
Description of Structure/ Building and Potential Roost Location	Photographs of Structure/ Building	Roost Locations and Hibernation Roost Potential
		<p>There are numerous areas for potential roosting including under slates, at wallheads, within the loft and within cracks in stonework. Due to the house being inhabited it will have a certain level of heat throughout the winter which means a highly conservation significant hibernation roost is less likely, but there is the opportunity for smaller numbers or individual bats to roost.</p>
<p>ST10 – Dunelm</p> <p>Dunelm is a single storey house with a converted home office, and two garden sheds close to the A9. The office is constructed from wood with a mono-pitched corrugated metal roof. The main house has a metal roof with underlying bitumen and is of wooden construction but wasn't surveyed as it is situated over 12m from the road and is shielded by the office from the road. The porch at the front of the house has a wooden wall which was part stone clad, with a flat felt roof.</p> <p>The whole structure was in the process of being clad in stone, with parts completed already. There were gaps at each corrugation of the metal roof, and where the wooden cladding met with the gutter. There was also a gap where a plank had pulled away from the wall on the south end, and a deep crack in the wood on the north side.</p> <p>The sheds (to the east of the house) are both wooden, with pitched felt roofs. The shed to the south had holes in the rear (north-east face)</p>

<p>Photograph 14</p>	<p>No roosts were found during the surveys.</p> <p>Hibernation Roost Potential – Low</p> <p>The sheds do not have the preferred levels of insulation that a bat would require in winter to roost although as there are gaps allowing access it cannot be ruled out that opportunistic bats may roost. The office, although having some roosting potential, has a corrugated metal roof and its walls are being clad in stone, and so the roost potential is low.</p>

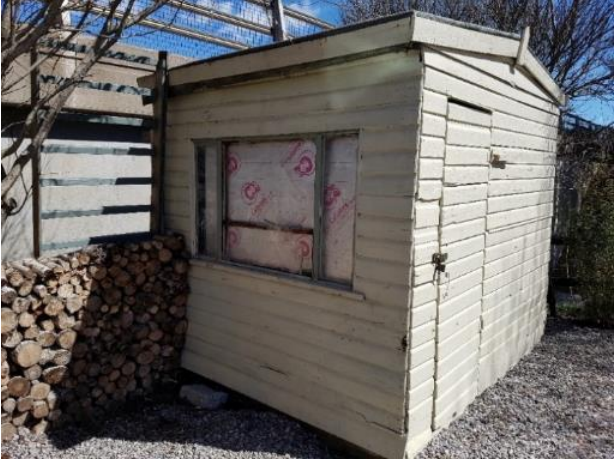
<p>Photograph 15</p>

Description of Structure/ Building and Potential Roost Location	Photographs of Structure/ Building	Roost Locations and Hibernation Roost Potential
<p>leading into the interior. There was a gap between the fascia and wall, and a gap where the felt roof had pulled away from the fascia on the south side. The shed to the north had no daylight visible from the inside, and the only gap on the exterior was on the north-facing edge where the fascia sat away from the wall.</p> <p>The BRP of the sheds and the office was assessed as low. The house was further from the works (over 12m from the road), looked newer and was in the process of being clad with stone, and although there were still potential areas a bat could roost it is sheltered from the works by the office and so wasn't surveyed.</p> <p>BRP – Low</p>

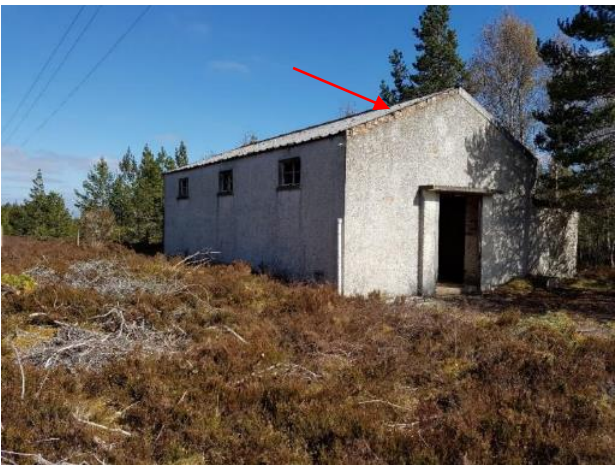
Description of Structure/ Building and Potential Roost Location	Photographs of Structure/ Building	Roost Locations and Hibernation Roost Potential
<p>ST11 – Telephone exchange</p> <p>The derelict main building is of brick construction with render and corrugated asbestos pitched roof. There is a small extension on south face. The large door on the west face was open and there were broken windows throughout. The interior was in poor condition; the cladding under the asbestos roof looked fire damaged and was broken in places, revealing a small void between roof sheeting and cladding. There were small gaps in the brick interior walls leading from the main room into the extension. A separate room at the east end had possible asbestos on floor (fallen from ceiling) so was not inspected. An adjacent outbuilding was also derelict and open on the north face. The exterior has an asbestos fascia and asbestos roof. There were gaps at the wallheads on north and south faces of the main building under the corrugations of the asbestos sheeting. On the east gable and south face were vents which may lead into the building. On the extension at the rear there were small gaps on the west face, and on the east face under the corrugations of the roofing.</p> <p>The structure had moderate BRP as there were multiple areas where bats could roost but the structures</p>

<p>Photograph 16</p>	<p>A pipistrelle (species unconfirmed) emerged from the apex of the roof (see red arrow) on 23/05/2017. It was likely to be a male or non-breeding female bat roost.</p> <p>Roost Classification:</p> <p>Unidentified pipistrelle – Non-breeding</p> <p>Hibernation Roost Potential – Low</p> <p>The buildings have open doors and windows and so the internal temperature will not be constant. There is a lack of suitable crevices to provide deep shelter to bats and so it may only be used by opportunistic bats in winter.</p>

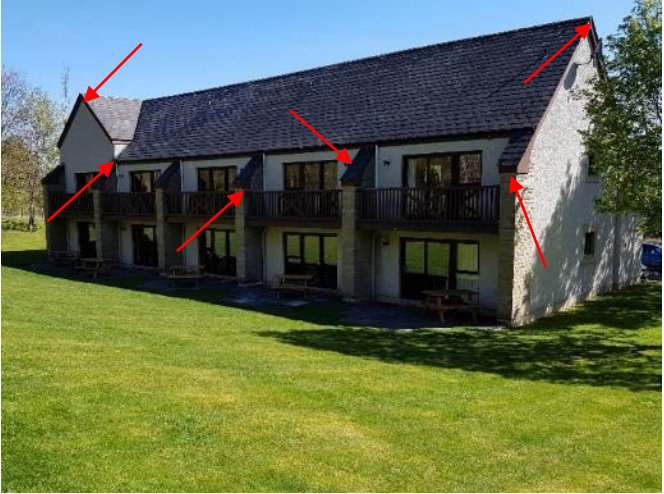
<p>Photograph 17 – northern building</p>	<p>Nine roosting locations were identified across the two buildings (as illustrated in Photographs 17 and 18) on 24/05/2017 with 11 (either common pipistrelle or unidentified pipistrelle) roosting bats entering in total. On 16/08/2017 three bats (two common pipistrelle and one soprano pipistrelle) were confirmed to leave roosts and a further nine potential roosting bats (five common pipistrelle, one soprano pipistrelle, two unidentified pipistrelle and one unidentified species) also observed.</p> <p>Roost Classification:</p> <ul style="list-style-type: none"> Common pipistrelle – Non-breeding Soprano pipistrelle – Non-breeding Unidentified pipistrelle – Non-breeding <p>Hibernation Roost Potential of both buildings – Moderate</p> <p>There are numerous gaps within the buildings and so due to the structures and the usage of the buildings by bats in summer there is more likelihood of bats being present in winter. However, due to habitation of the structures a large roost is unlikely to be present.</p>

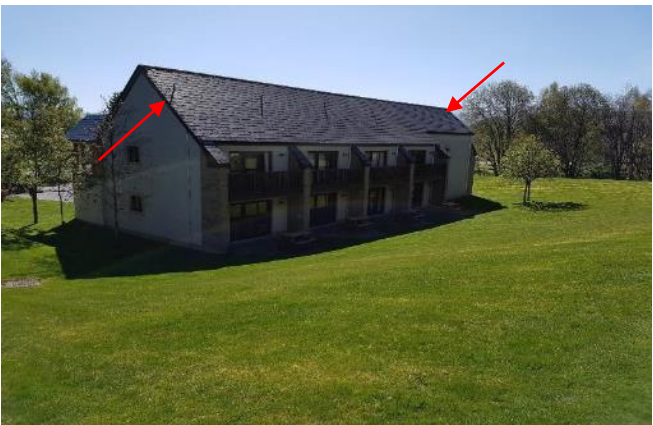
<p>Photograph 18 – southern building</p>	
<p>ST12-3 and ST12-4 – Macdonald Staff Accommodation Blocks A & C</p> <p>The staff accommodation block C (ST12-4) is a three-storey structure built of brick with render, and a pitched tiled roof. Generally, wallheads and soffits were tight with very few gaps. Roofs looked in good condition. The second staff accommodation, Block A (ST12-3) is two-storey of the same brick construction and a pitched roof with concrete roof tile. On staff accommodation block C, a dry verge system covers the tile ends at the gables, with the exception of one cap which was loose, and a there was a gap in the soffit box at the northern end.</p>

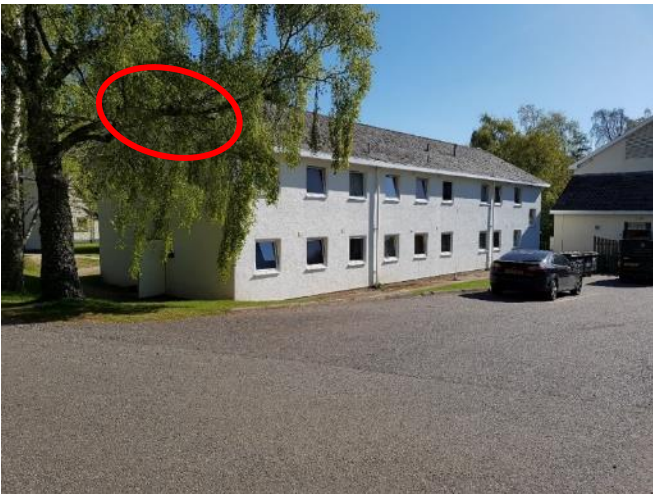
<p>Photograph 19 – Block A</p>	<p>Staff accommodation: One common pipistrelle emerged from under a roof tile on block A at the north end of the gable at 22:30 on 20/06/2017 (as shown by circle on Photograph 19, area is hidden from view by tree). No roosting bats were seen on 10/07/2017 or 07/09/2017.</p> <p>Roost Classification:</p> <p>Common pipistrelle – Non-breeding</p>

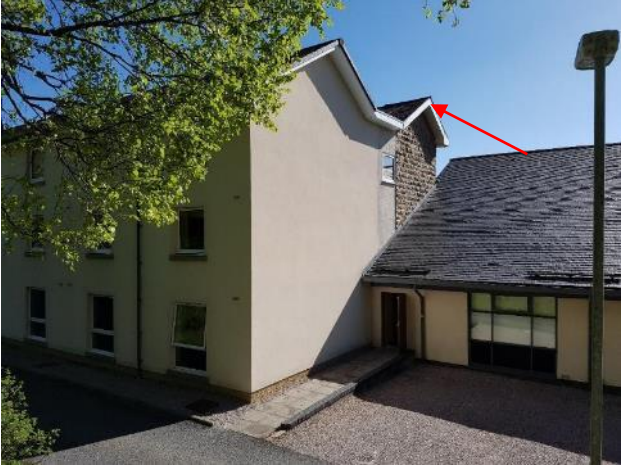
<p>Photograph 20 – Block C</p>

Description of Structure/ Building and Potential Roost Location	Photographs of Structure/ Building	Roost Locations and Hibernation Roost Potential
<p>Staff block A had no caps over the ends of the tiles and so there was the possibility of bat access.</p> <p>BRP for Block C - Moderate</p> <p>ST12-2 – Activity Centre and ST12-1 - Macdonald Highlands Hotel</p> <p>Further south the rear of the Highlands Hotel building is single storey with a tiled, mono-pitch roof. The tiles were tight to one another and there were no cavities at the wallheads. Adjacent to this is a four-storey tall section and adjoined to that a three-storey block of guest rooms. Both of these were in good condition with tiles flush to one another and no gaps at wallheads. There was a small gap at the apex of the south-facing gable end leading under the ridge.</p> <p>The activity centre is low height at the rear with a pitched slate roof. The slates looked generally in good condition although there were gaps visible due to the irregular shape of the slates. The flashing around the skylights and vents was also in good condition and flat with no gaps. There may be gaps under the edges of the tiles in the valleys between the roofs. There were potential gaps at the edge of the gable where the slates end. There</p>

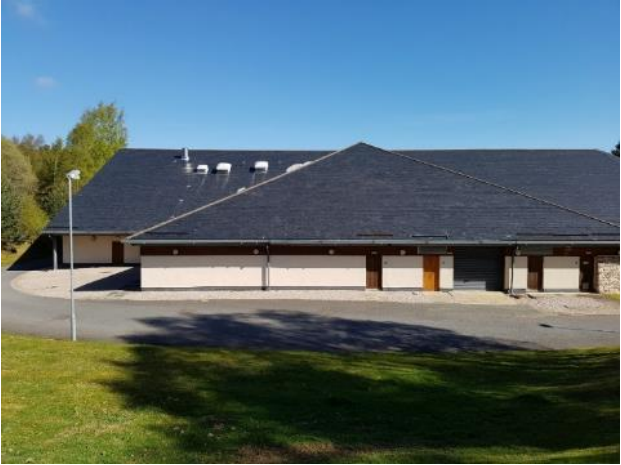
<p>Photograph 21</p>	<p>Hotel: One common pipistrelle entered at the apex of the gable end (see red arrow) of the Highlands Hotel block to the immediate north of the activity centre on 24/05/2017. No roosting bats were seen on 07/09/2017.</p> <p>Roost Classification:</p> <p>Common pipistrelle – Non-breeding</p> <p>Activity centre: No bats were roosting in the structure during the surveys.</p> <p>Hibernation Roost Potential – Staff Accommodation, Hotel and Activity Centre – Low</p> <p>There are very few areas of potential on the staff accommodation building and Highlands hotel which could be used by bats, which makes winter usage less feasible. The activity centre has a slated roof and there are more potential areas for roosting, although this building will be heated all year round and therefore it is likely to be too hot for hibernating bats.</p>

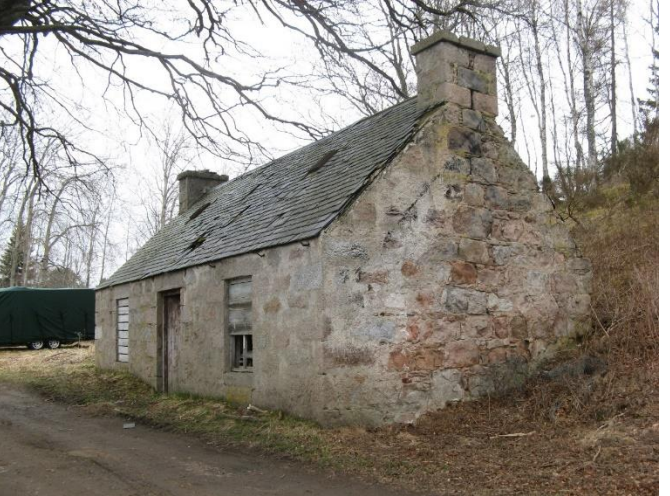
<p>Photograph 25</p>

Description of Structure/ Building and Potential Roost Location	Photographs of Structure/ Building	Roost Locations and Hibernation Roost Potential
<p>ST22 – Derelict Cottage</p> <p>The cottage is a sandstone building with pitched slated roof and lead flashing along the ridge. There are multiple gaps within the roof leading into the cottage interior. There were also multiple gaps in the sandstone, including the chimney. Potential access points into the building also included open doors and broken windows.</p> <p>As the cottage was in a very poor state of repair, it was unsafe to access and fully inspect internally.</p> <p>BRP - High</p>	<p>Photograph 24</p>

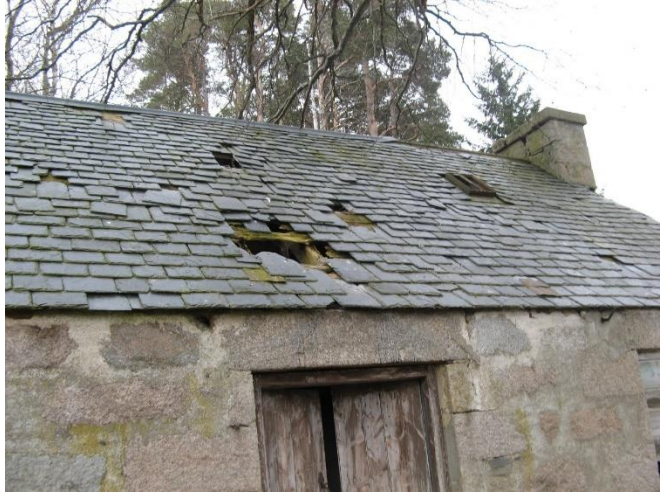
<p>Photograph 26</p>

<p>No evidence of current or historic bat roosting was recorded during the external inspection of the property. Internal inspection of the property was not undertaken due to the H&S concerns regarding the integrity of the structure. It was noted that birds were nesting within the property during survey.</p> <p>Hibernation Roost Potential – Moderate</p> <p>The derelict structure and presence of multiple potential roost features, as well as access egress opportunities, is likely to result in the building maintaining a cold, humid climate during the hibernation period, and it is therefore assessed to offer moderate hibernation roost potential.</p>

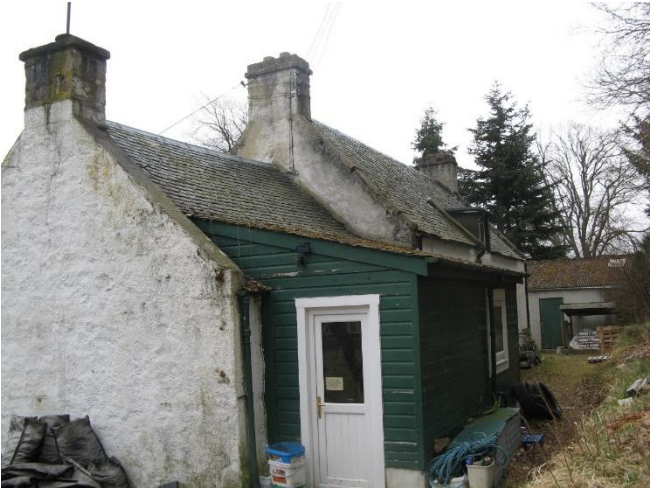
<p>Photograph 27</p>

Description of Structure/ Building and Potential Roost Location	Photographs of Structure/ Building	Roost Locations and Hibernation Roost Potential
<p>ST23 – Lynphail Farmhouse</p> <p>The farmhouse consisted of single-storey and two-storey sections with wooden-clad porches at the front and the rear. The house is a stone and render building with pitched slated roof and lead flashing. Multiple gaps were seen to be present at wall-heads that could potentially provide access into the loft spaces. There were also multiple gaps under the roof slates and under the lead flashing.</p> <p>The loft space within the single-storey section was floored and covered in old wooden cladding which was bent in some places.</p> <p>The loft space within the two-storey section could only be inspected from the loft hatch due to the small size of the hatch. The loft contained wooden rafters, sarking and a layer of insulation on the floor. No light from outside was visible.</p> <p>The garage adjacent to the house was a rendered breeze block structure with corrugated roofing sheets. The interior was open with no suitable roosting locations. Potential access into the garage</p>

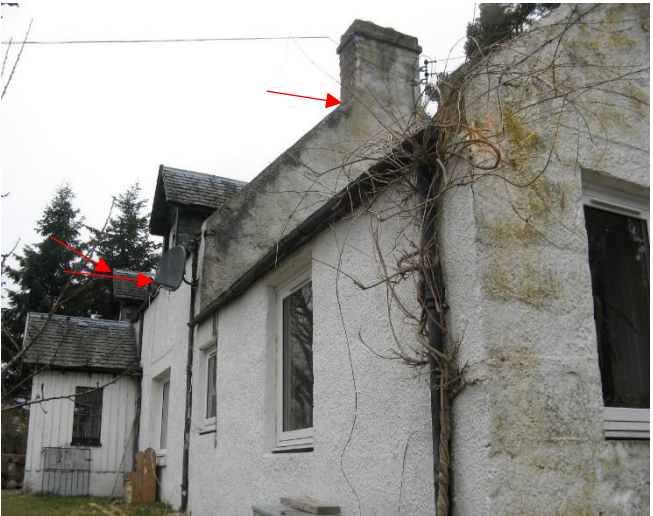
<p>Photograph 28</p>	<p>No evidence of bat activity or presence was recorded during the external or internal inspection of the property. Low numbers of bats (less than five) were recorded exiting or returning to features about the property during activity surveys. Re-entry of one common pipistrelle was recorded at the base of the chimney and one soprano pipistrelle recorded entering at a gap between the skylight window and roof tiles. One emergence from apex of roof at dormer window by soprano pipistrelle.</p> <p>Roost Classification:</p> <p>Common pipistrelle – Non-breeding Soprano pipistrelle – Non-breeding Unknown species – Non-breeding</p> <p>Hibernation Roost Potential – Low</p> <p>As the property is inhabited year-round, conditions are likely to be unsuitable during the hibernation roosting season, however, given the presence of multiple PRFs hibernation roosting by bats cannot be ruled out.</p>

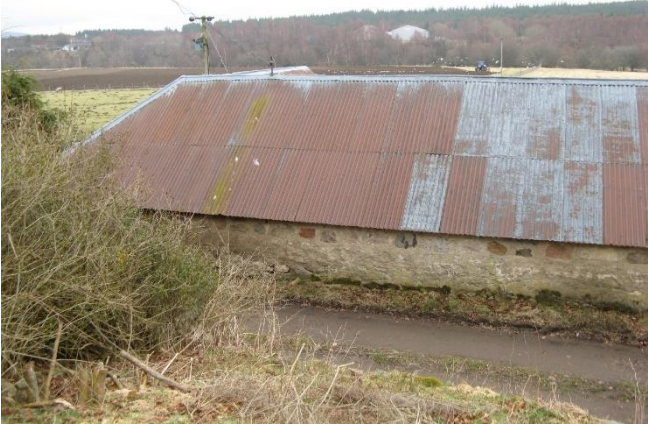
<p>Photograph 29</p>

Description of Structure/ Building and Potential Roost Location	Photographs of Structure/ Building	Roost Locations and Hibernation Roost Potential
<p>was provided by the gap above the garage door.</p>		
<p>ST24 – Lynphail Animal Shed</p> <p>The building had stone walls and corrugated roofing sheets over wooden rafters. The building also contained a wooden extension to the south-east. The potential access points into the stone building included open doors and windows. Despite the presence of access points there were limited roosting locations within the building.</p> <p>BRP - Moderate.</p>

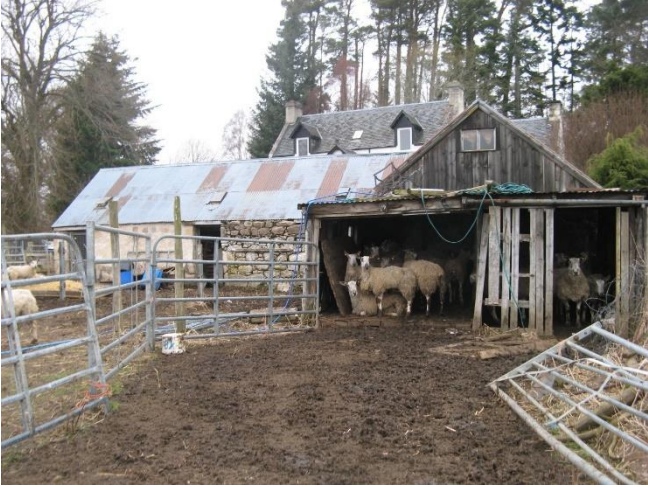
<p>Photograph 30</p>	<p>No evidence of current or historic bat roosting was recorded during the external inspections of the property and internal inspection was not possible. No evidence of bat emergence or return was recorded during activity surveys.</p> <p>Hibernation Roost Potential – Negligible</p> <p>Given the limited number of opportunities for roosting bats, albeit ample access/egress points are present, and the likely permanent presence of livestock use of the structure during the hibernation period, the building is considered to have negligible hibernation roost potential.</p>

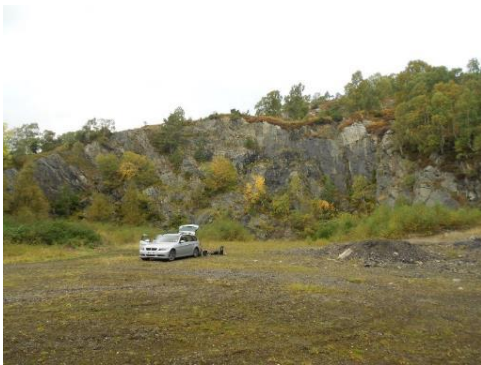
Description of Structure/ Building and Roost Location	Photographs of Structure/ Building	Roost locations and Hibernation Roost Potential
<p>RF01 – Lynwilg Quarry Face</p> <p>The quarry face is 40m wide by 25m high. There were numerous gaps and crevices in rock, and the rock escarpment is stepped at the north-east section. The upper sections of the rock escarpment could not be clearly surveyed from the ground even with binoculars and a torch.</p> <p>BRP – High</p>

<p>Whilst no roosts were identified during dusk emergence or dawn re-entry surveys, two roosts were recorded during aerial inspection surveys. A roost containing two common pipistrelle and a second roost containing three common pipistrelle were recorded during aerial surveys.</p> <p>The roost with two common pipistrelle recorded was surveyed on two separate occasions (26/9/17 and 02/11/17) with two bats present during the second visit. Given the time of year of the second visit it was considered that this is likely a hibernation roost.</p> <p>Roost Classification: Common pipistrelle – Non-breeding Common pipistrelle – Hibernation</p> <p>Hibernation roost potential (rest of rock face) – Moderate</p> <p>Given the limited knowledge surrounding hibernation roost selection, particularly in respect to rock faces, and in cognisance of the abundant features present along the rock face as well as the presence of two bats roosting during a roost inspection in November, the remainder of rock face RF01 has been assessed as of moderate potential to support roosting bats.</p>

- 4.2.11. Bat roosts were recorded in one rock face, RF01 (former Lynwilg quarry). This rock face has a variety of fissures and features with the potential to support roosting bats, particularly within the higher reaches of the rock face. Whilst no roosting activity was recorded during activity surveys (see Table 4.4 below), two roosts were identified during aerial inspection surveys, with two common pipistrelle recorded within an upwards facing crack at the northern end of the rock face (Annex A, Table 1.1 – ref. annotation 3). The roost was recorded as occupied by two bats on two separate survey visits (26/09/17 and 02/11/17). Given the date of the second visit to the roost and the continued presence of bats, the roost has been assessed to be a hibernation roost. A second roost was recorded at the southern end of the rock face (Annex A, Table 1.2 ref. annotations 14 & 15), with three common pipistrelle recorded within a cavity set amongst large boulders. The roost was judged to be a hibernation roost with the bats recorded on 02/11/17.

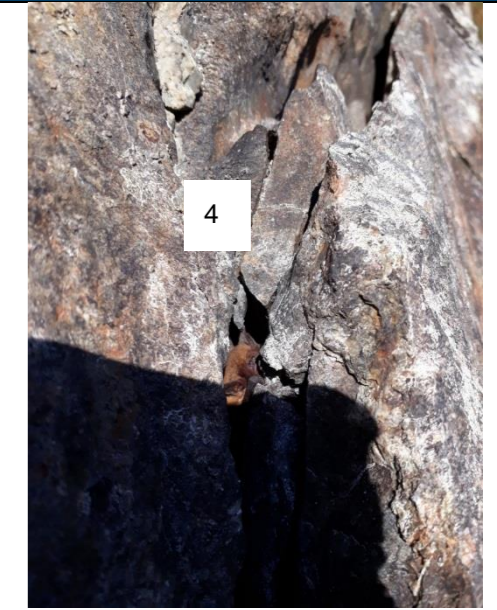
Good suitability for roosting bats in boulder outcrops in corner of quarry (ref. annotation 5) and cracks and crevices in rock from cliff top to c. 4m down face. Cracks lower down noted to be wet, often seeping water, and unsuitable for roosting bats. Large obvious cracks in main vertical headwall (ref. annotation 6) have areas of limited suitability only due to water ingress.

BRP High

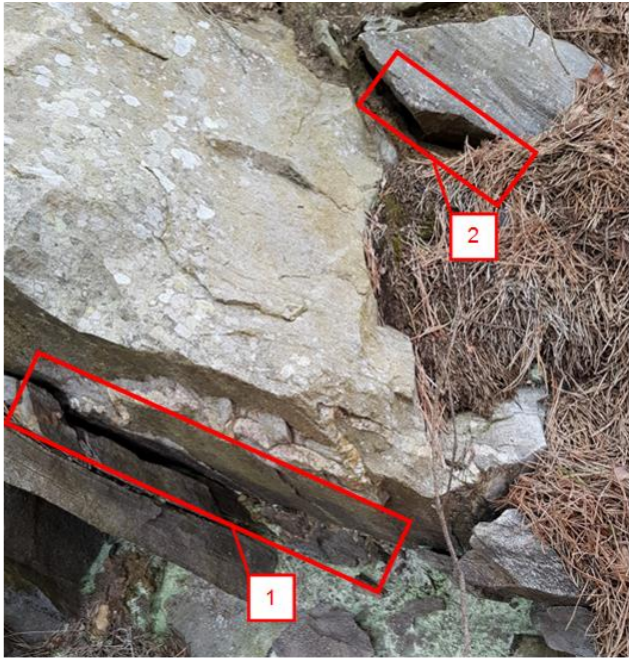
Description / Results Including Bat Roost Potential (BRP) and Potential Roost Features (PRF)	Photograph
<p>Cavity in between two sheets of rock, c. 25cm long and 10cm deep. Feature is low and amongst trees - Low BRP. (ref. annotation 1)</p> <p>Gap under a rock and extending into a cavity which cannot be fully inspected (ref. annotation 2). - Low BRP.</p>

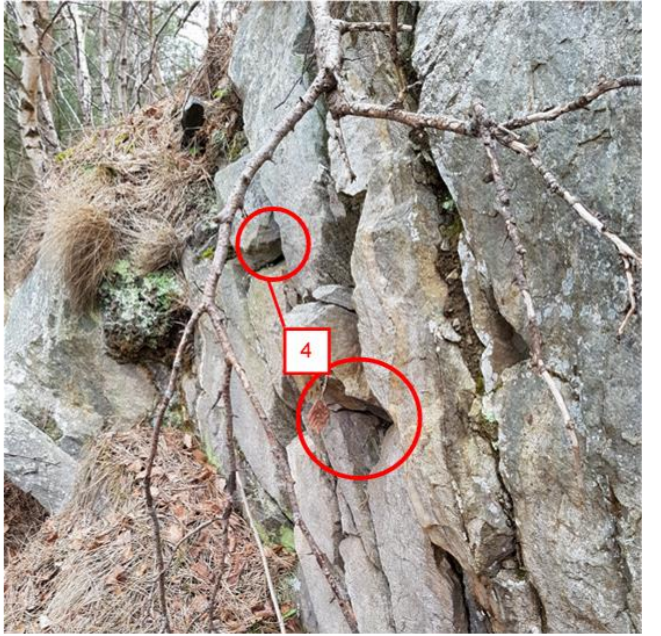
Description / Results Including Bat Roost Potential (BRP) and Potential Roost Features (PRF)	Photograph
<p>A few small gaps up and under rocks on a sheer face, inaccessible on foot to inspect (ref. annotation 4).</p> <p>Moderate BRP.</p>

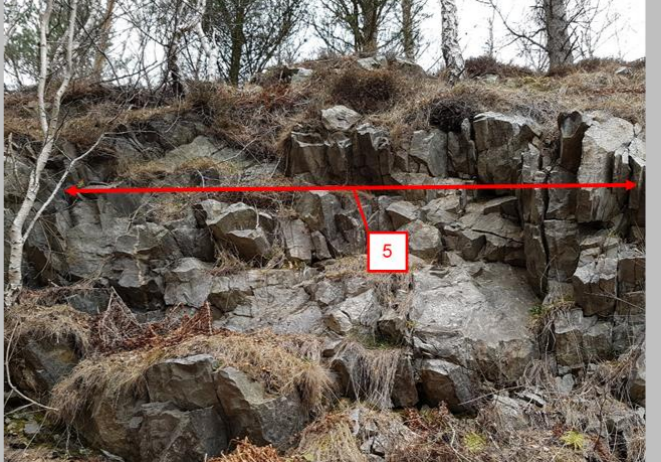
<p>10m length of rock face which could only be torched from the ground. Numerous crevices and cavities between sheets of rock although they don't appear to be deep. There is lots of dead grass which in summer will cover some of the features. There are areas with water running through which will be unsuitable for bats (ref. annotation 5).</p> <p>Moderate BRP.</p>

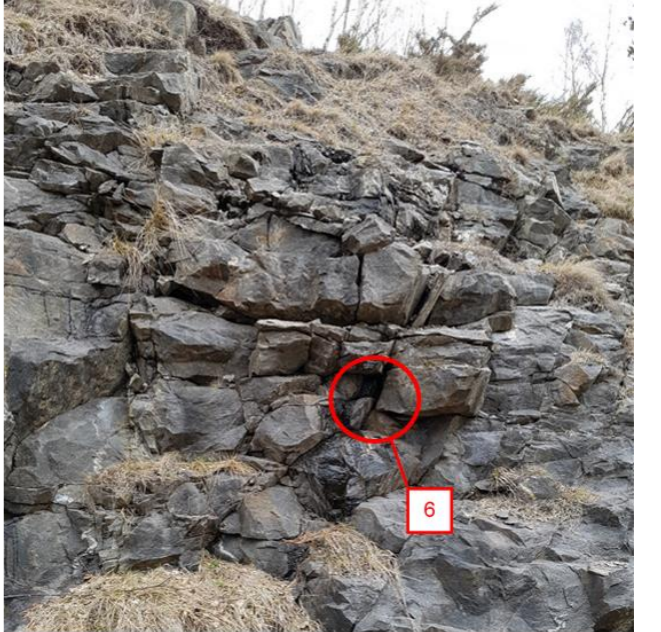
<p>Gaps in between rocks which extend back and cannot be fully inspected (ref. annotation 6).</p> <p>Low BRP.</p>

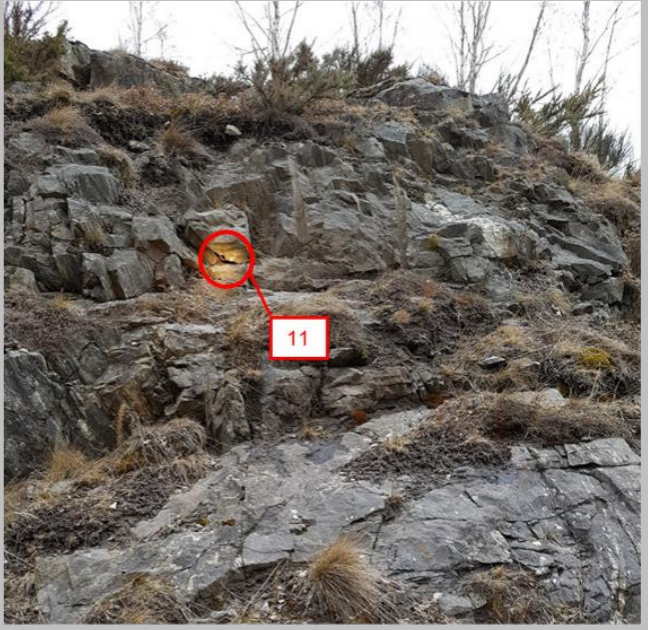
Description / Results Including Bat Roost Potential (BRP) and Potential Roost Features (PRF)	Photograph
<p>Crevices under a rock but can't fully inspect as the feature cannot be reached from on foot (ref. annotation 11).</p> <p>Low BRP.</p>

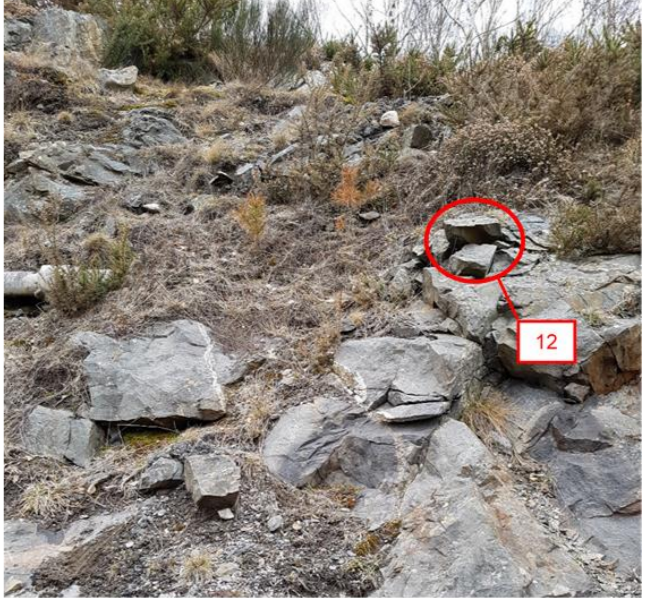
<p>Piles of rocks with cavities and crevices extending behind. Complex feature means it cannot be surveyed by endoscope due to the multiple directions the cavities travel in (ref. annotation 12).</p> <p>Low BRP.</p>

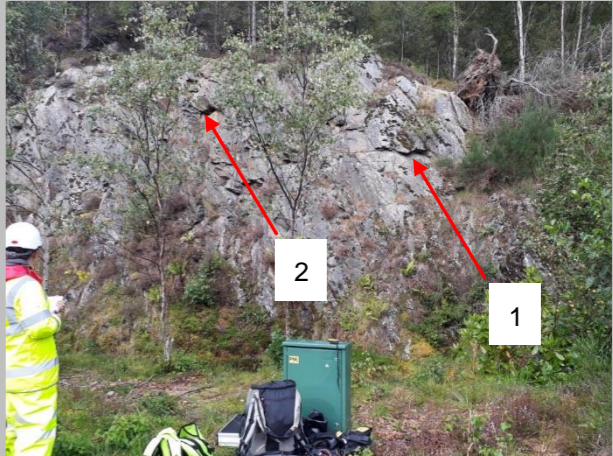
Description / Results Including Bat Roost Potential (BRP) and Potential Roost Features (PRF)	Photograph
<p>Northern end of rock face.</p> <p>Large crack in psammite c. 2m beneath top (ref. annotation 1). Roost identified (289068 811258) - Bat dropping of pipistrelle type within crack but not possible to recover. Large complex cavity extending into face behind crack. No bats observed through endoscope inspection.</p> <p>Large crack exposed from area of fallen psammite with complex cavity extending up c. 3m and out of sight (ref. annotation 2).</p> <p>One confirmed roost, with remainder of rock face of Moderate BRP.</p>

- 4.2.12. Rock face RF04, located south of Aviemore and illuminated at night, has numerous fissures and features present along much of the length of the rock face. Potential roost features were limited towards the southern end of the face due to recent rock fall and loose material. A single dropping, likely of pipistrelle species (dropping unable to be recovered for analysis), was recorded at the northern end of the rock face (Annex A, Table 1.4 – ref. annotation 1), however, no bats were recorded during the aerial inspection.

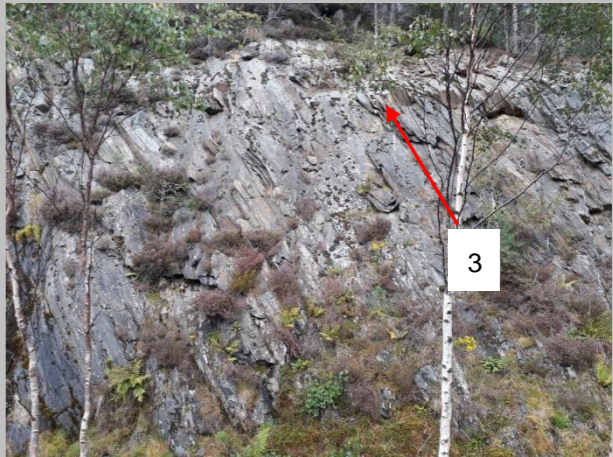
Description / Results Including Bat Roost Potential (BRP) and Potential Roost Features (PRF)	Photograph
<p>Northern end of rock face. Large cracks in psammite predominantly in first 3m beneath top of face, leading to complex cavities extending into face behind crack. Jackdaw nest recorded within cavity (ref. annotation 3).</p> <p>BRP High</p>

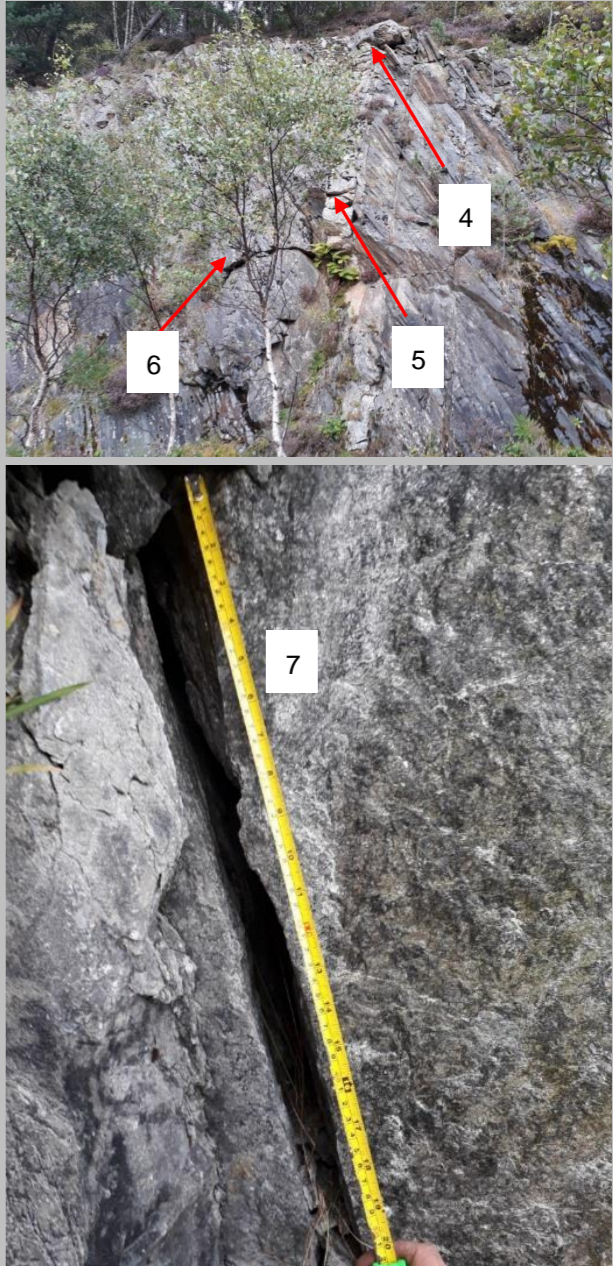
<p>Northern end of rock face Large cavity beneath boulder at top of face: jackdaw nest recorded within cavity (ref. annotation 4). Large gaps recorded around quartzite seam in psammite (ref. annotation 5). Large cracks in psammite extending back c. >1.5m and out of sight (ref. annotation 6): no bat roost evidence observed through endoscope inspection.</p> <p>BRP High</p> <p>Photo annotation 7 illustrates example of crack in psammite with good suitability for roosting bats.</p>

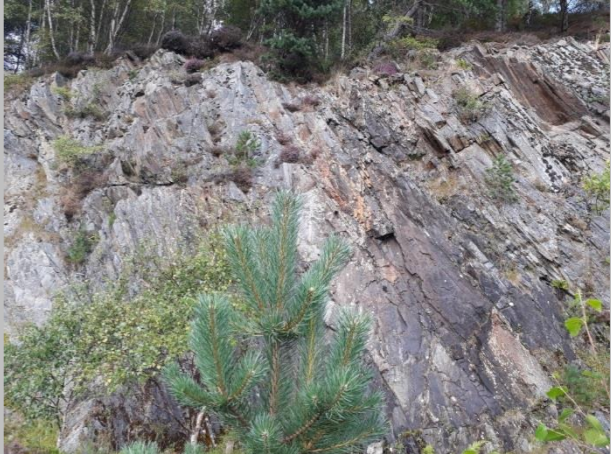
Description / Results Including Bat Roost Potential (BRP) and Potential Roost Features (PRF)	Photograph
<p>Northern end of rock face. Area with fewer cracks and features with bat roost potential than sections to east. Quartzite becoming more prevalent with loose material on face.</p> <p>BRP Low</p>

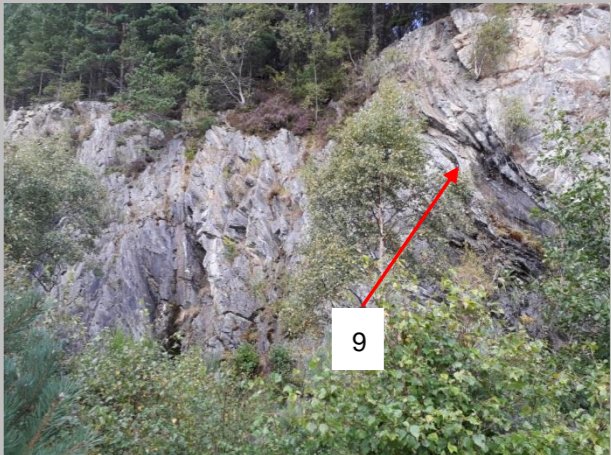
<p>Northern central rock face. Section with quartzite/psammite interface (ref. annotation 9). Some limited suitability for roosting bats noted within cracks in consolidated psammite immediately south of interface; no suitability recorded in quartzite.</p> <p>BRP Low</p>

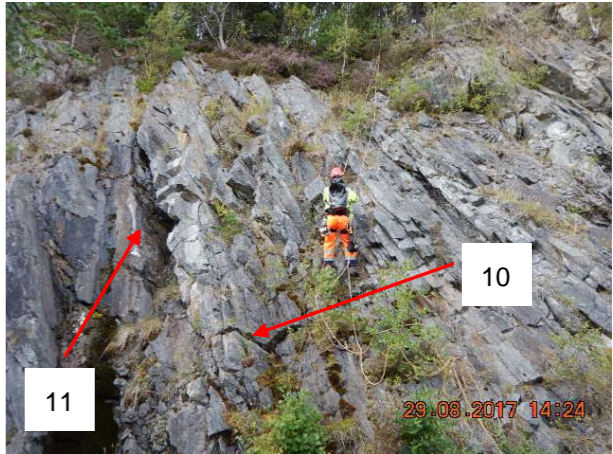
Description / Results Including Bat Roost Potential (BRP) and Potential Roost Features (PRF)	Photograph
<p>Northern central rock face. Crack with good suitability for roosting bats c. 3m above base of rock face (ref. annotation 10). Cavity extends up behind cleft for c. 1.2m. Other cracks above noted to be of limited suitability due to shallowness. Predominantly damp but gaps of limited suitability behind large flake c. 3m below top of rock face. Drill holes also present, again providing limited suitability for roosting bats (ref. annotation 11).</p> <p>BRP Moderate</p>

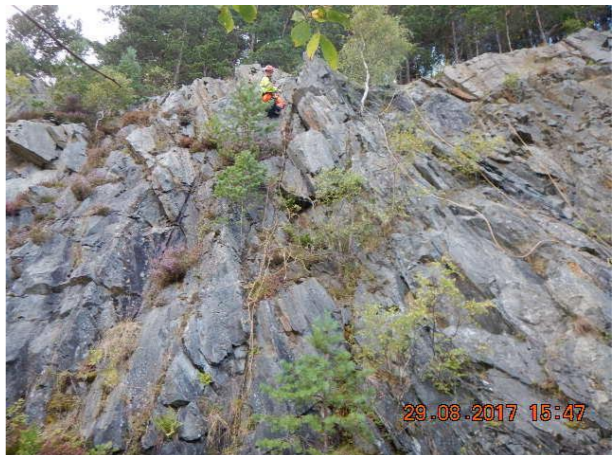
<p>Central rock face. Large cavities behind psammite blocks c. 3m from top of rock face provide good suitability for roosting bats. Jackdaw nest present.</p> <p>BRP High</p>
