Appendix 12.5

Bats

Transport Scotland

August 2018

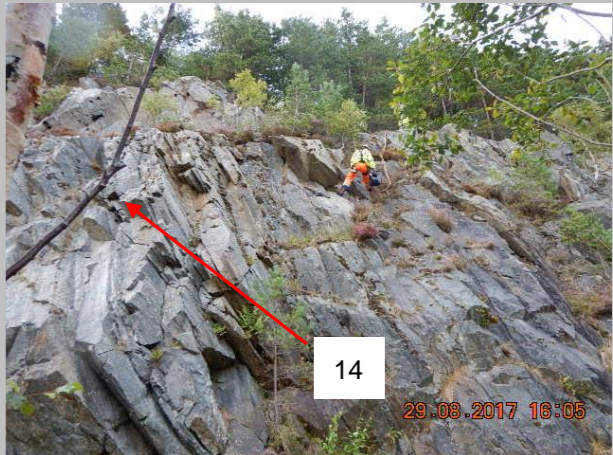
Description / Results Including Bat Roost Potential (BRP) and Potential Roost Features (PRF)	Photograph
<p>Central rock face. Several large cracks in psammite provide good suitability for roosting bats across length of face inspected. Drill holes (ref. annotation 14) present and as blocked at top provide suitable bat roost features.</p> <p>BRP High</p>

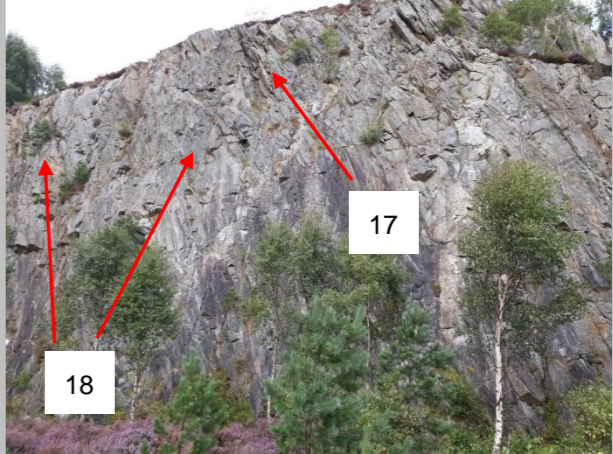
Description / Results Including Bat Roost Potential (BRP) and Potential Roost Features (PRF)	Photograph
<p>Southern central rock face. Areas of large cracks and crevices behind layers and outcrop provide good suitability for roosting bats (ref. annotation 17). Occasional cracks and two drill holes provide suitable bat roost features on fairly blank main face to south of rib (ref. annotation 18). Jackdaw nests present in large cavities near top of face.</p> <p>BRP High</p>

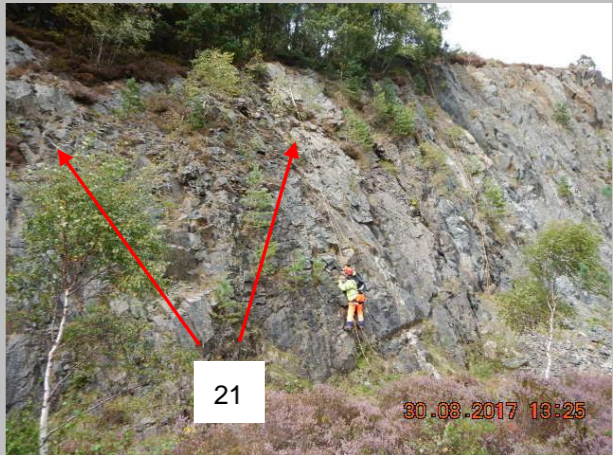
<p>Southern end rock face. Section has recent rockfall and very loose material: no suitability for roosting bats (ref. annotation 21).</p> <p>BRP Unsuitable</p>

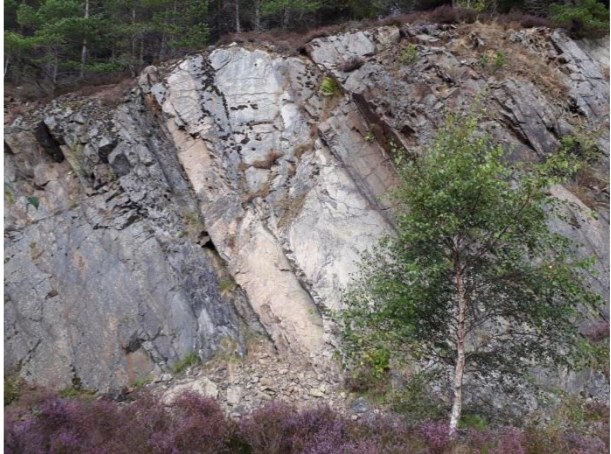
Description / Results Including Bat Roost Potential (BRP) and Potential Roost Features (PRF)	Photograph
<p>Southern end rock face. Section largely unsuitable for roosting bats; one small crack between bedding plane in smooth section provides very limited suitability. Section for c. 10m to south has very loose material: no suitability for roosting bats</p> <p>BRP Negligible</p>

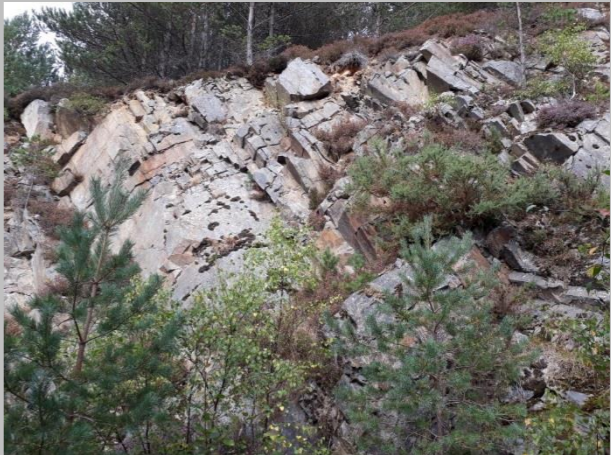
<p>Southern end rock face. Section largely unsuitable for roosting bats; few cracks amongst blocks at top of face provide very limited suitability. Becomes vegetated (pine, birch and gorse) at southern end of rock face.</p> <p>BRP Negligible</p>

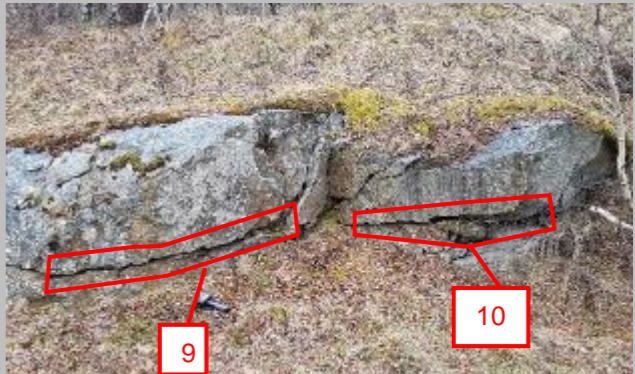
Description / Results Including Bat Roost Potential (BRP) and Potential Roost Features (PRF)	Photograph
<p>Open crevice which can be fully inspected with a torch, and seen to be more open to the elements (ref. annotation 10)</p> <p>BRP Low</p>

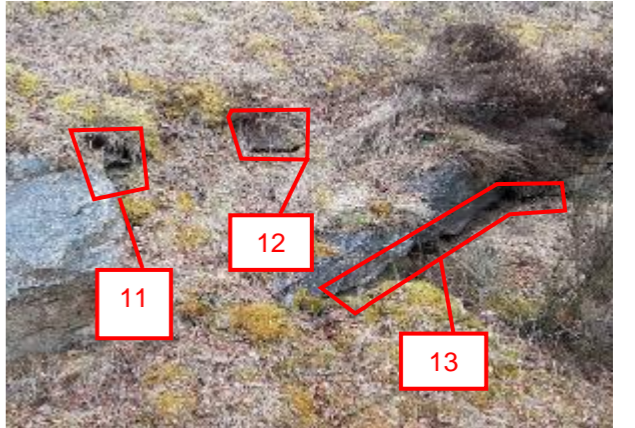
<p>Small hole with vegetation all around. Can be fully inspected with a torch (ref. annotation 11)</p> <p>BRP Low</p> <p>Shallow gap with no protection from the elements (ref. annotation 12)</p> <p>BRP Negligible</p> <p>Rock overhang with a shallow open gap beneath (ref. annotation 13)</p> <p>BRP Negligible</p>

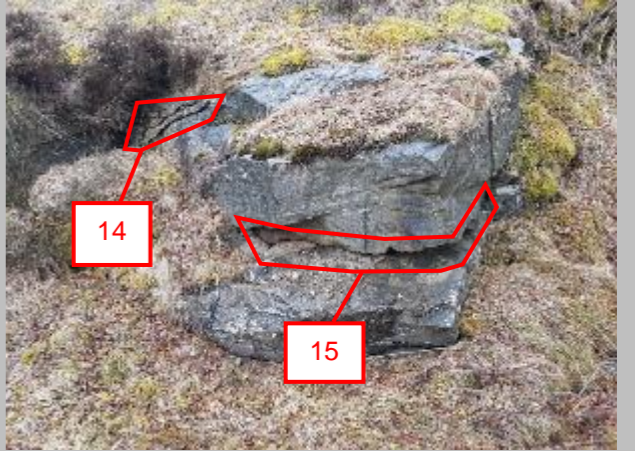
<p>Narrow gaps that could not be fully inspected with an endoscope. Gaps have running water through them (ref. annotation 14)</p> <p>BRP Negligible</p> <p>Large horizontal gap; could not be fully inspected with an endoscope, gap narrows down towards back (ref. annotation 15)</p> <p>BRP Moderate</p>

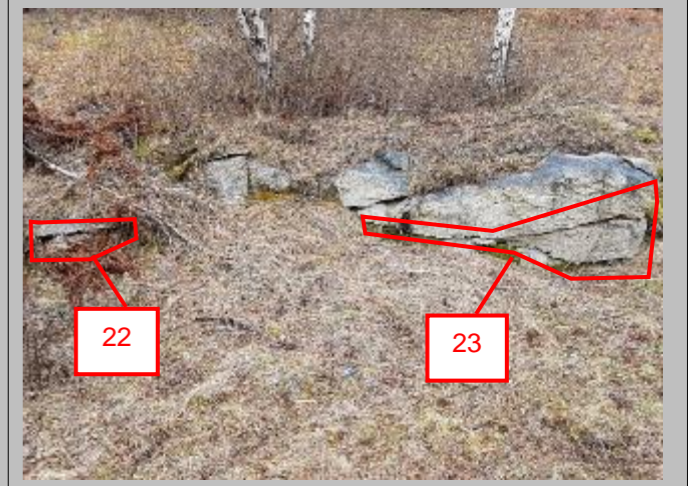
<p>Narrow gap which is filled with bracken (ref. annotation 22) BRP Negligible</p> <p>Long narrow gap which was unable to be fully inspected in sections (ref. annotation 23) BRP Low</p>

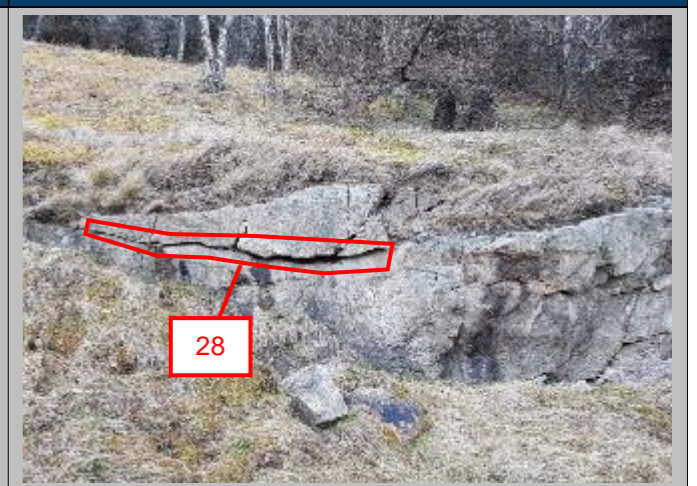
Description / Results Including Bat Roost Potential (BRP) and Potential Roost Features (PRF)	Photograph
<p>Shallow gap narrows quickly, could not be fully inspected (ref. annotation 28)</p> <p>BRP Low</p>

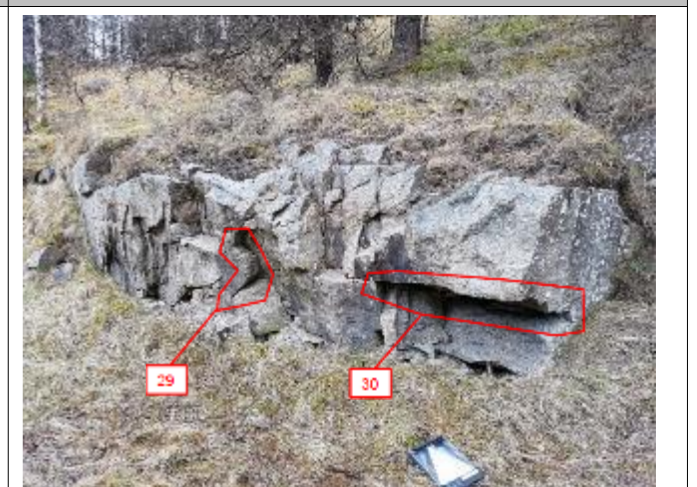
<p>Narrow gap behind the rock face, extending inwards from the side. Could not be fully inspected (ref. annotation 29)</p> <p>BRP Low</p> <p>Large gap which narrows as it extends backwards. Dry and sheltered gap. Could not be fully inspected (ref. annotation 30)</p> <p>BRP Low</p>

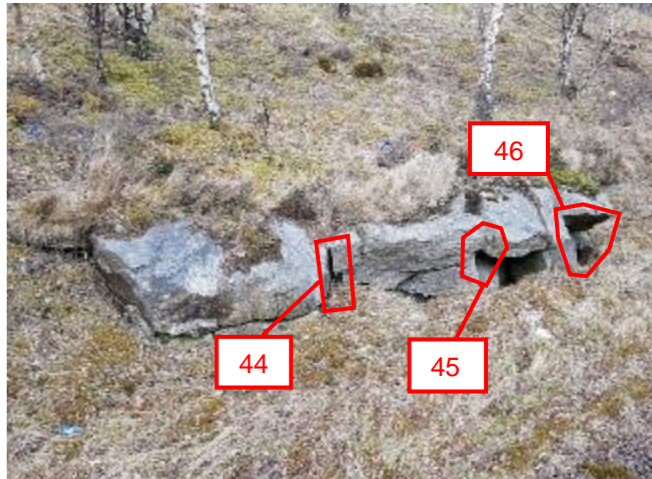
Description / Results Including Bat Roost Potential (BRP) and Potential Roost Features (PRF)	Photograph
<p>Vertical cavity, extends backward and narrows, extends downwards. Could not be fully inspected (ref. annotation 44) BRP Low</p> <p>Vertical cavity, extends backward and narrows, extends downwards. Could not be fully inspected (ref. annotation 45) BRP Low</p> <p>Vertical cavity, extends backward and narrows, extends downwards. Could not be fully inspected (ref. annotation 46) BRP Low</p>

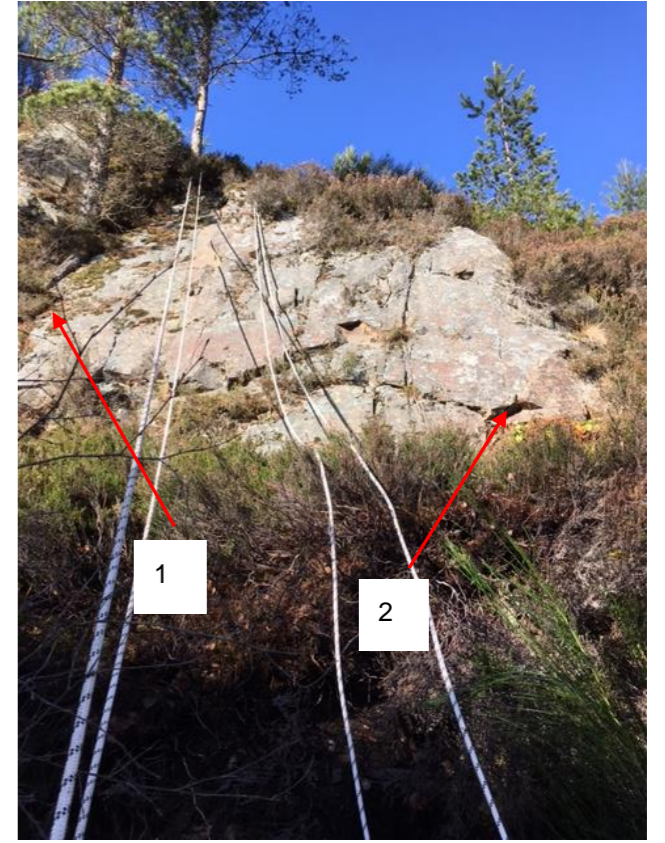
Occasional cracks in rock from cliff top all way down face but only two noted to provide roost suitability. No evidence of bats.

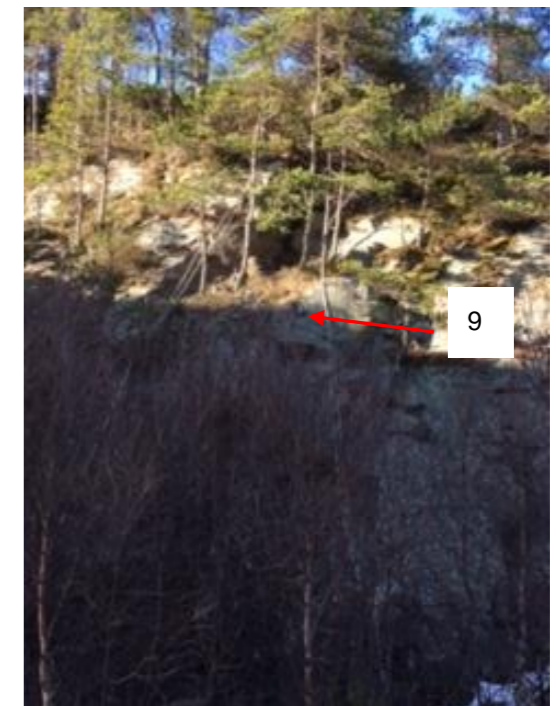
Section of very low suitability for roosting bats due to an almost complete lack of crevices in larger slabs forming middle and lower section of slope.

One suitable crevice identified in upper section, just below treeline. Feature vertical and extending c. 10cm into rock. Entrance c. 15cm x 2cm (ref. annotation 9).

BRP Low

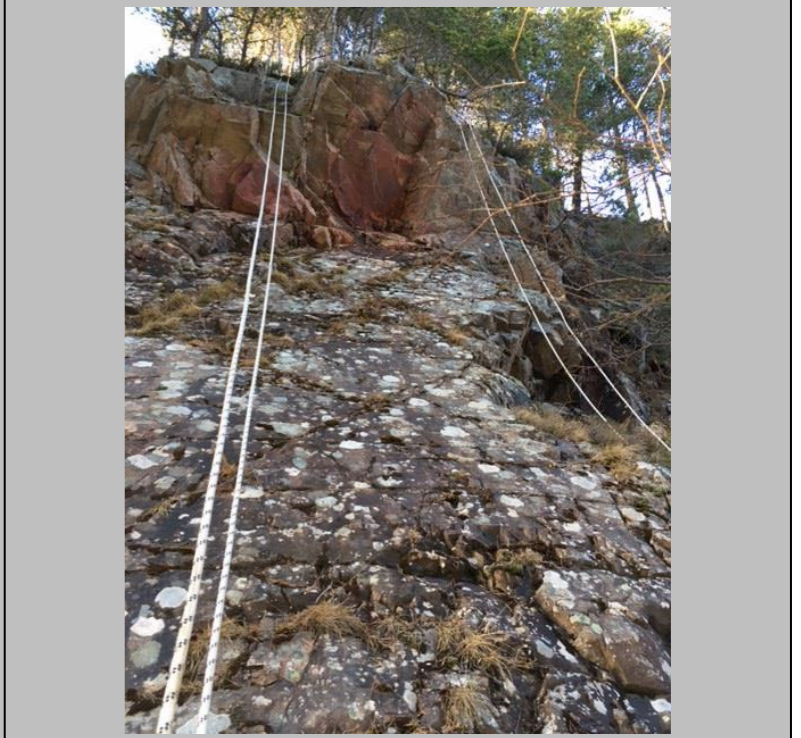
No suitable bat roost features identified.

BRP Unsuitable

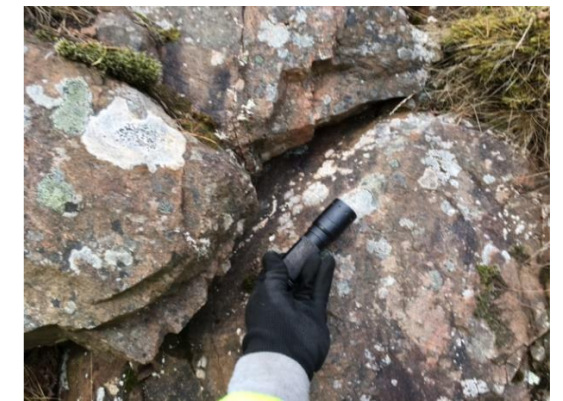
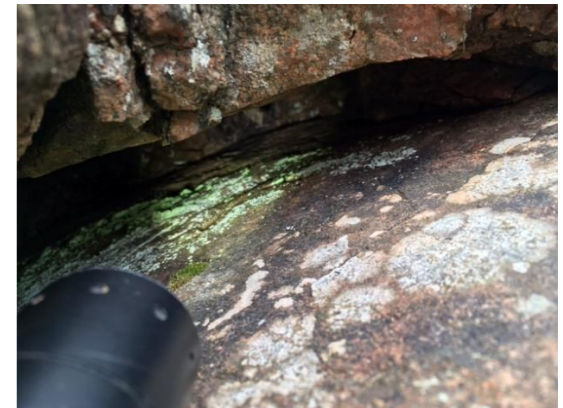
Gully section of rock face between two slabbed overhang sections. Loose rock prevalent. One suitable bat roost feature identified near the base:
 Ref. annotation 10- Suitable crevice for roosting bats under rock slab c. 3 m above base of rock face. Feature c. 40cm in length, extending c. 25cm into rock with an entrance 5cm high. No evidence of bats but the feature was clear and free of debris.

BRP Moderate

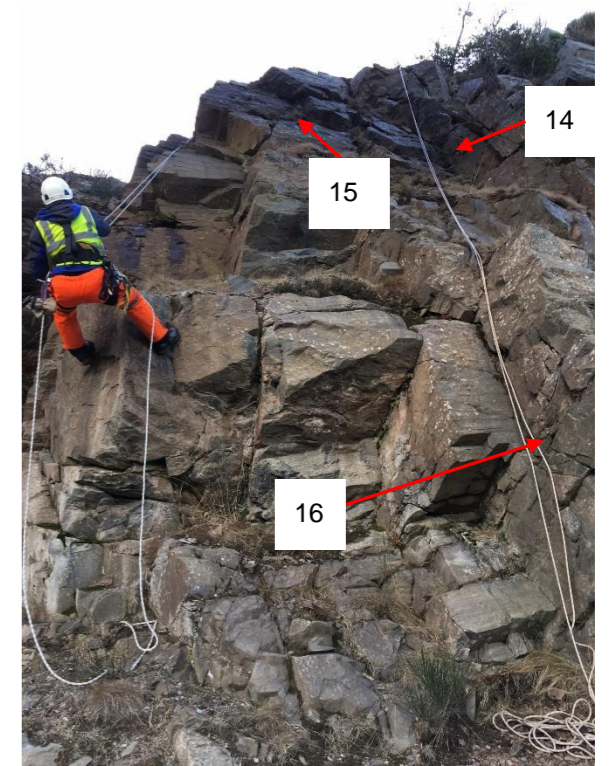
Section covering corner of rock face almost directly beneath A9 road bridge. Large vertical cracks present at the top section to the left of the corner provide excellent suitability for roosting bats. The large slab of rock to the right provides few small shallow cracks of limited suitability for roosting bats and no features considered worth detailing.

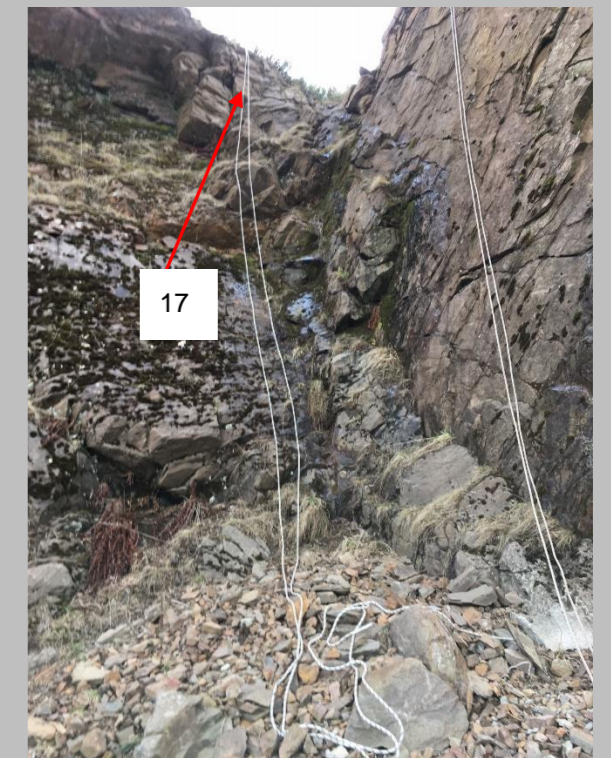
Ref. annotation 17 – Slab containing vertical cracks which extend deep into rock. Crevices c. 1m high with entrances (c. 5cm) leading to internal cavities. No evidence of roosting bats identified.

BRP High

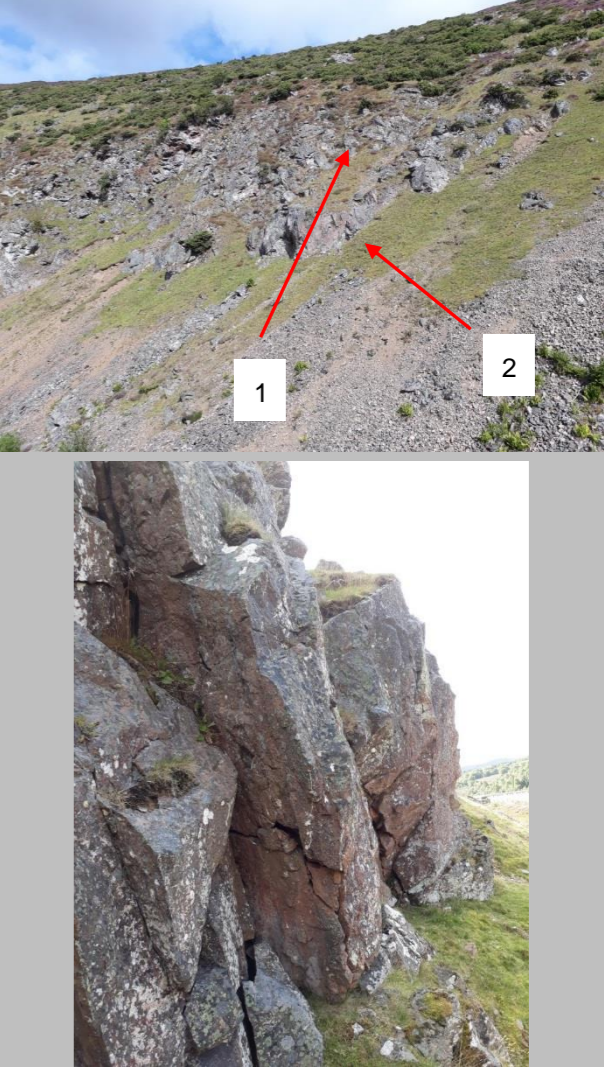
<p>Vegetated overhang largely unsuitable for roosting bats due to lack of suitable cavities/cracks: occasional shallow cracks provide limited suitability (ref. annotation 3). Section for c. 9m to north composed of unconsolidated material/loose rock with no suitability for roosting bats present.</p> <p>BRP Low</p>

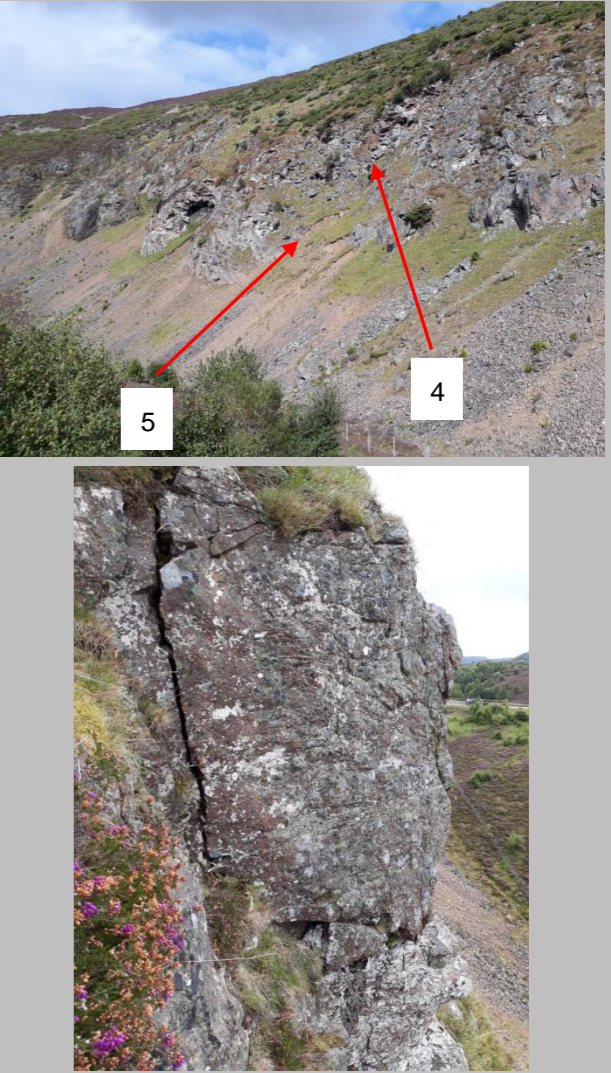
<p>Large overhang section between buttresses. Survey access not possible as considered too dangerous through prevalence of very loose material. Good suitability for roosting bats with cracks and cavities amongst blocks of rock and into overhang when viewed from ground level and from adjacent abseils.</p> <p>BRP High</p>

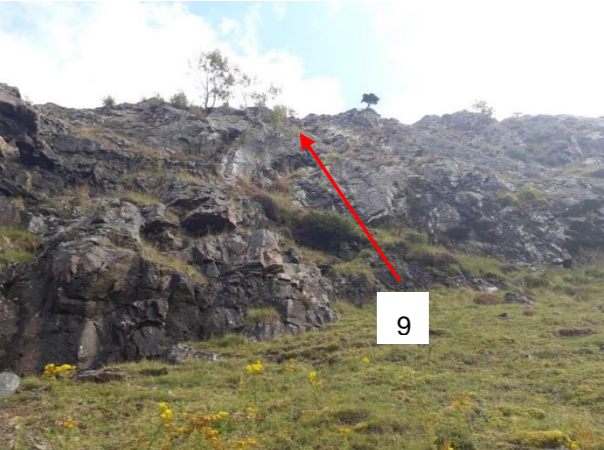
Description / Results Including Bat Roost Potential (BRP) and Potential Roost Features (PRF)	Photograph
<p>Good suitability for roosting bats in cracks in outcrop area around rowan and aspen (ref. annotation 9). Cracks in surrounding outcrop sections (including beneath suitable outcrop) noted to be wet and often running with water.</p> <p>BRP Moderate</p>

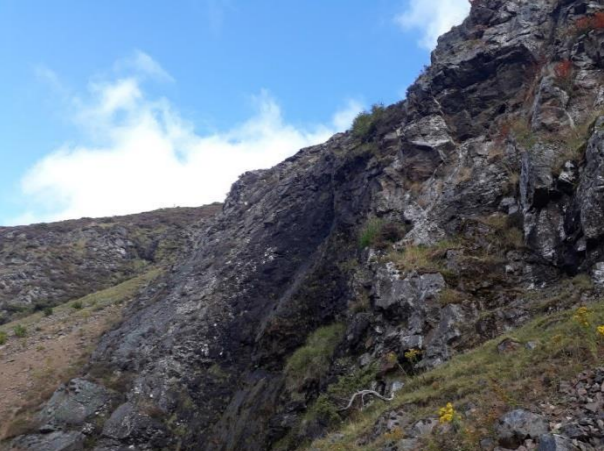
<p>Wet section of shallower gradient with no suitability for roosting bats noted.</p> <p>BRP Unsuitable</p>

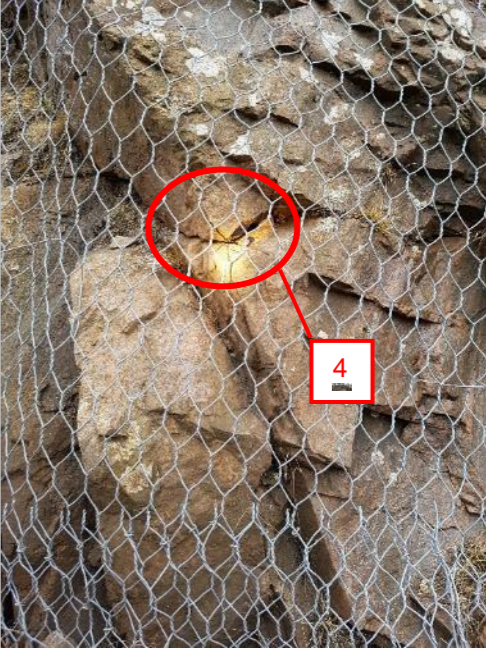
Description / Results Including Bat Roost Potential (BRP) and Potential Roost Features (PRF)	Photograph
<p>Crevice leading under rocks, 1.5m above ground level (ref. annotation 4).</p> <p>BRP Low</p>

A photograph showing a crevice leading under rocks, 1.5m above ground level. A red circle highlights a specific feature, and a red box with the number '4' is connected to it by a line.
<p>Crevice at the side of and under rocks, 1.5m above ground level (ref. annotation 5) –</p> <p>BRP Low</p>

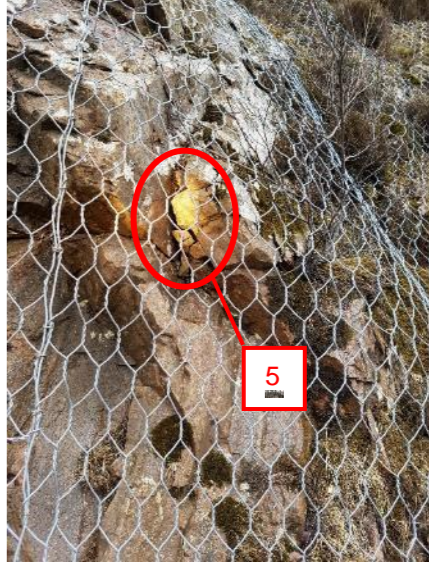
A photograph showing a crevice at the side of and under rocks, 1.5m above ground level. A red circle highlights a specific feature, and a red box with the number '5' is connected to it by a line.
<p>Cavity and gaps around the sides of the rocks (ref. annotation 6).</p> <p>BRP Low</p>

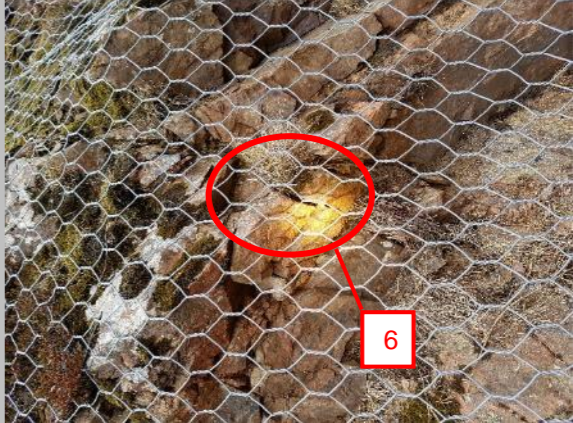
A photograph showing a cavity and gaps around the sides of the rocks. A red circle highlights a specific feature, and a red box with the number '6' is connected to it by a line.

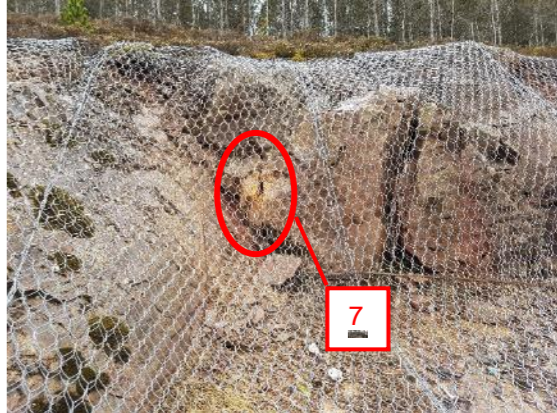
Description / Results Including Bat Roost Potential (BRP) and Potential Roost Features (PRF)	Photograph
<p>Vertical crack in recessed area of rock (ref. annotation 7).</p> <p>BRP Moderate</p>

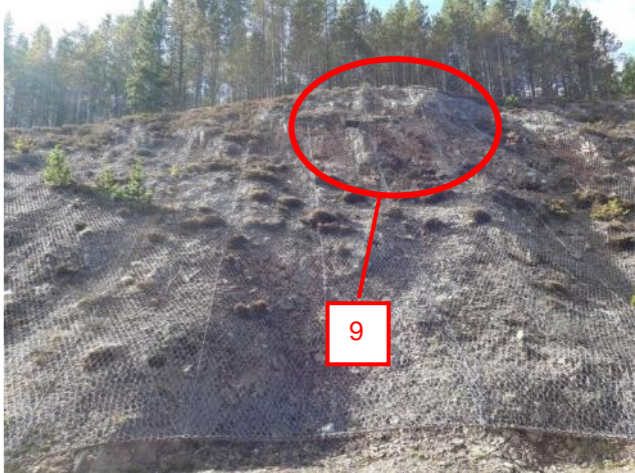
<p>Slightly steeper section of outcrop at top of slope with occasional shallow (<20cm) cracks. Material beneath rock mesh noted to be extremely unstable (ref. annotation 9).</p> <p>BRP Low</p>

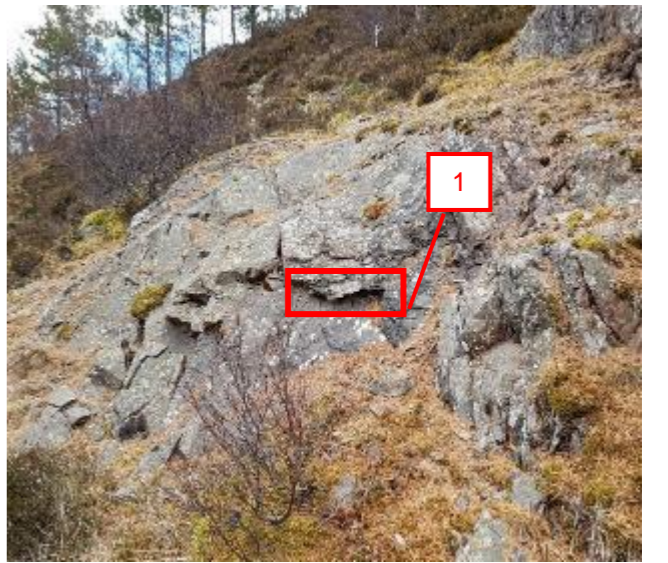
Description / Results Including Bat Roost Potential (BRP) and Potential Roost Features (PRF)	Photograph
<p>Recess under sheet of rock. Extends back about 15cm. The feature is dry but low to the ground (ref. annotation 1). BRP Low</p>

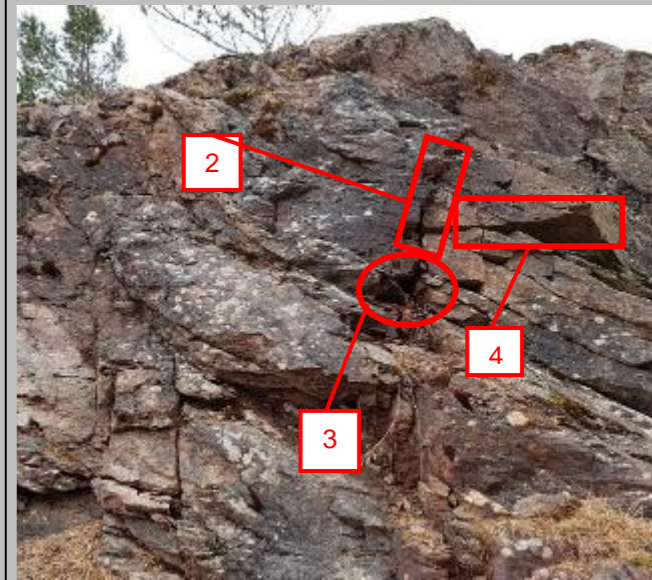
<p>A deeper gap between two rocks. The feature extends back about 25cm and is approximately 8cm high. The gap can be fully viewed. Partially covered by moss/heather (ref. annotation 5) – Low BRP.</p>

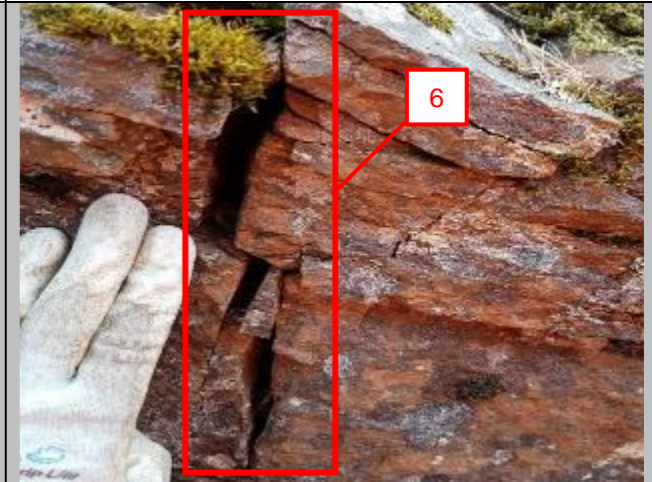
<p>Vertical crack in rock which is dry inside. Quite a tight gap but potentially room for one bat to squeeze in (ref. annotation 6).</p> <p>BRP Low</p>

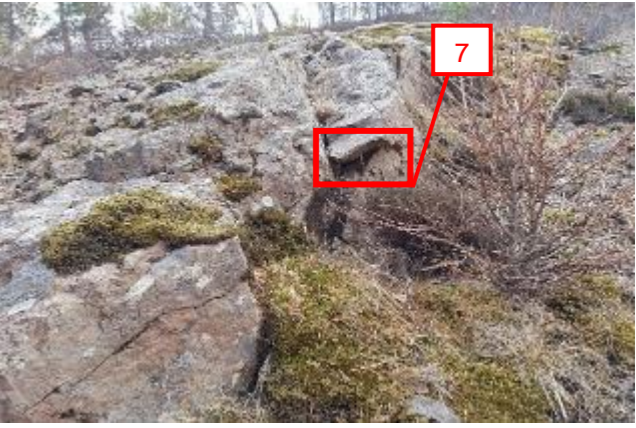
Description / Results Including Bat Roost Potential (BRP) and Potential Roost Features (PRF)	Photograph
<p>Crevice underneath a small outcrop of rock. The feature is very close to the ground and partially covered with heather, larch saplings and grass (ref. annotation 7)</p> <p>BRP Low</p>

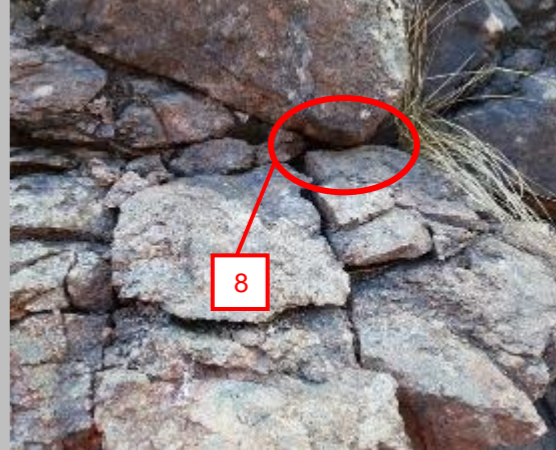
<p>Complicated crevice which extends in various directions into the rock. Cannot be fully inspected with the endoscope due to the complexity of the feature (ref. annotation 8).</p> <p>BRP Moderate</p>

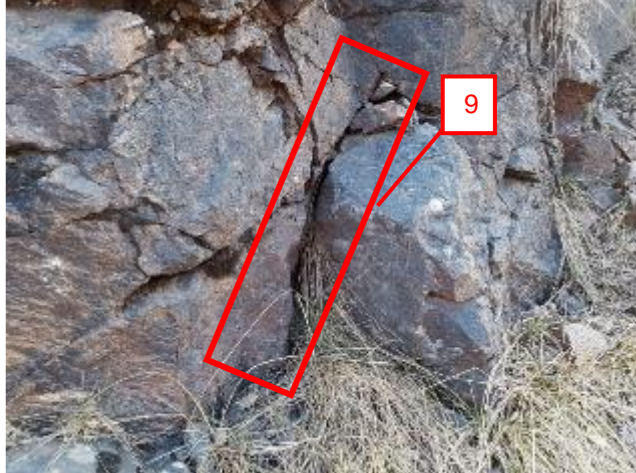
<p>Vertical crevice between rocks, it narrows towards the back of the feature. It is around 15cm high, although the lower part is obscured by grass (ref. annotation 9).</p> <p>BRP Low</p>

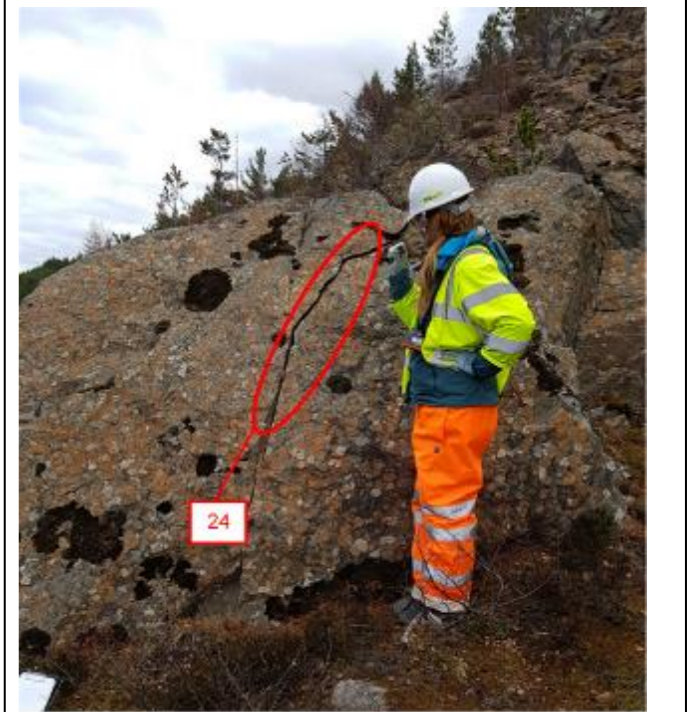
<p>Features underneath boulders and vertical crack in stone. Potential small mammal burrow underneath rock (bedding inside) and rabbit skull outside (ref. annotation 25).</p> <p>BRP Low</p>

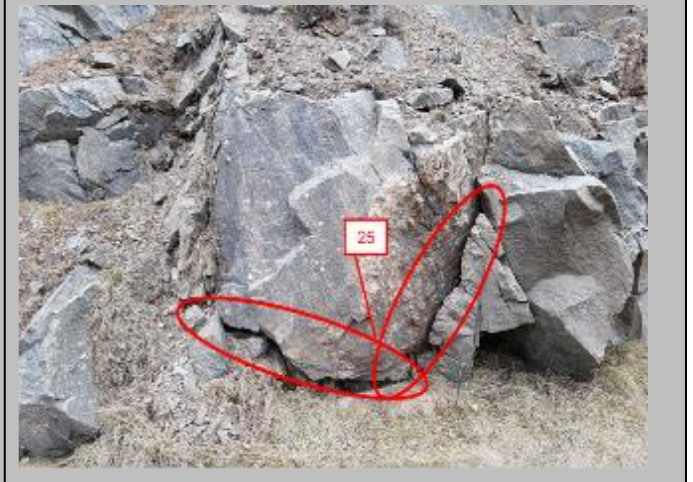
<p>Cracks where stone has broken away; shallow but potential space for a single bat (ref. annotation 26) – BRP Low</p> <p>Crack in rock, open at top but may be dry at the bottom due to the zig-zag shape of the feature (ref. annotation 27) – BRP Low</p> <p>Horizontal crack in rocks (ref. annotation 28) –BRP Low</p> <p>Gap behind overhang of rock, although feature is low to the ground (ref. annotation 29) - BRP Low</p>

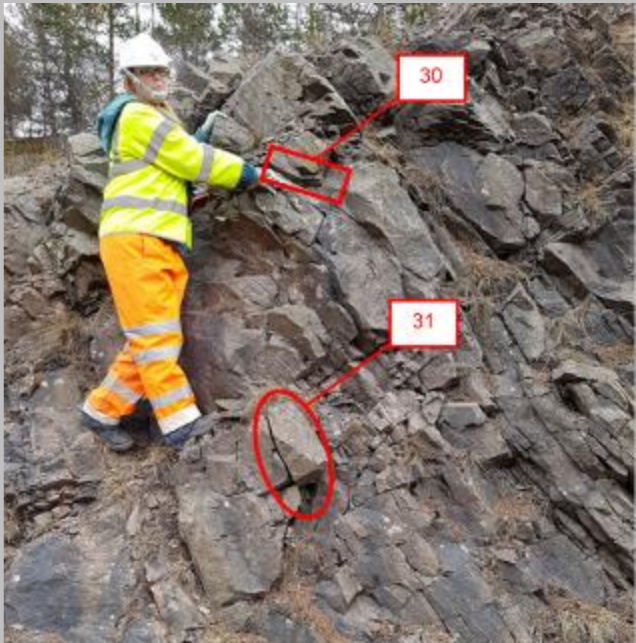
<p>Many areas of shallow features where rock is shearing away in layers. Feature shown in photo (ref. annotation 32)</p> <p>BRP Low</p>

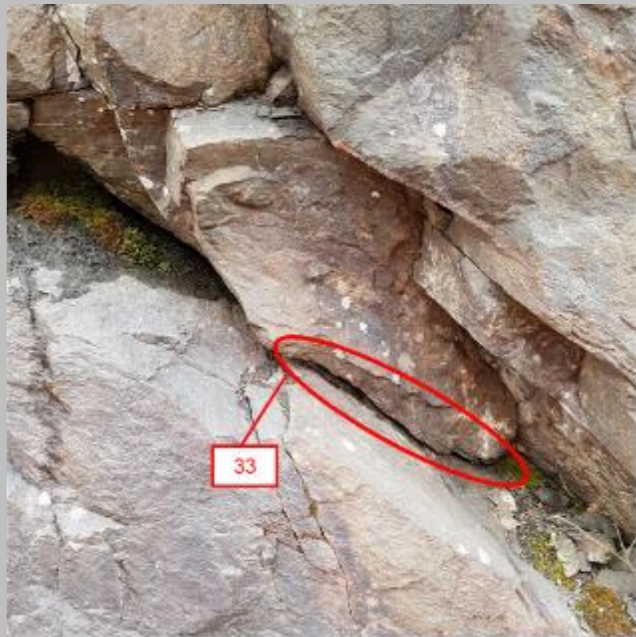
<p>Diagonal crack on a small rock about 30cm long and 15cm deep with a vertical hole on other face of the rock (ref. annotation 34) –</p> <p>BRP Low</p> <p>Deep hole immediately behind which cannot be fully inspected and extends far into the rock –</p> <p>BRP Moderate</p>

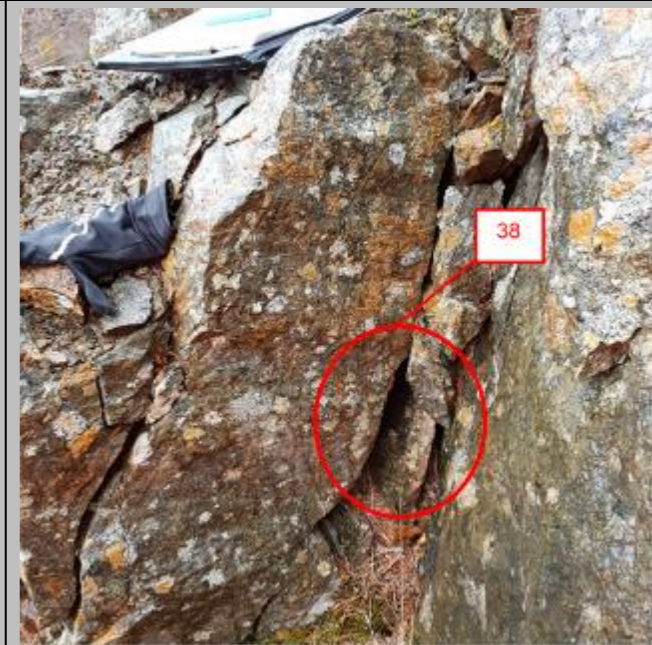
Description / Results Including Bat Roost Potential (BRP) and Potential Roost Features (PRF)	Photograph
<p>Deep cavity in corner between rocks; cannot be fully inspected (ref. annotation 38)</p> <p>BRP Moderate</p>

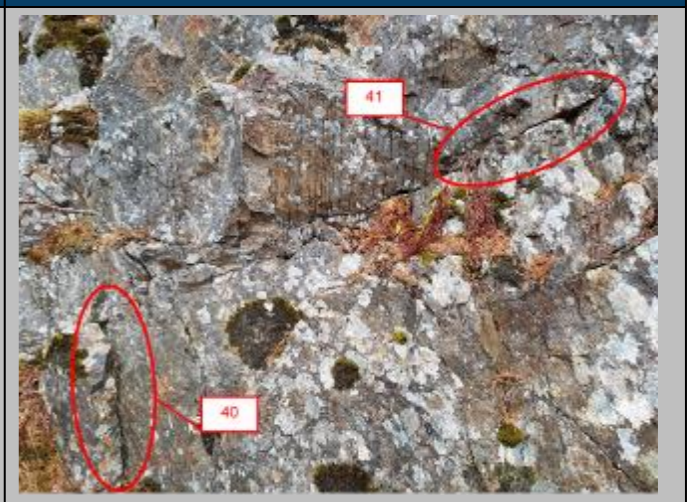
<p>Small hole (5cm x 2cm) leading into rock which can't be fully inspected as endoscope won't manoeuvre inside (ref. annotation 42) BRP Low</p>

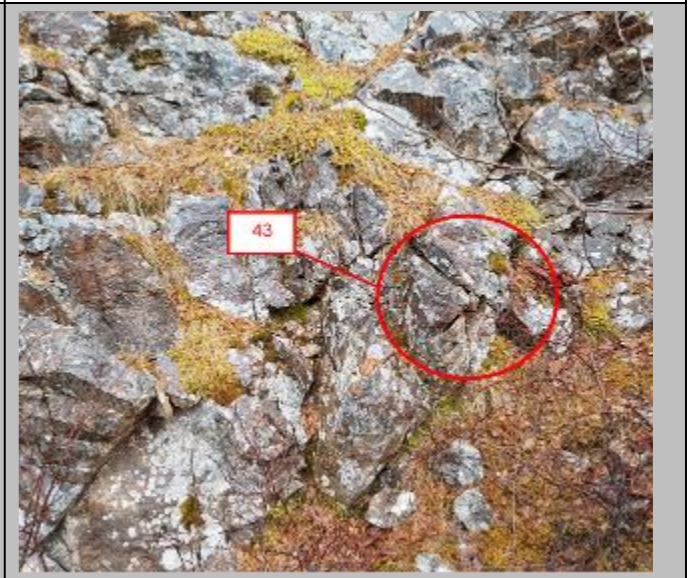
<p>Multiple small cavities (ref. annotation 43) BRP Low</p>

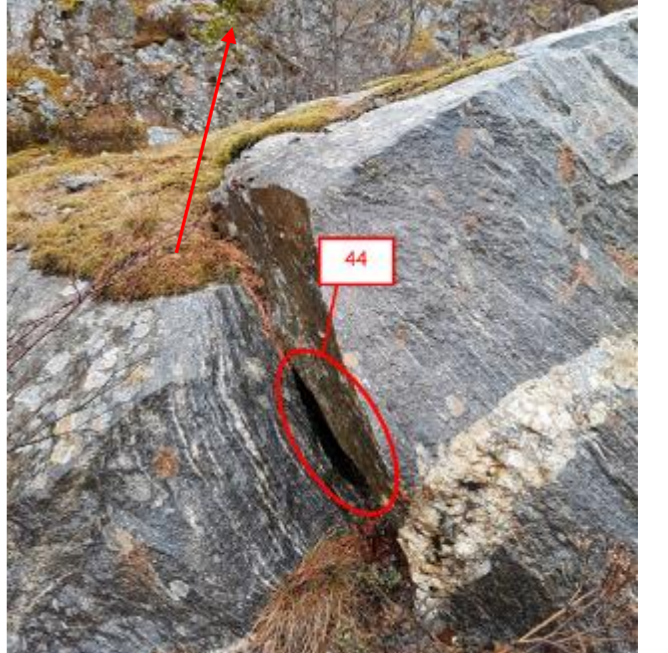
Description / Results Including Bat Roost Potential (BRP) and Potential Roost Features (PRF)	Photograph
<p>Cavity between two rocks extends quite far back although is relatively open and other animals may be able to access (ref. annotation 44).</p> <p>BRP Low</p>

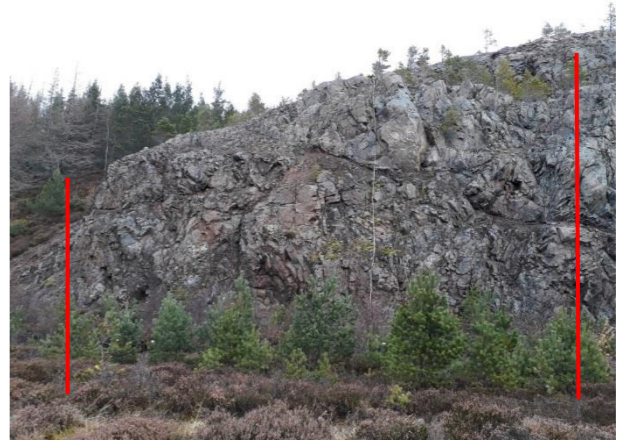
Description / Results Including Bat Roost Potential (BRP) and Potential Roost Features (PRF)	Photograph
<p>Western end of rock face – composed of distinct upper and lower section with bench between. Much of face very unstable. Gaps apparent from base found to be very shallow on close inspection and no suitability for roosting bats identified (area of unsuitability as indicated by vertical red lines on photograph).</p> <p>BRP Unsuitable</p>

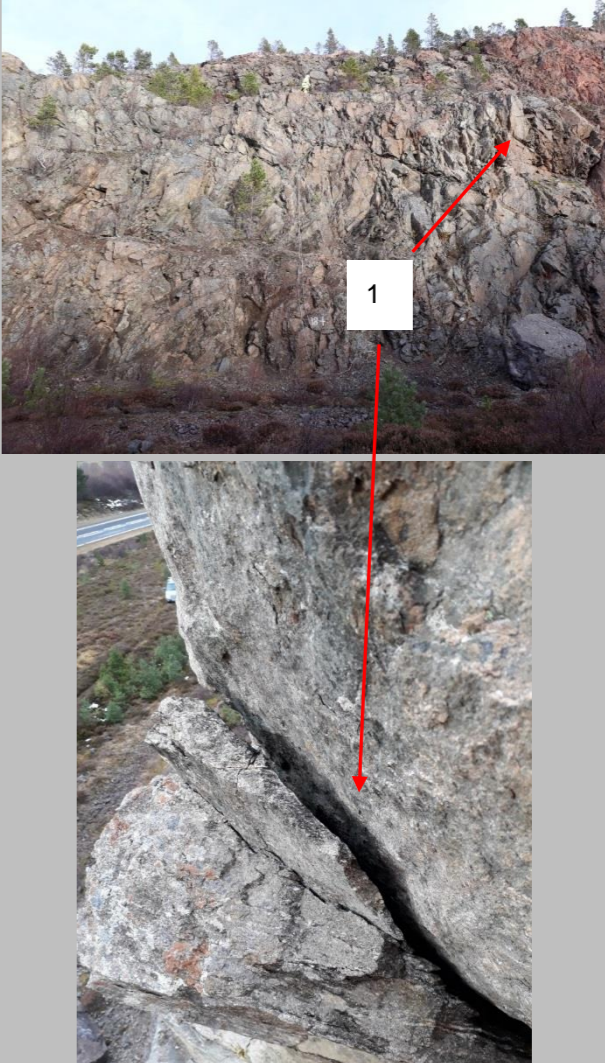
<p>Western central rock face. Occasional fractures in outcrops where more stable material is present on lower half of face. Upper half of face composed of very loose material with no suitability for roosting bats identified.</p> <p>BRP Moderate</p>

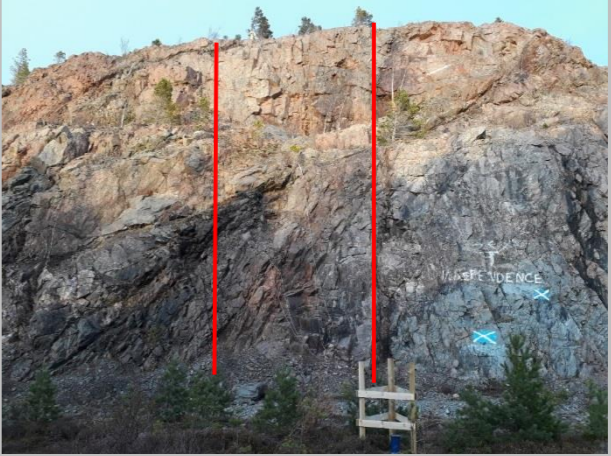
Description / Results Including Bat Roost Potential (BRP) and Potential Roost Features (PRF)	Photograph
<p>Central rock face. Upper half of face composed of loose material with no suitability for roosting bats identified and water running from fractures at base of upper face (behind flags). Lower half of face has occasional fractures with good suitability for roosting bats: cavities extending back into rock >0.75 m and dry.</p> <p>BRP High</p>

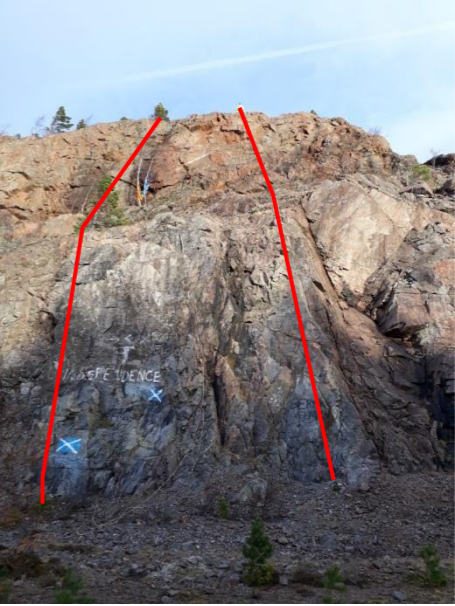
<p>Central rock face. Occasional cracks and fractures on upper and lower halves of rock face provide limited suitability for roosting bats. Cavities, although dry, noted to be shallow; generally extending < 0.3 m. Much loose material on upper half.</p> <p>BRP Moderate</p>

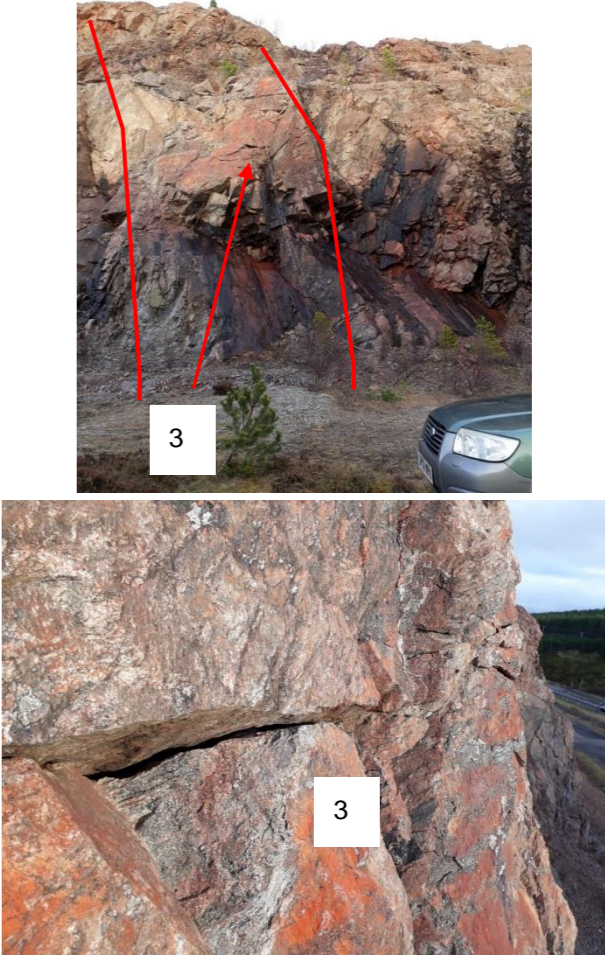
<p>Central rock face. . Upper half of face composed of loose material with no suitability for roosting bats identified. Lower half fractures predominantly wet and running with water (as visible in photograph). Two shallow (< 0.2 m) fractures c. 5 m above toe of lower half of rock face provide very limited suitability for roosting bats.</p> <p>BRP Negligible</p>

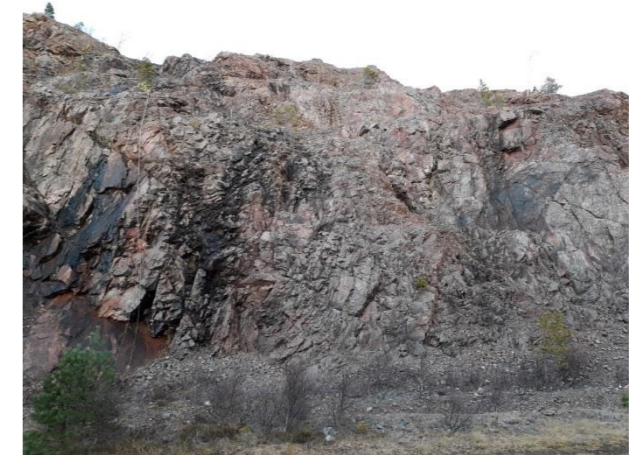
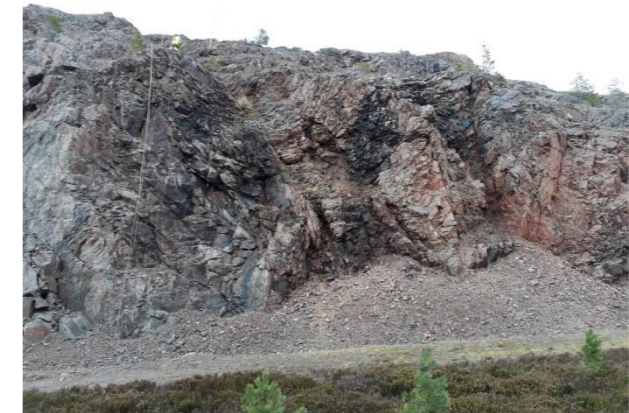
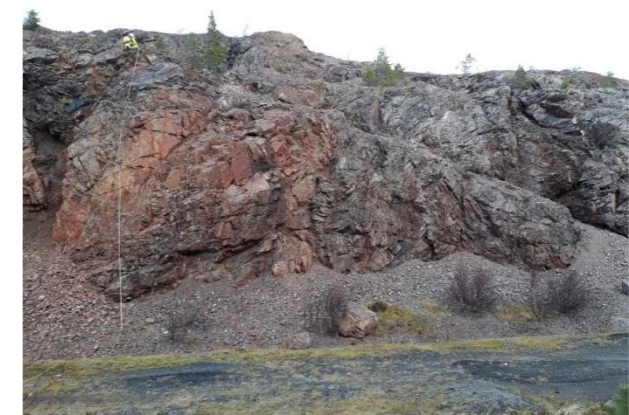
Central – eastern end of rock face. 100 m section from c. 284990 823930 east to former quarry. All apparent fractures within rockface (as visible from base) discovered to be shallow and unsuitable for roosting based on inspection. Gradient of slope lessens towards eastern end, further reducing any potential areas of bat roost suitability. Much of section (as photographed in series opposite) composed of very loose material.

BRP Unsuitable

The photograph column contains three vertically stacked images of a rocky cliff face. The rock is reddish-brown and shows signs of weathering and fracturing. Sparse vegetation, including small trees and shrubs, is visible on the upper parts of the cliff. The foreground is a dark, gravelly or rocky area.
