Appendix 6.2

Dellmore Mitigation Plan

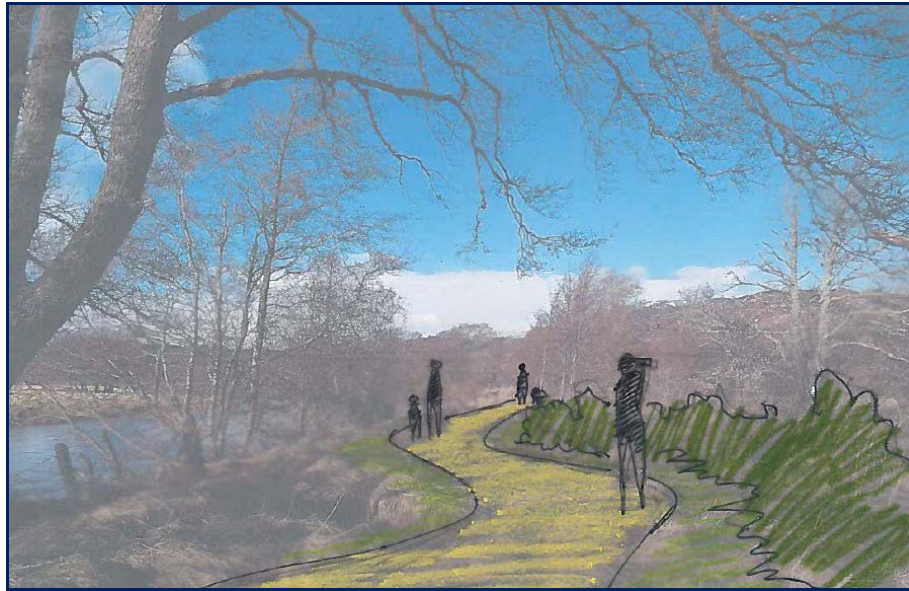
Figure 4-1: Example of improved track or path with waist level scrub as screening

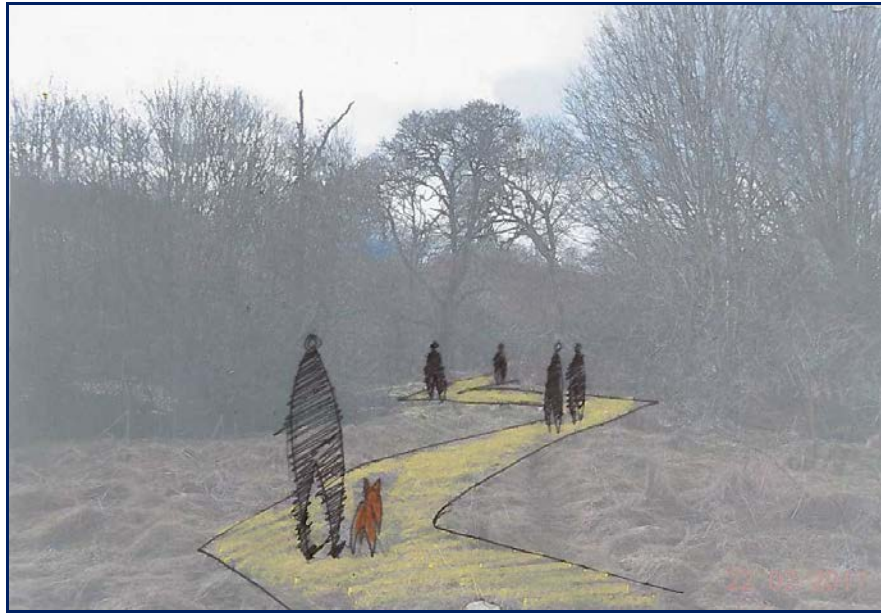
Figure 4-2: Example of improved track or path through riparian woodland

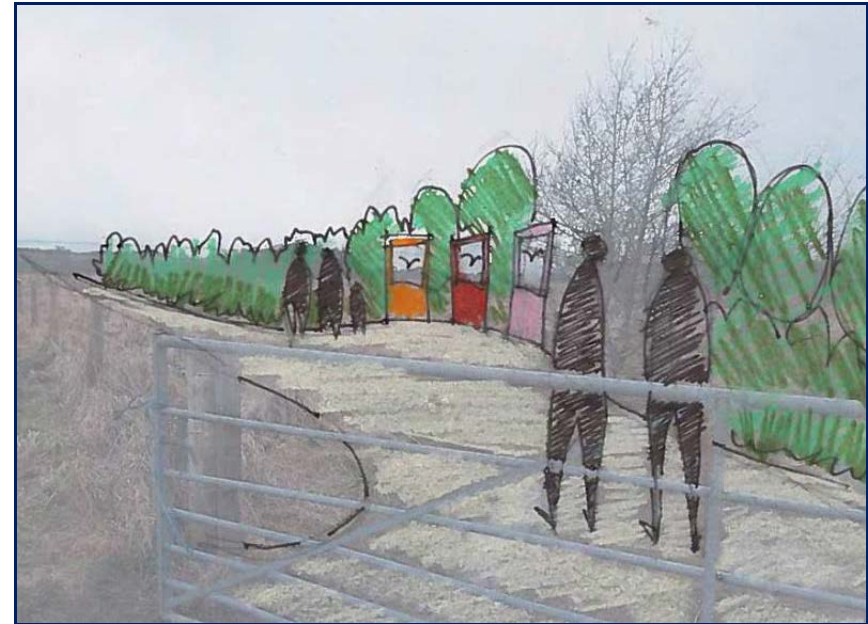
Figure 4-3: Example of orientation area at entrance to Dellmore

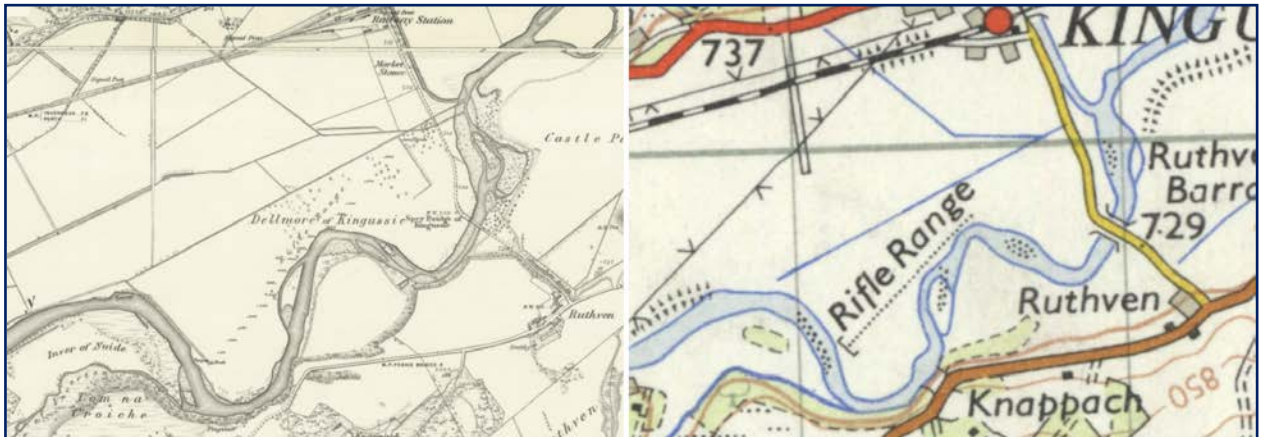
Figure 6-1: Rifle range documented on OS Six Inch (1843-1882) on the left and OS One Inch 7th Series (1955-61) on the right

- 6.1.4 Also shown on the OS 1843-1882 map, and depicted up until OS 1955-61, is a rifle range within the Site. There are two Highland Council Historic Environment Records (HER) for a firing range (grid reference NN75138 99366), stating that it is “shown on the 1st edition OS map, 1872.”, and that it was a “1000 yard range”.

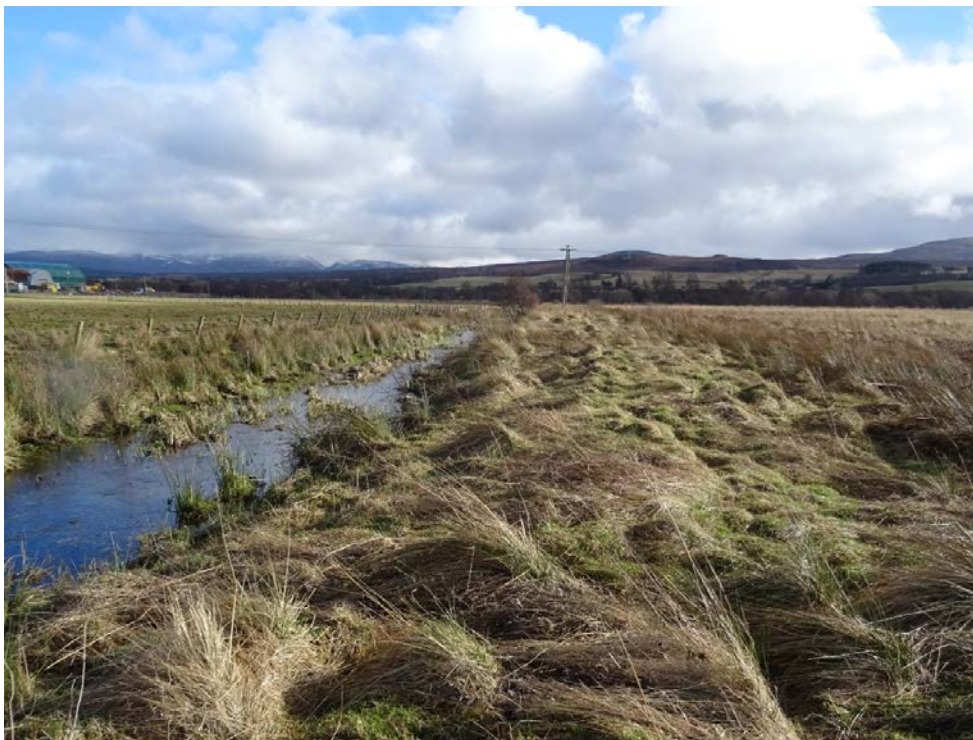
Figure 7-1: Looking south east along the Pitmain Burn towards a power line and pole

- 7.7.1 There are three SSE overhead power lines and associated poles which traverse the northern and eastern parts of the Dellmore Site; see **Drawing 6.2.23** and **Figure 7-1**. Recent correspondence suggests that SSE is considering placing these lines underground at the request of the local Community Council. It is anticipated that SSE will carry out an instrument survey of each line such proposals can be discussed with landowners in greater detail.
- 7.7.2 At present, these lines and poles may be used as predator perches within the Dellmore Site and undergrounding may see a benefit with regards habitat creation for breeding waders.

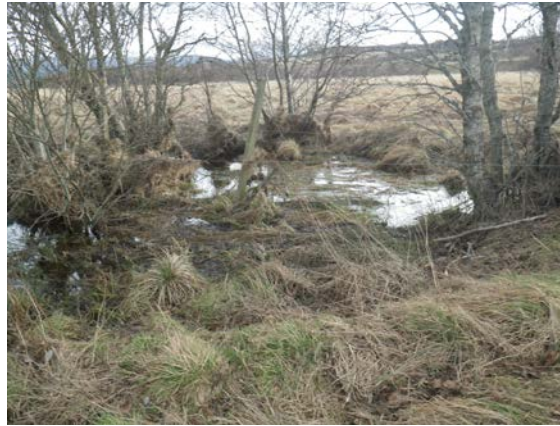
Photograph 2: Ponding in lower wider section of ditch

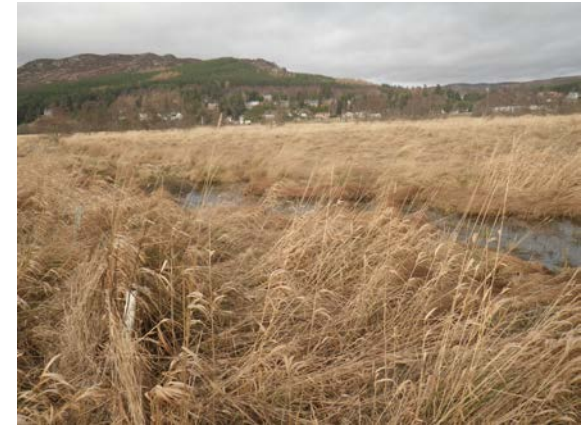
Photograph 3: Wet, but very slow flowing drain

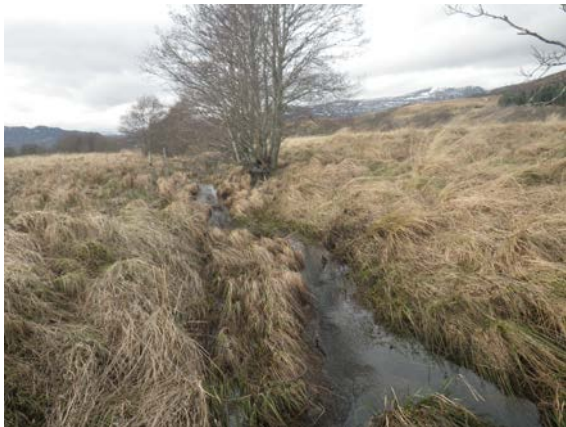
Photograph 4: Upstream narrow drain, with fast flow

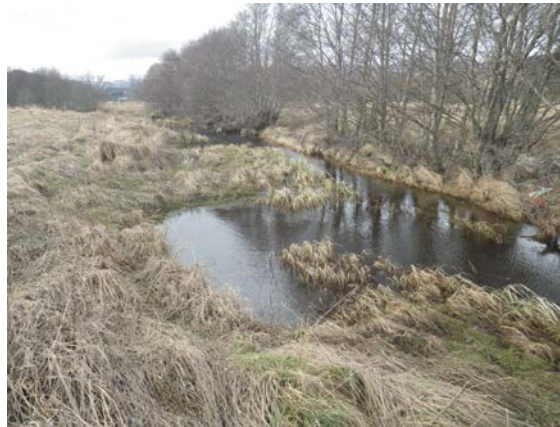
Photograph 5: Upstream backwater areas of slow flow attached to ditch

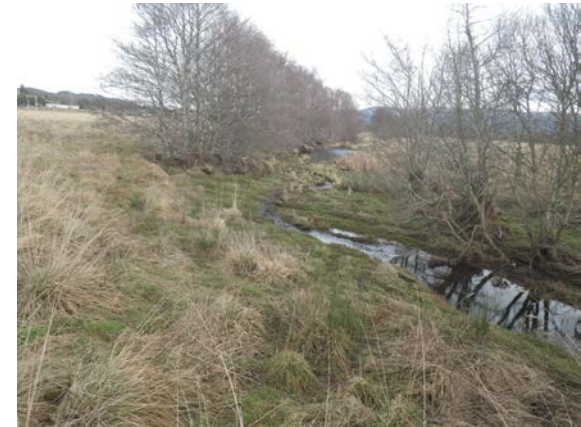
Photograph 6: Downstream small channel with varied form and flowing water

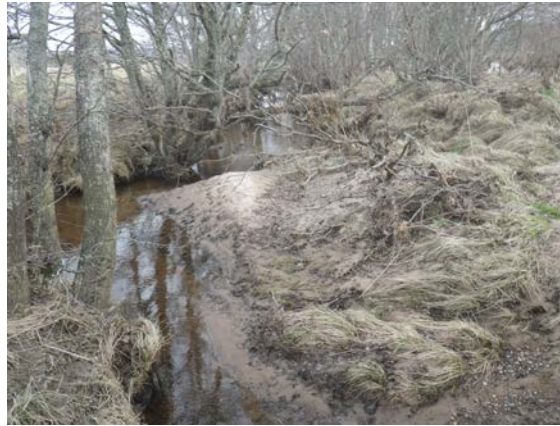
Photograph 8: Backwater/ high flow channel with sand deposited in bed.

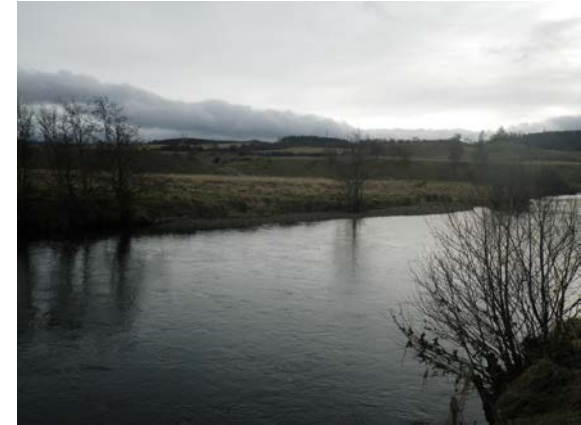
Photograph 9: Upstream small gravel bar

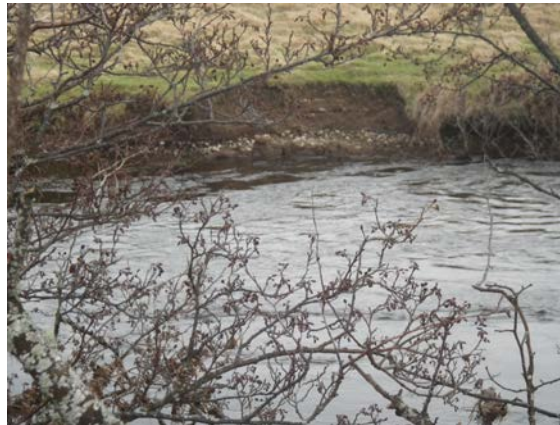
Photograph 11: Erosion bank, of fines over laying gravels. Gravels will be removed at higher flows and the fines will then collapse into channel

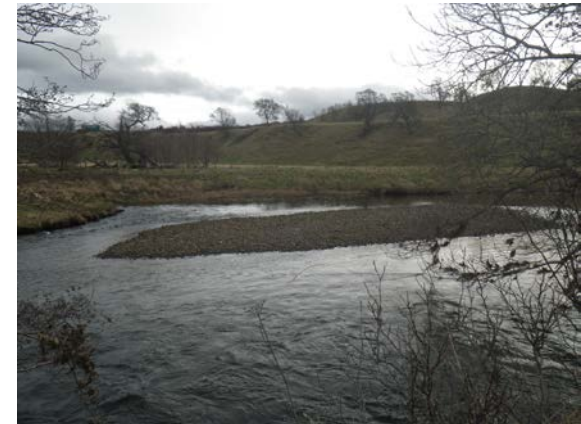
Photograph 12: Gravel mid channel bar

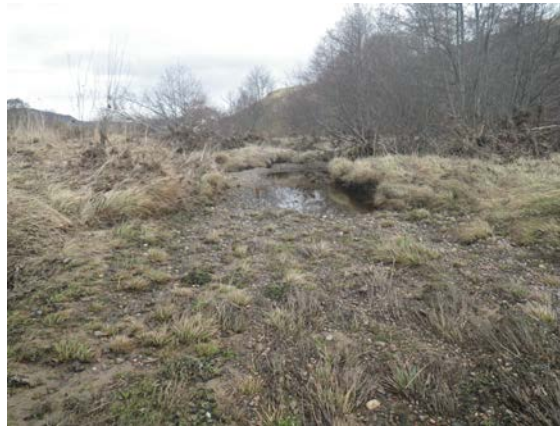
Photograph 14: Downstream high flow channel. Gravel deposits are starting to vegetate which will in turn stabilise them in this area

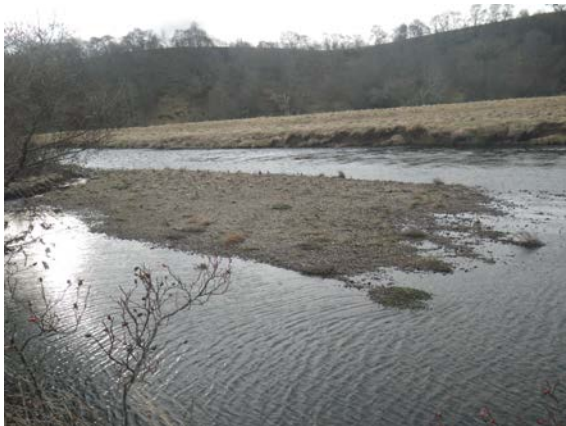
Photograph 16: Gravel bar

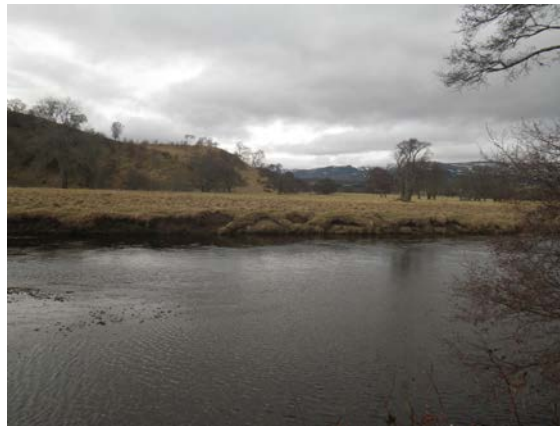
Photograph 17: Eroding bank

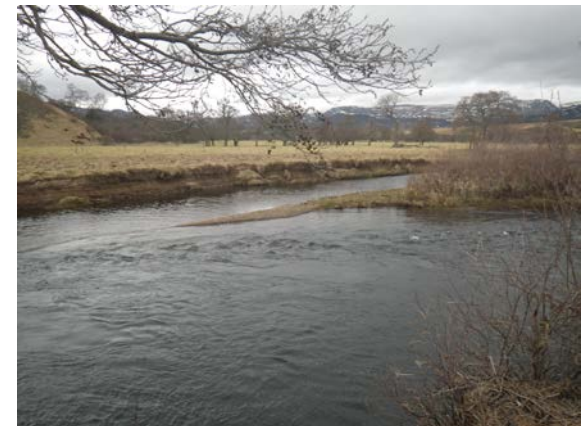
Photograph 18: Upstream eroding bank adding sediment to the channel, extending gravel bar

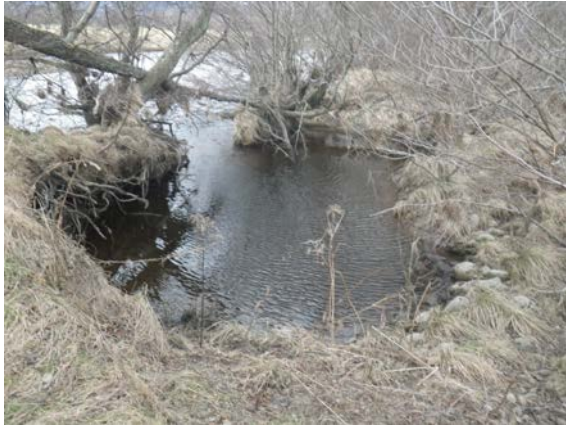
Photograph 19: Breach in embankment

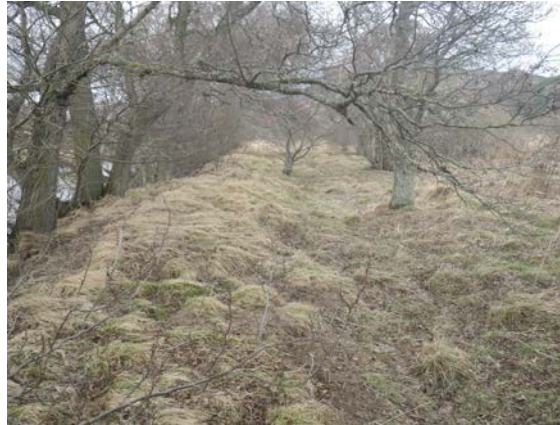
Photograph 20: Upstream low embankment

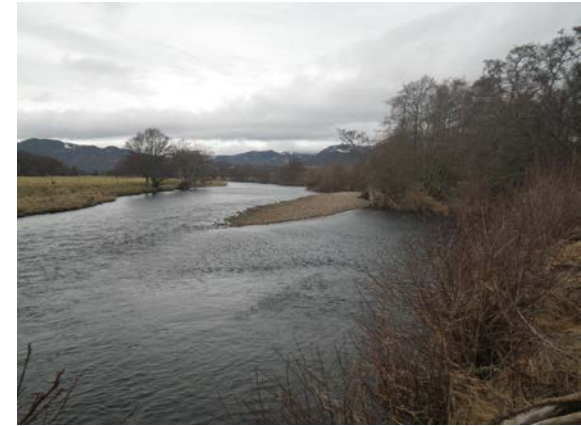
Photograph 21: Upstream gravel bar deflecting flows away from left bank

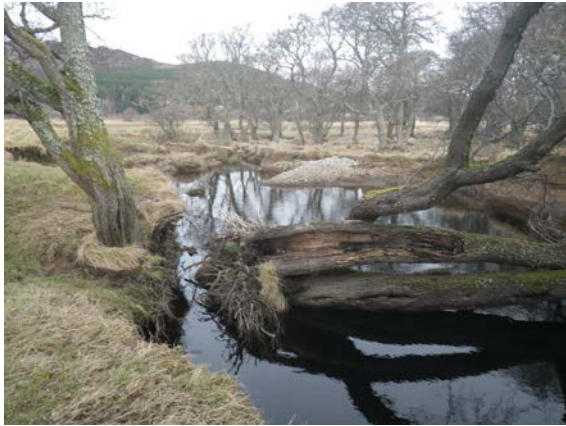
Photograph 22: Looking north, area of scour through embankment, uprooting trees

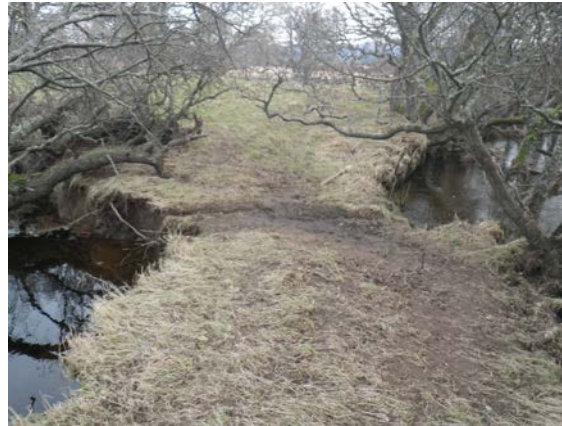
Photograph 23: Looking east, area of scour to left, Spey to right. Bank is not breached

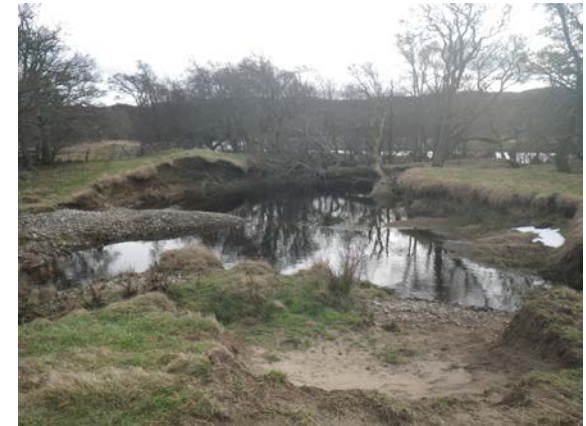
Photograph 24: Looking south towards Spey, area of extensive scour

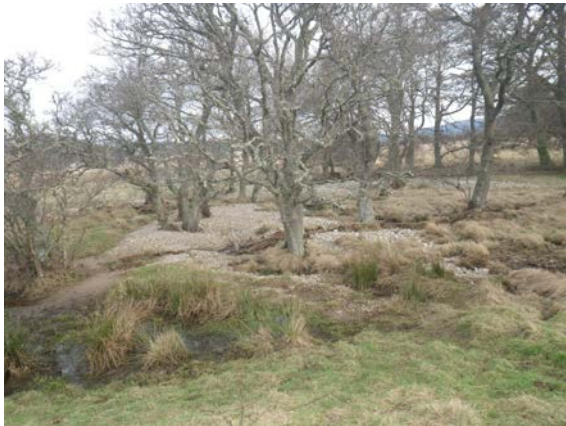
Photograph 25: Extensive deposition of coarse gravels on the floodplain

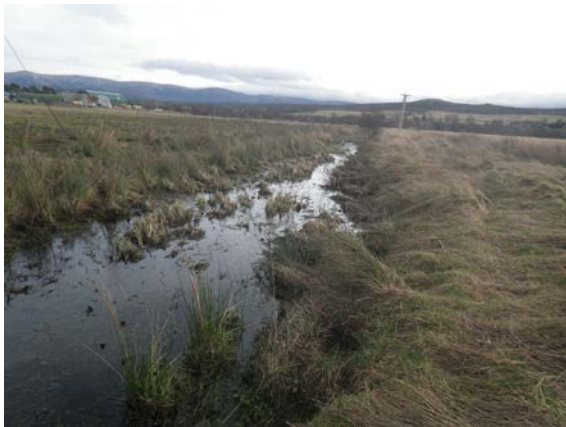
Photograph 55: Downstream low embankment on right bank side

- 3.2.7 The Pitmain Burn flows along the eastern boundary of Dellmore and has been historically modified to create a straight and uniform channel. Banks are low and there is a low embankment along the right bank side of the channel, probably comprised of the arisings from past channel dredging.
- 3.2.8 Over time the channel has adjusted to historic straightening and is creating a smaller more sinuous channel, helped by vegetation establishing in the channel, collecting sediment. There are no bed forms within the channel.

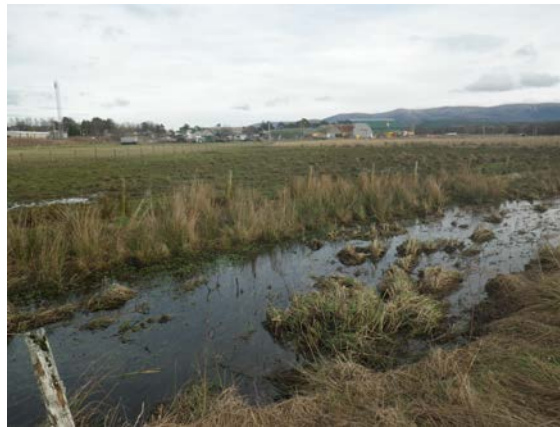
Photograph 56: Over wide channel, with lots of in-channel vegetation

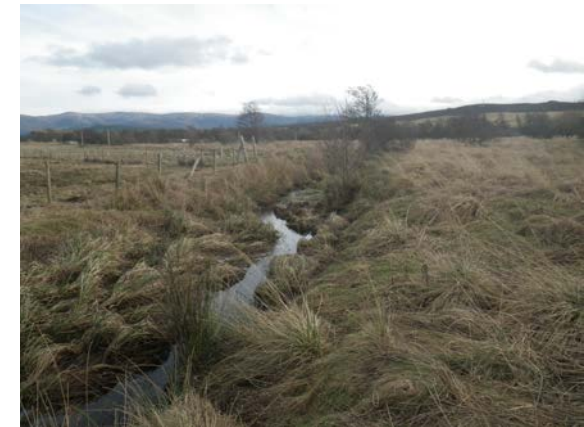
Photograph 58: Downstream channel self-narrowing as deposition and vegetation grow occur, creating more sinuous planform
