Trial Trenching

Metal Detecting

Design Refinements - Overview

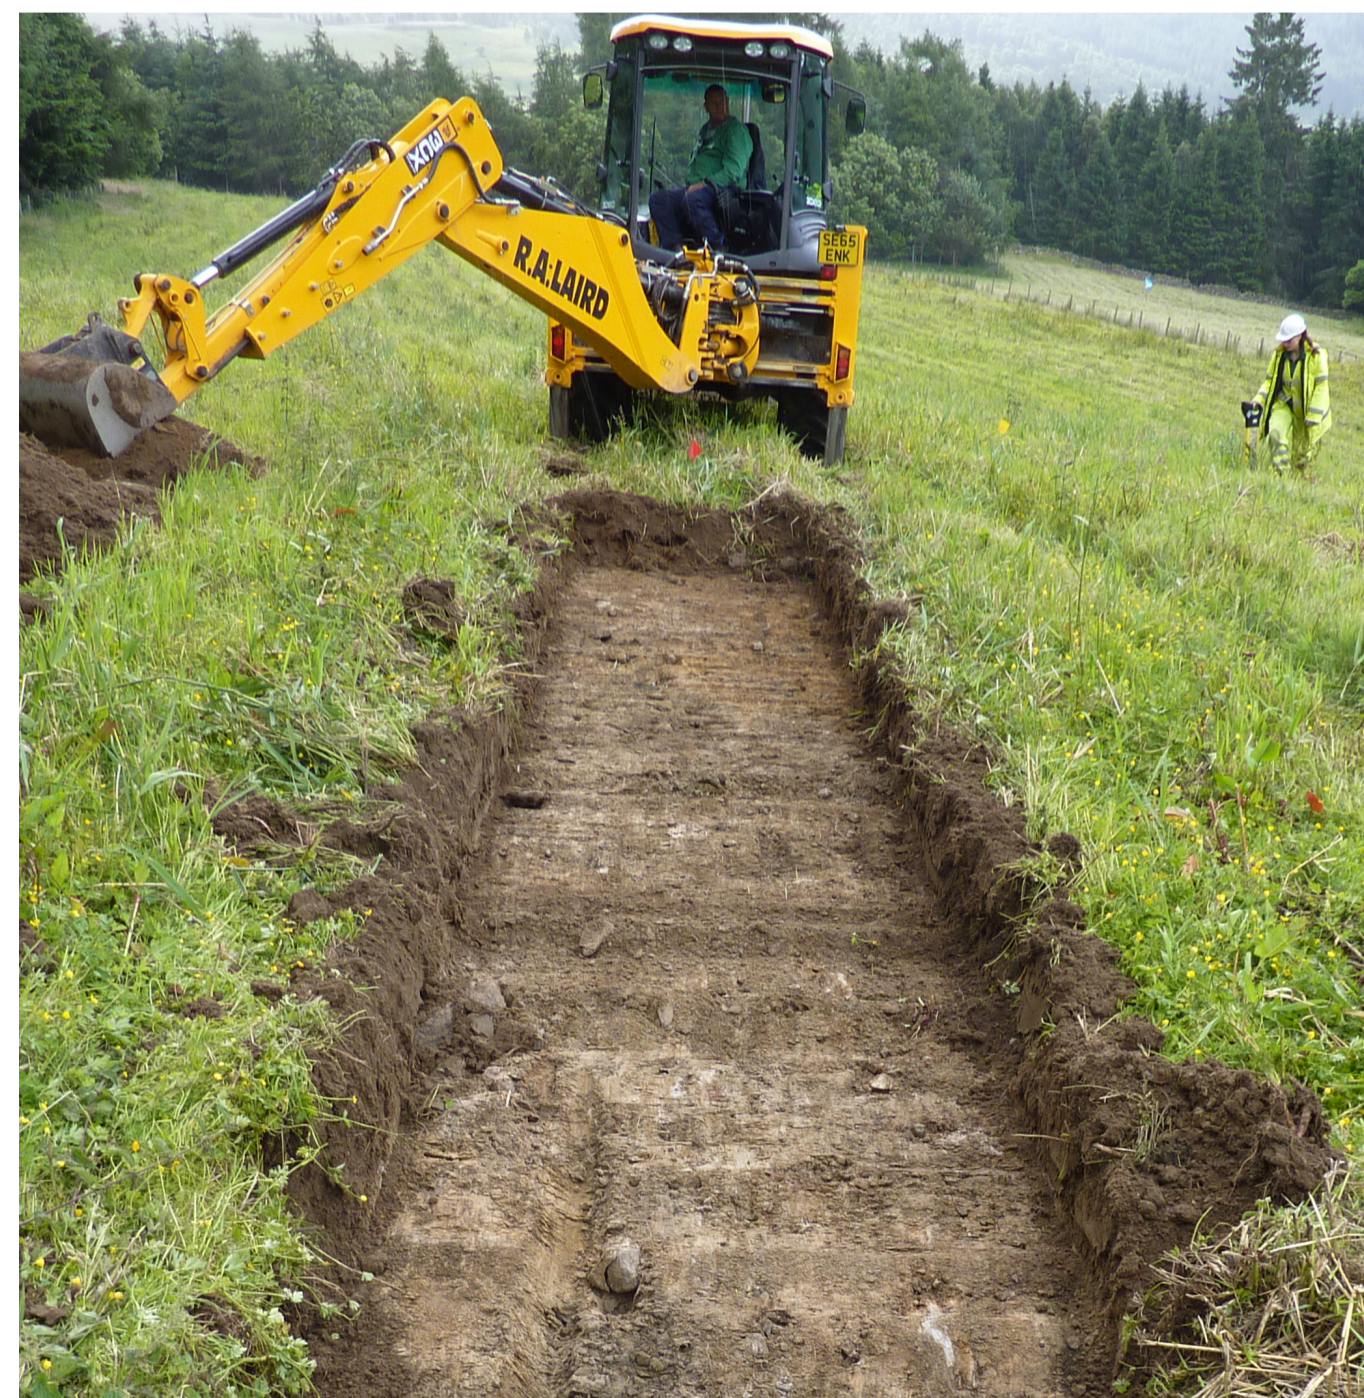
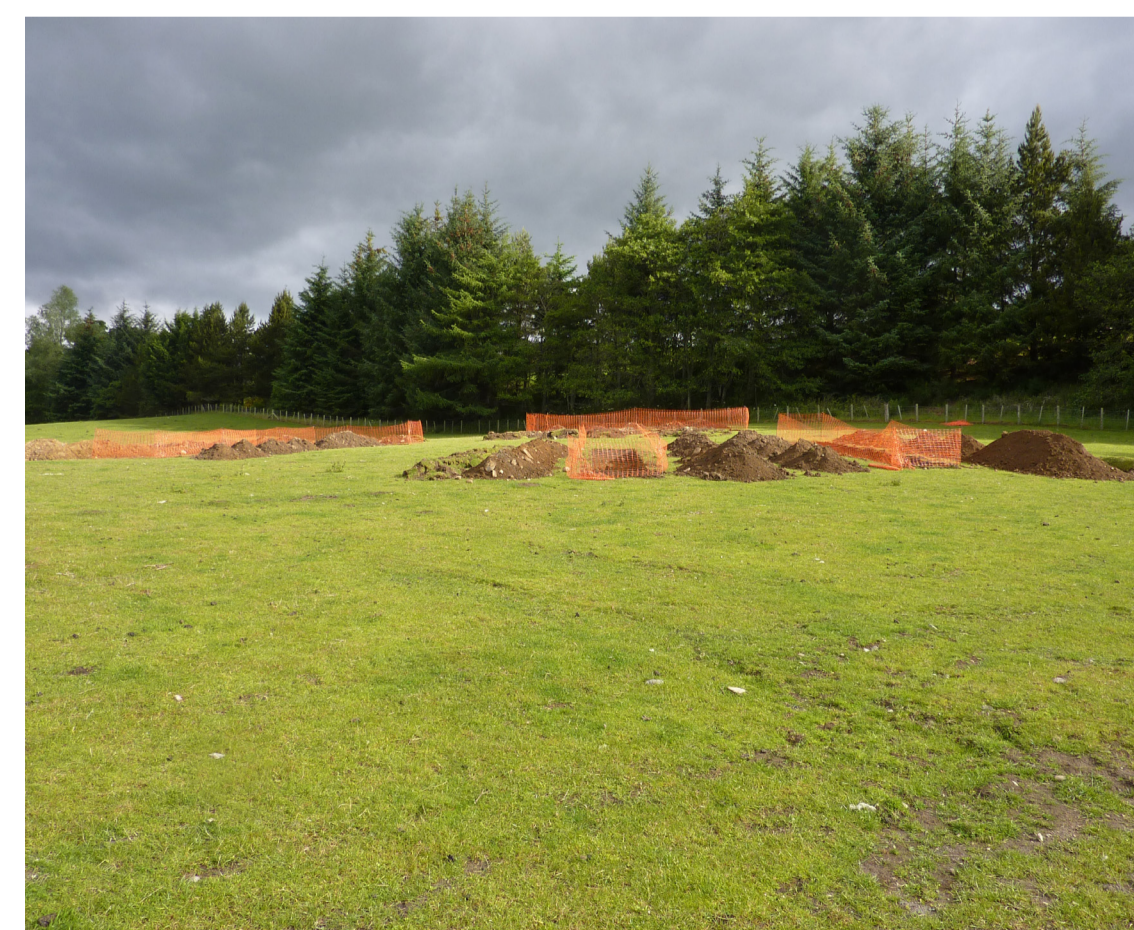
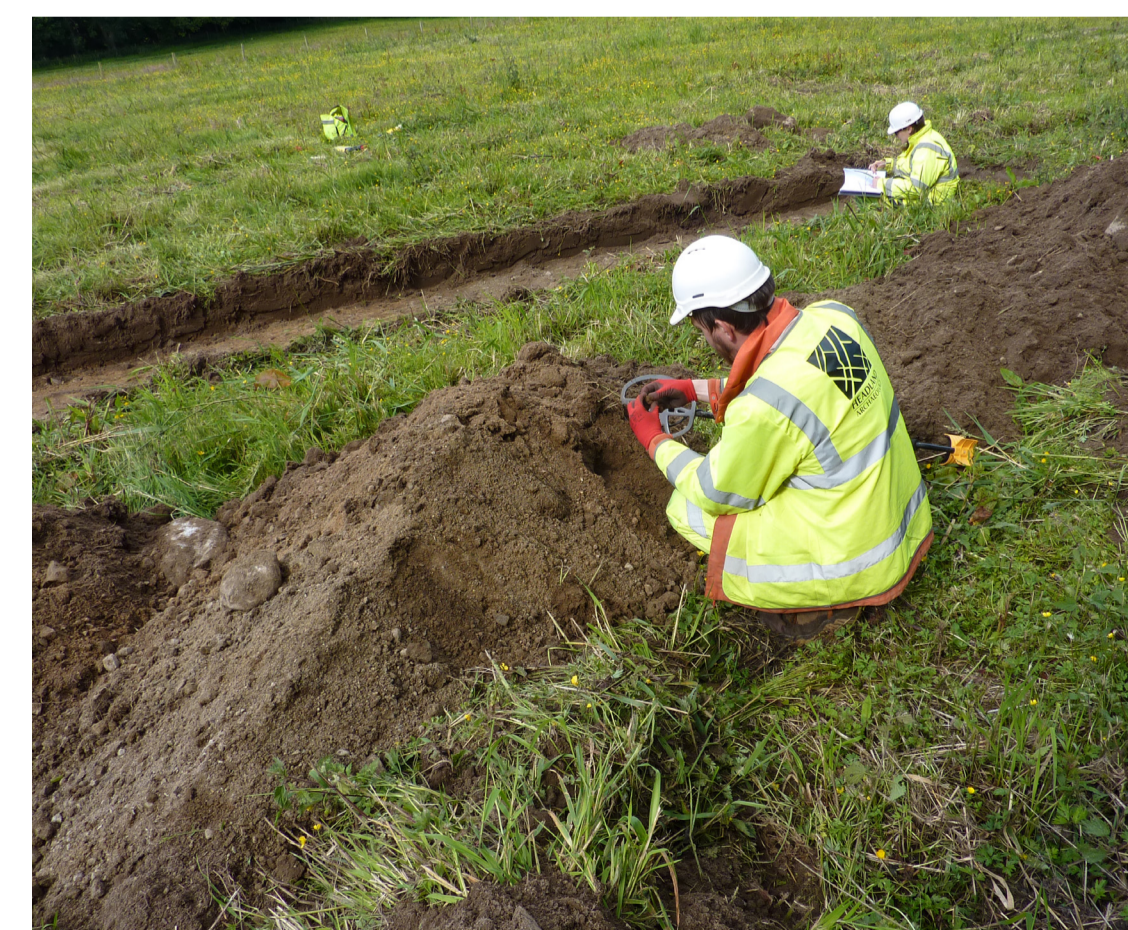
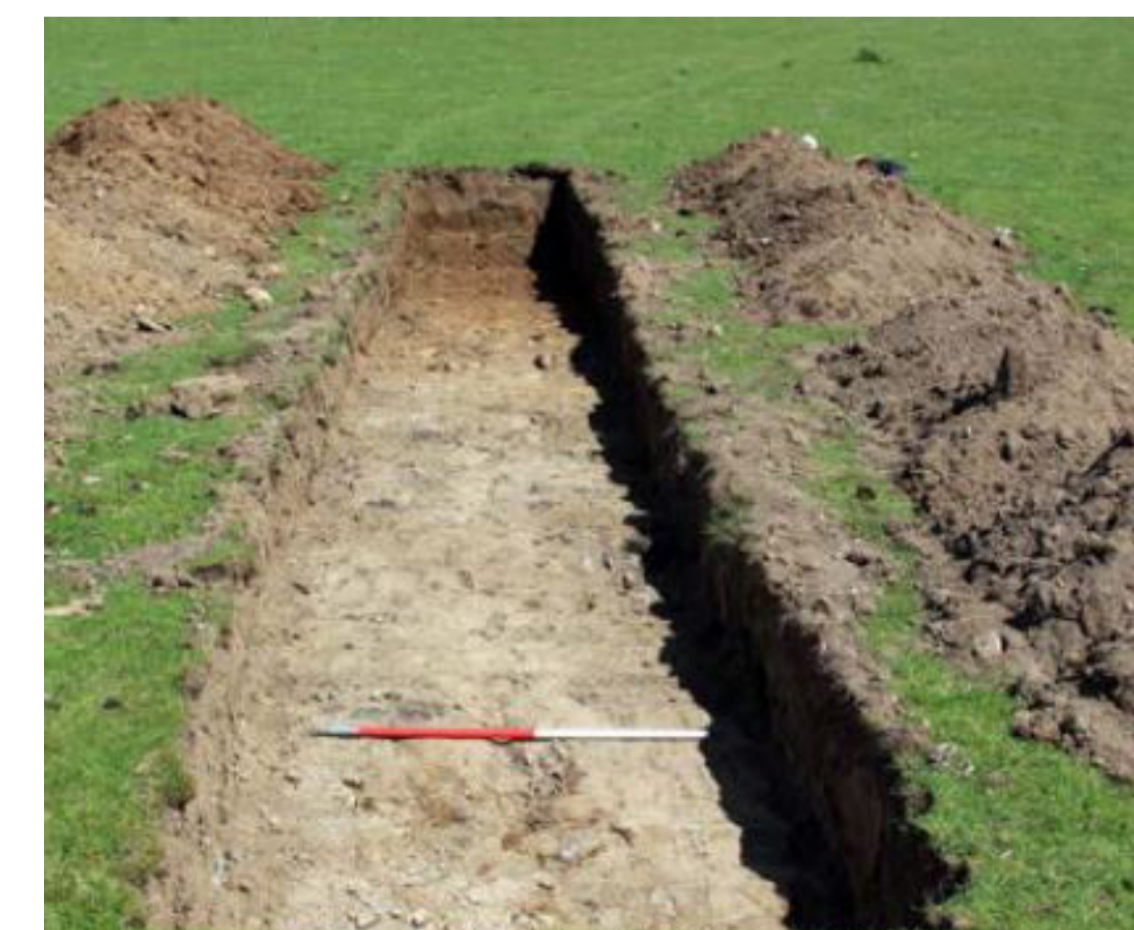
Trial trenching, Killiecrankie Battlefield, June 2018.

Archaeological trial trenching of the pit like features identified by the 2016 geophysical survey (commissioned by Transport Scotland) was also undertaken. In summary:

- A total of 10 trial trenches were excavated and each of the possible pits was trenched;
- No burials or other archaeological features were present in any of the trenches with the anomalies identified by the 2016 geophysical survey resulting from geological and natural processes such as localised iron-panning or peat deposits formed over the natural sub-soil; and
- While the geophysical survey undertaken in 2018 identified no anomalies of definite archaeological potential, 4 trial trenches were excavated over a sample of the larger geological anomalies to confirm their interpretation as natural features. It confirmed that these features were natural in origin.

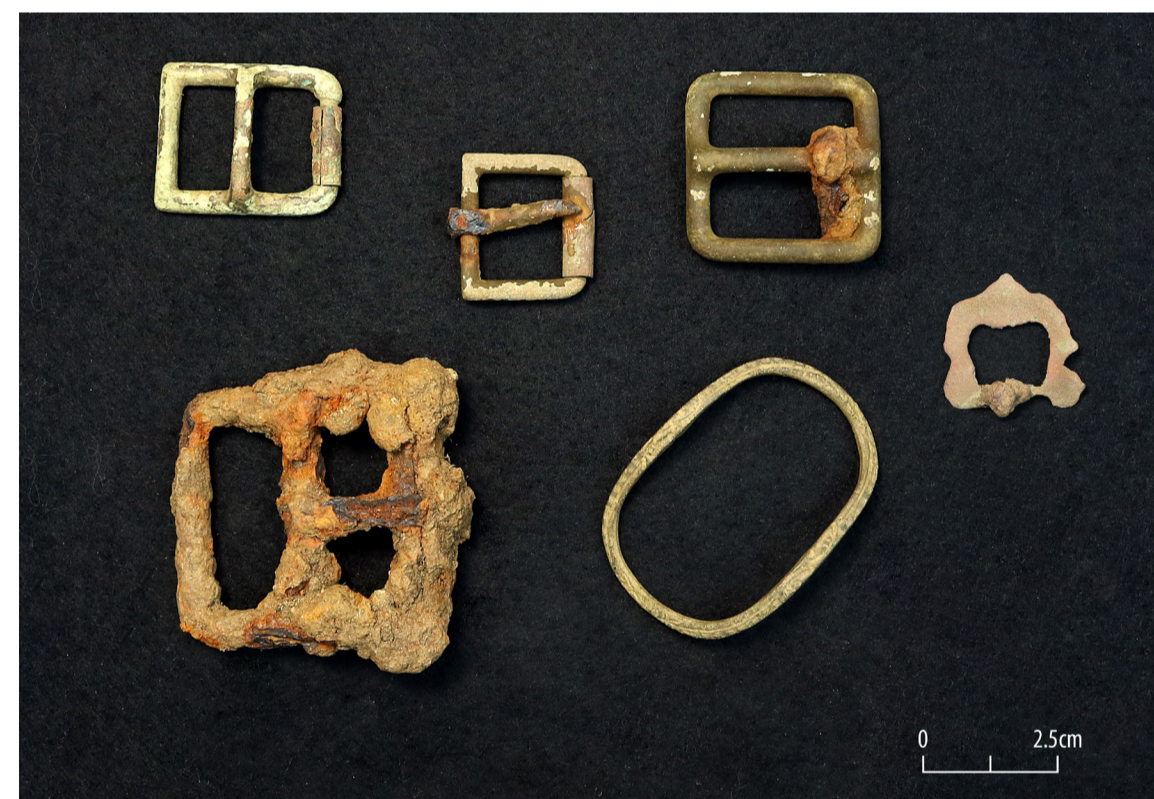
Buckles.

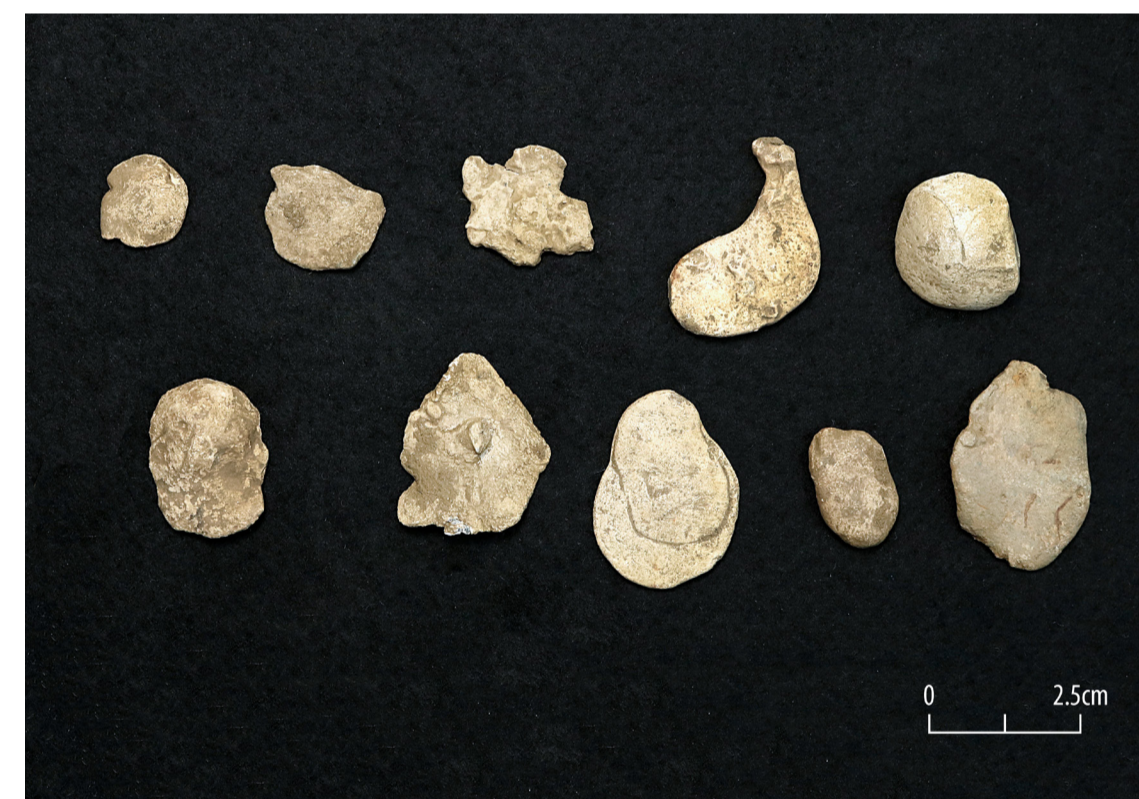
Splattered Lead Shot.

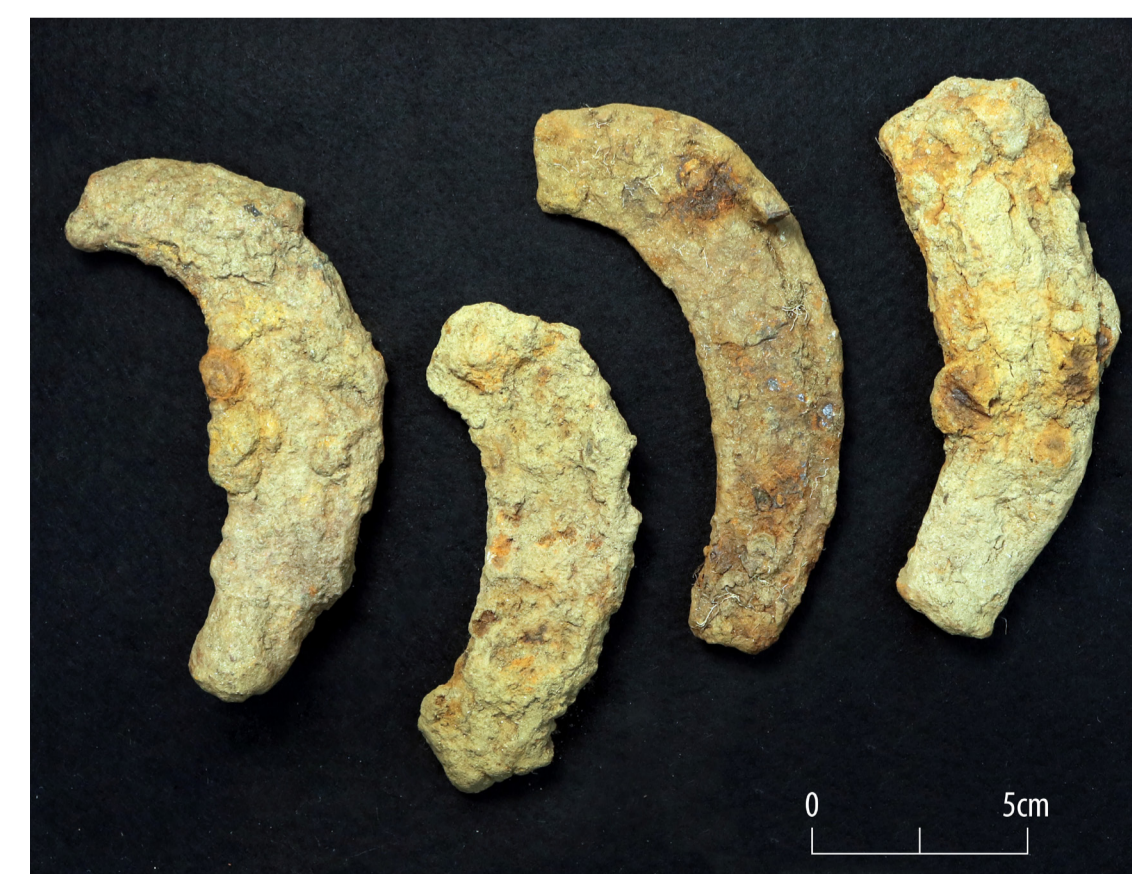
Horseshoes.

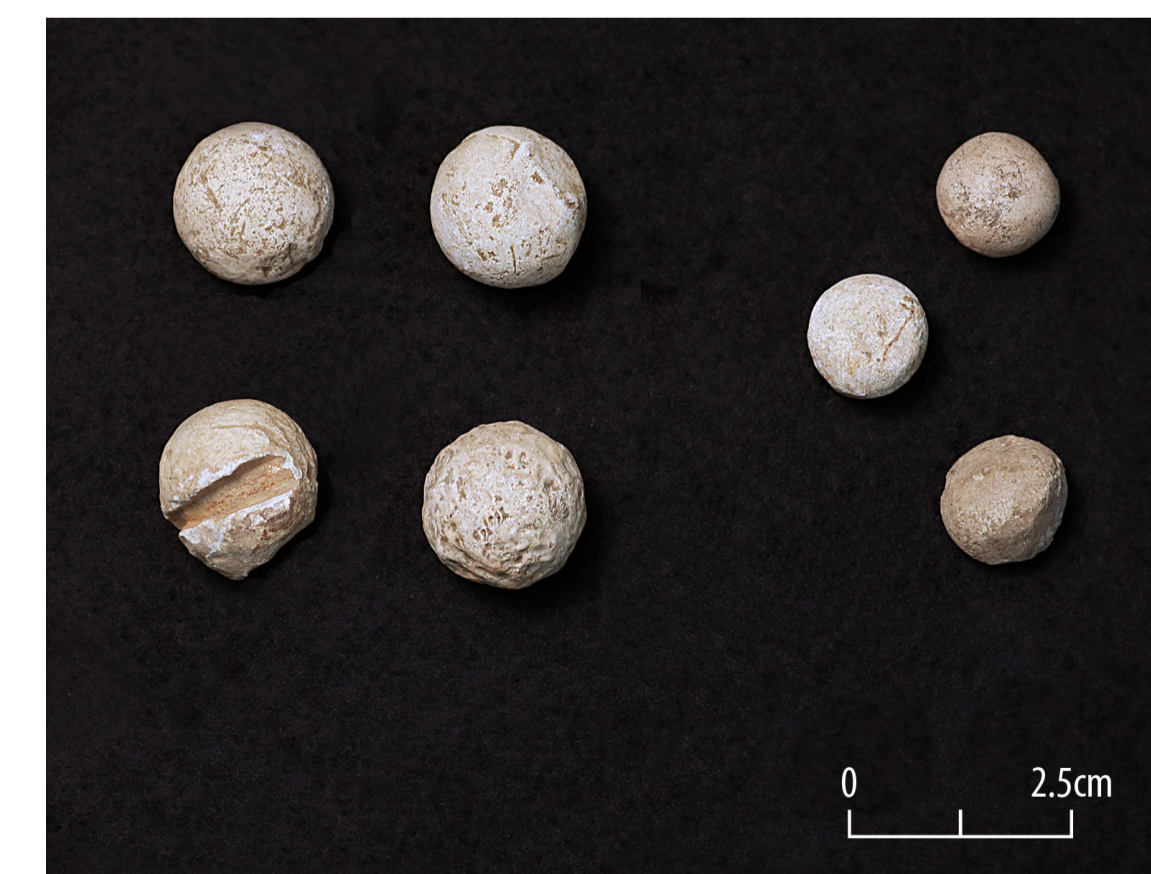
Musket and Pistol Shot.

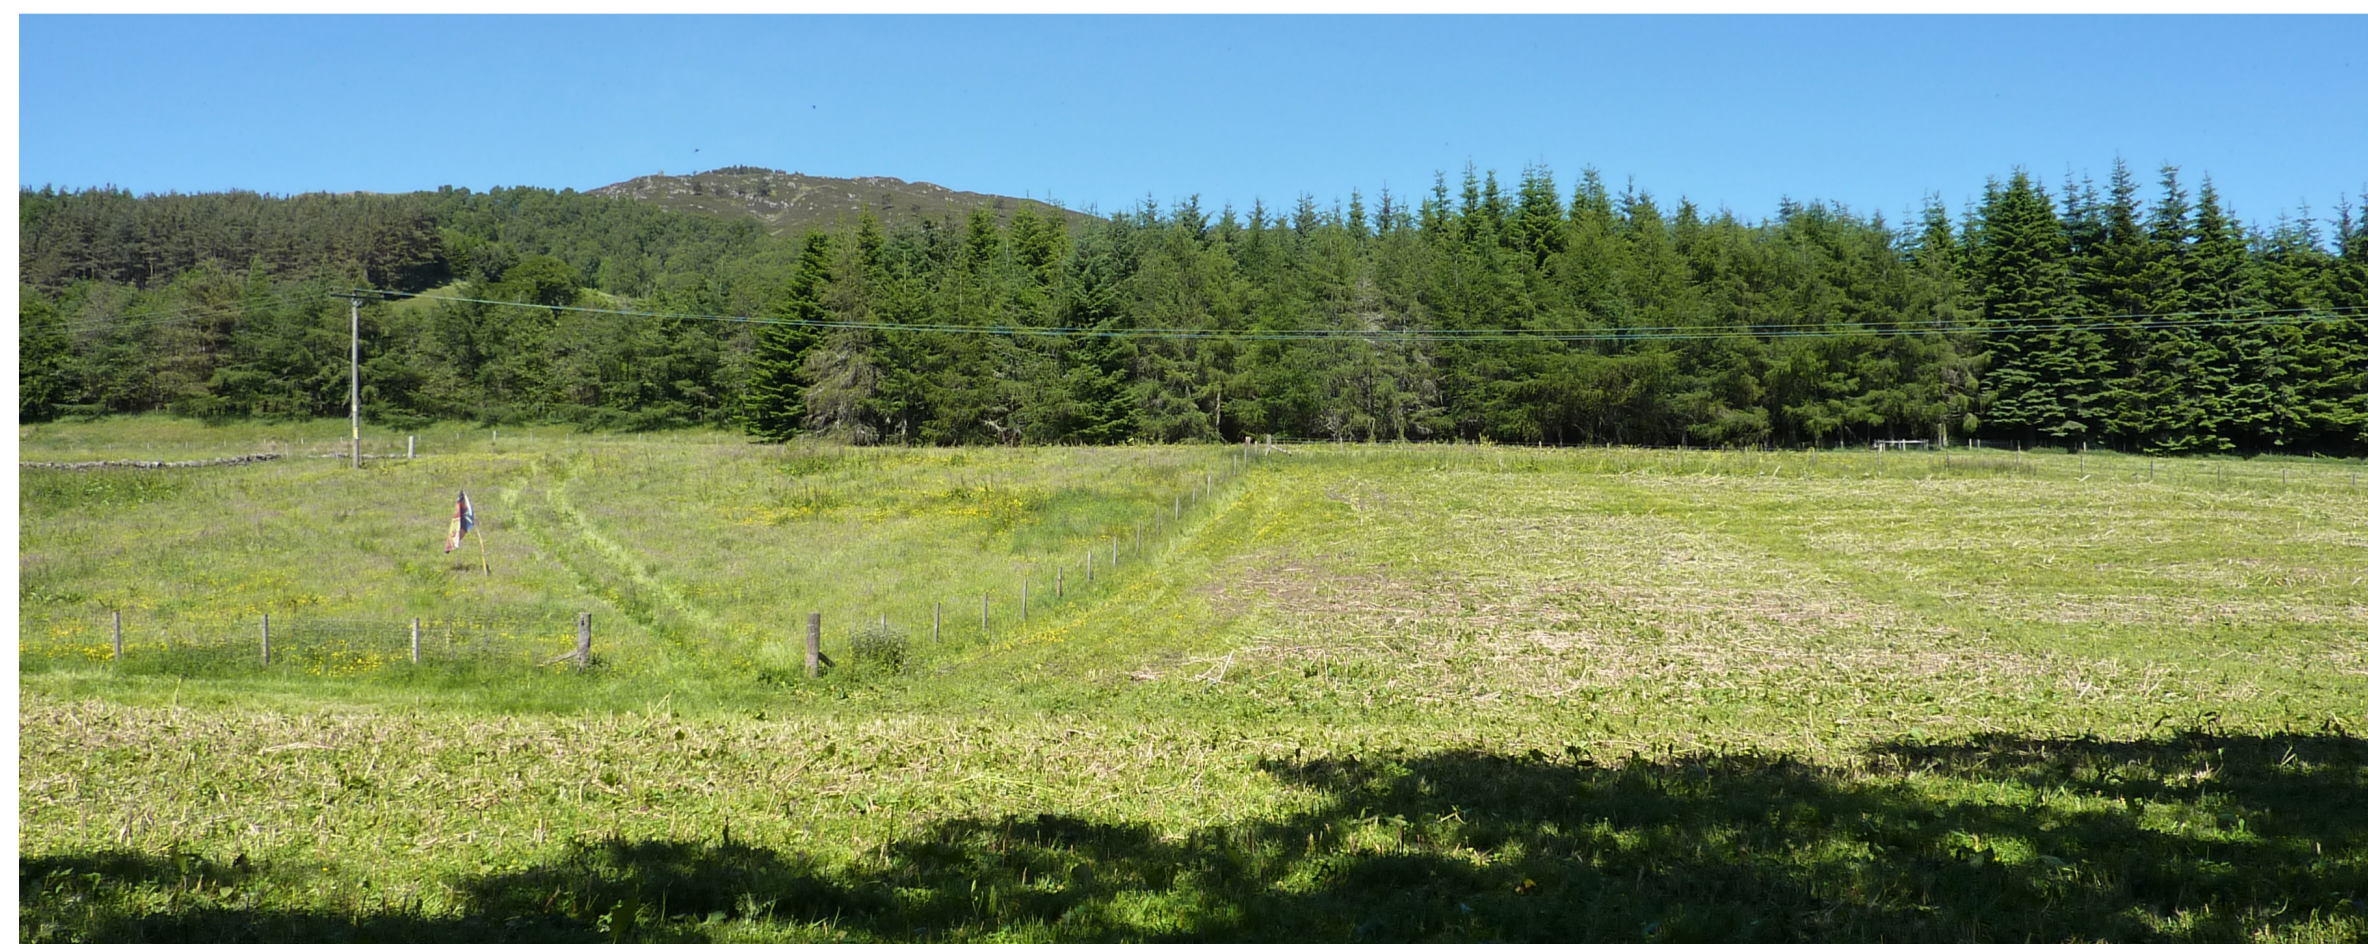
The terrace in Field F7 may have partially shielded the Jacobites from fire from the Government troops below.

- There is additional evidence for intensive fighting in the form of munitions recovered from Field F7 and F8. However, the concentration of munitions recovered from the southern edge of a small terrace in the west of Field F7 (which was interpreted by Pollard and Oliver (2003) as evidence for the final volley from the Government forces at the Jacobites), did not extend eastwards. This may reflect localised changes in topography with the transition from a terrace to moderate slope providing greater visibility of the charging Jacobites; and

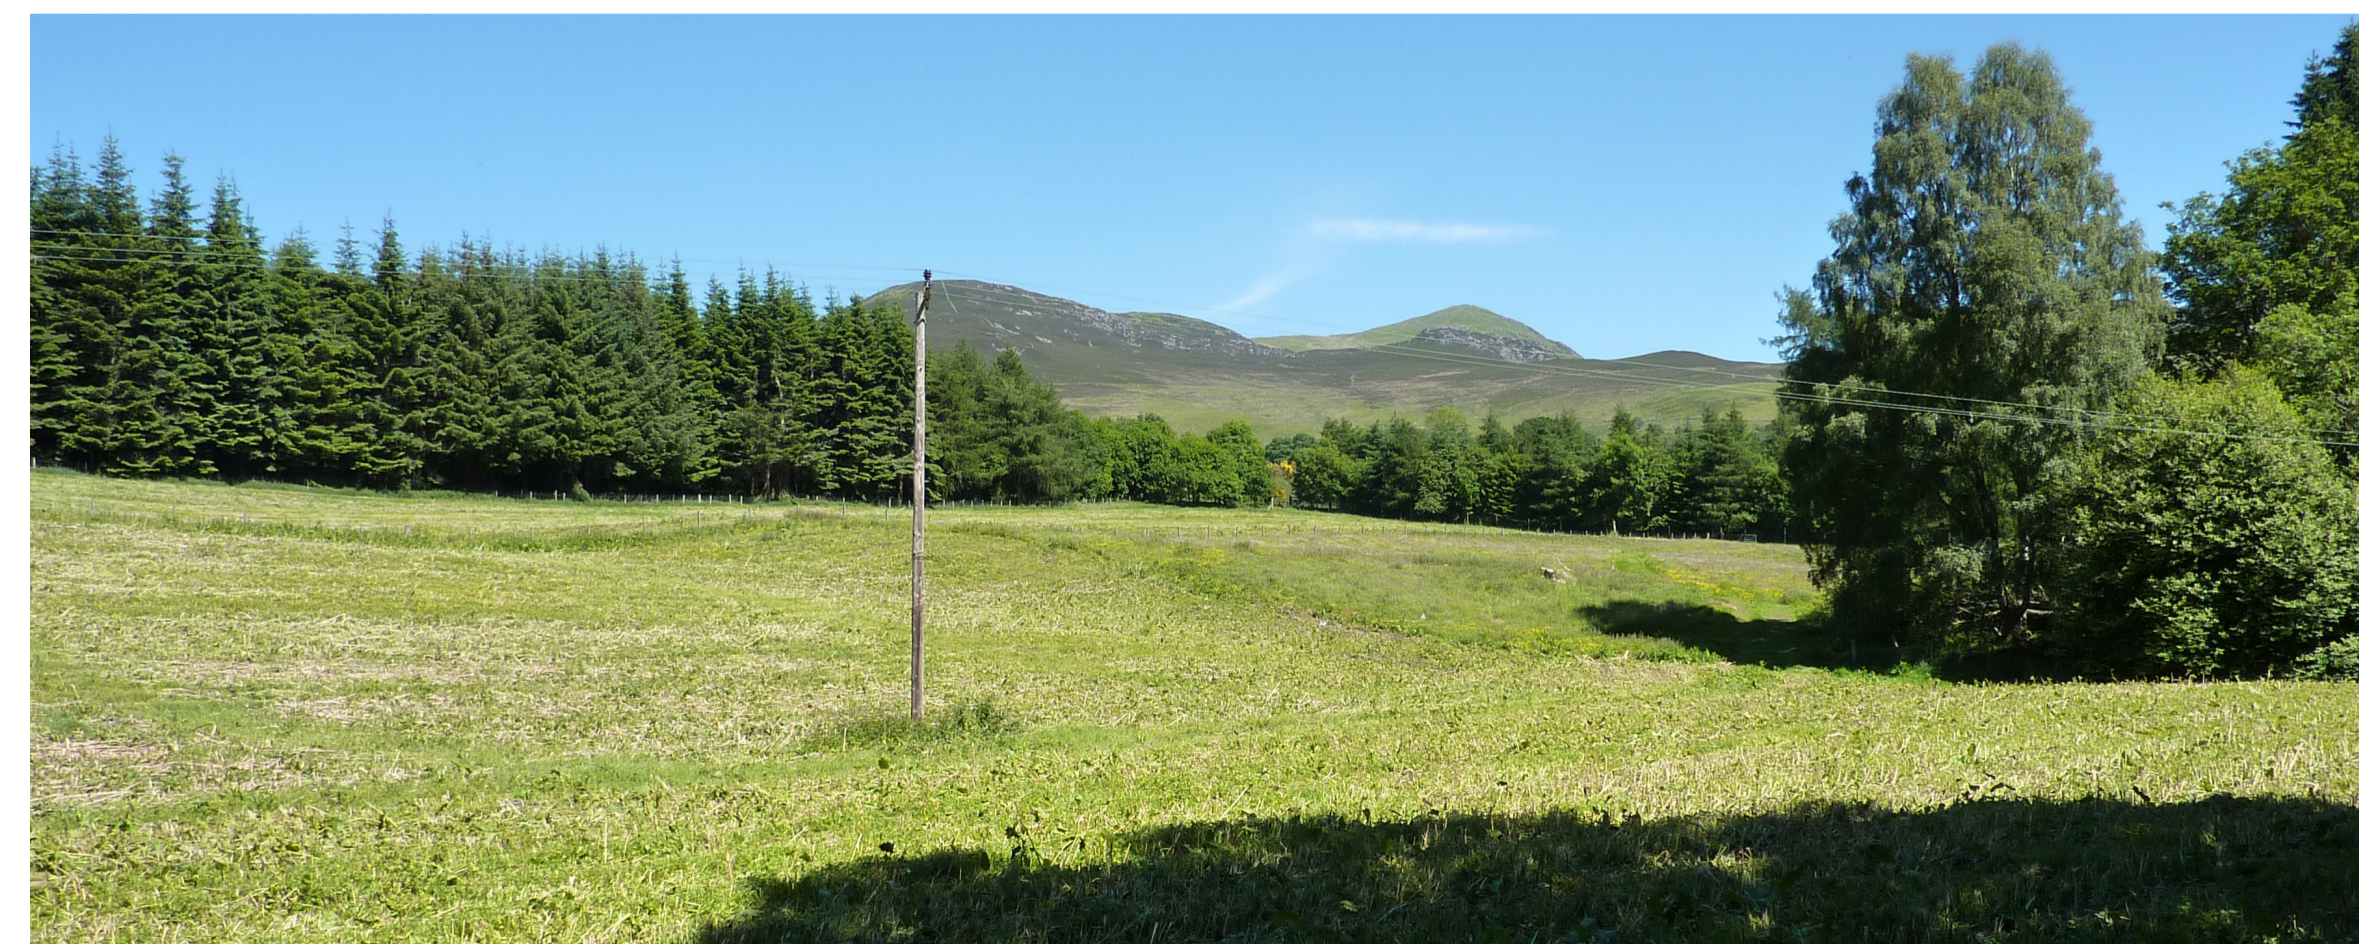
However, as the slope becomes more moderate and uniform, the terrace disappears, so the shielding effect may have been lost.
