Project **FORTH REPLACEMENT CROSSING**

**AIR QUALITY MONITORING REPORT  
AUGUST 2018**

Made by Steven Westwater	Checked By: Chris Higgins
Initials: SWR	Initials: CHS
Document number	Rev
<b>REP-00359</b>	<b>00</b>

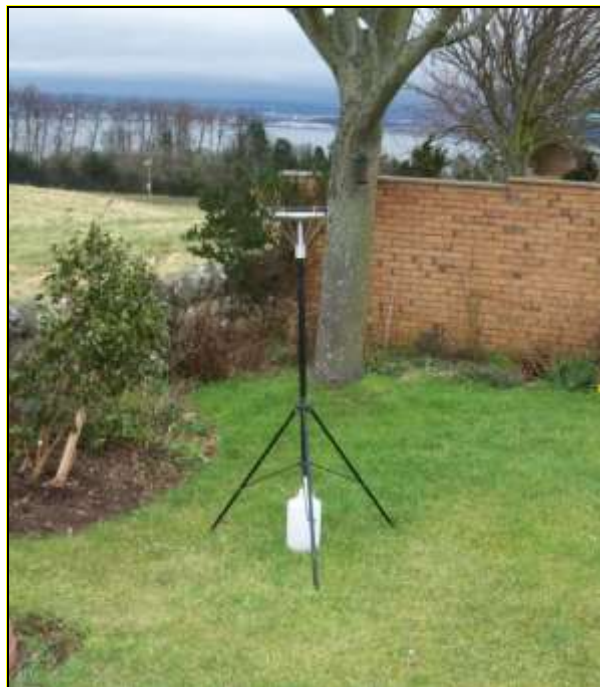
**2.1.** Air quality is being monitored on site using Frisbee gauge dust deposition monitoring. Four Frisbee gauges are currently set up at sensitive locations across the site to measure dust deposition rates (Figure 1). Table 1 lists the air quality monitoring equipment present at each monitoring location, including the date it was installed.

**Figure 1: Example of an Installed Frisbee Gauge Meter**
