Queensferry
Crossing

Project FORTH REPLACEMENT CROSSING

VIBRATION MONITORING REPORT
NOVEMBER 2016

Document number	Rev
REP-00300	00

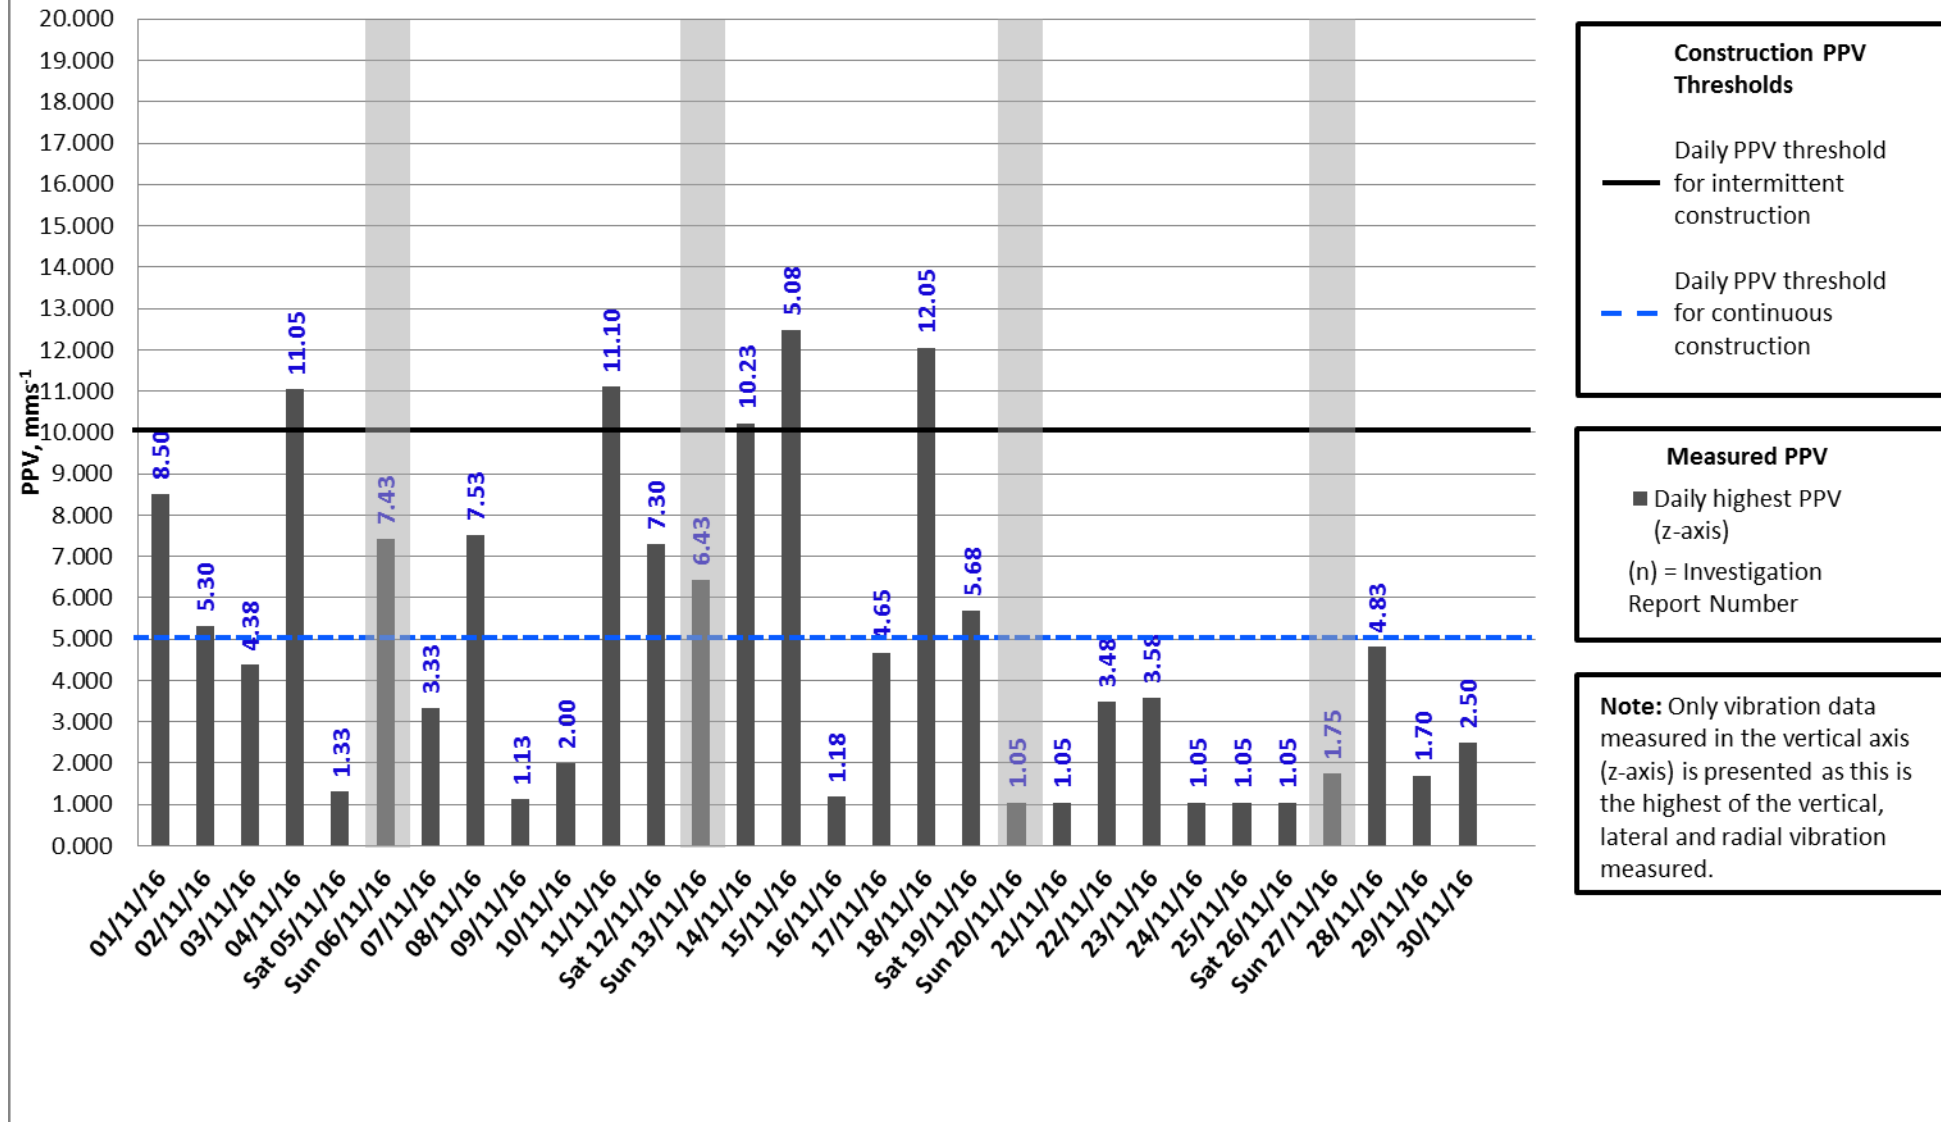
Measured highest Daily Peak Particle Velocity (PPV), Clufflat Brae, Measurement period: November 2016

Data missing on the 21st – 30th November was caused by electrical issue with monitor.
