Boulder Hazards Study - Phase 2A Boulder Hazard Inventory for A83 Beinn Luibhean

Document No. B2359902/TGE/REP/02 | 0

November 2022

Scottish Road Research Board

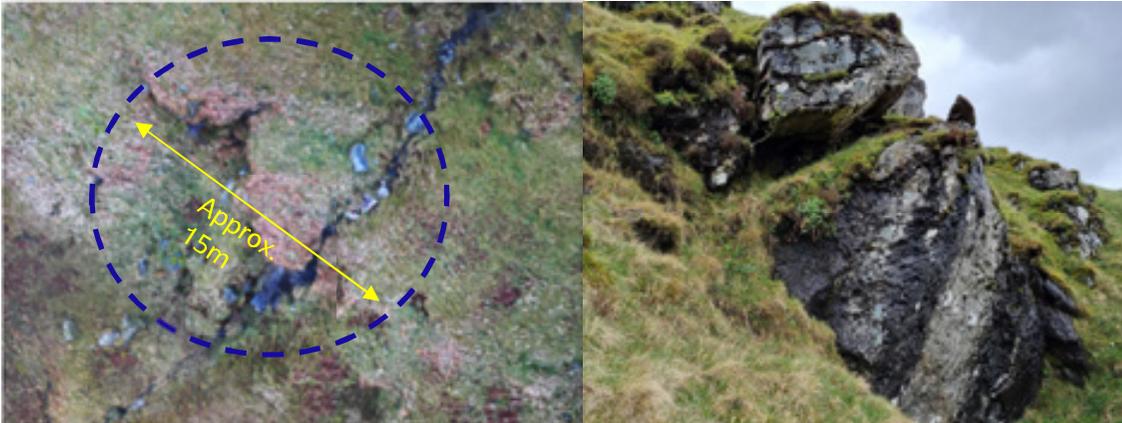
<p>Feature B – This feature is similar to Feature A but smaller in area. The feature is approximately 15m long and comprises stacked boulders.</p> <p>The aerial view image was generated from the DEM, provided by GeoRope Ltd, using Pix4D viewing software (GeoRope, 2020)</p>

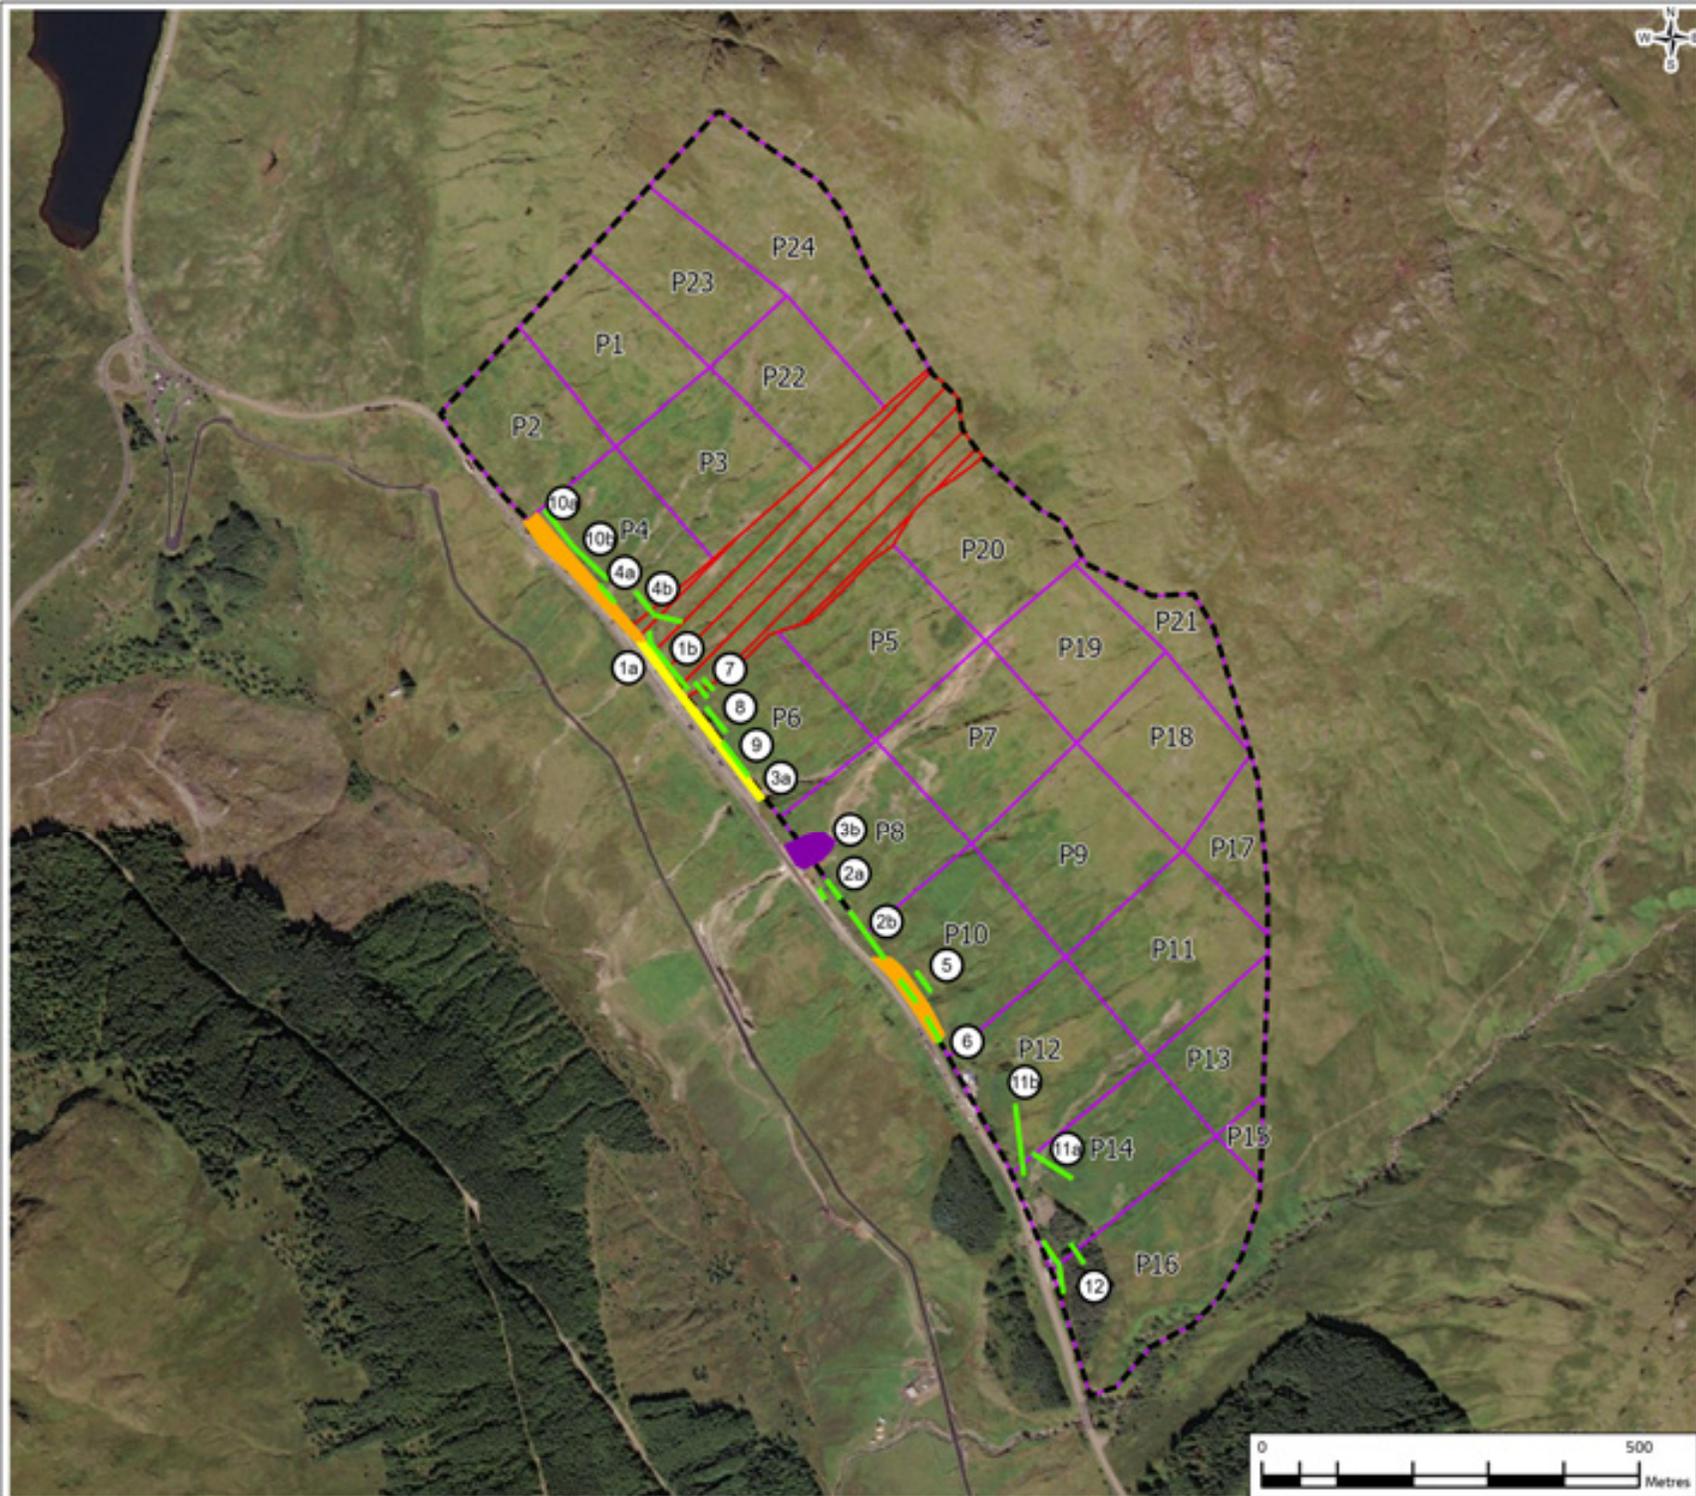
Debris flow mitigation measures including debris flow barriers and a series of debris catch pits have been constructed immediately above the A83. At the time of writing, catch pits were being constructed within the study area at Phase 1 and 3B in an attempt to mitigate against natural terrain hazards in the short-medium term, while studies are ongoing to select a route option to achieve a more resilient section of the A83 in this area. The location of the mitigation measures is shown on Drawing 1 in Appendix A.
