# Appendix 11.4

## Hydromorphology Assessment Part 1

- 1.1.1 This appendix presents the detail of the hydromorphology assessment of the Proposed Scheme for Project 8 – Dalwhinnie to Crubenmore (Central Section) of the A9 Dualling Programme. It supports the summarised findings presented in **Chapter 11** of the Environmental Statement (ES). The Proposed Scheme that was assessed is described in **Chapter 5** of the ES.

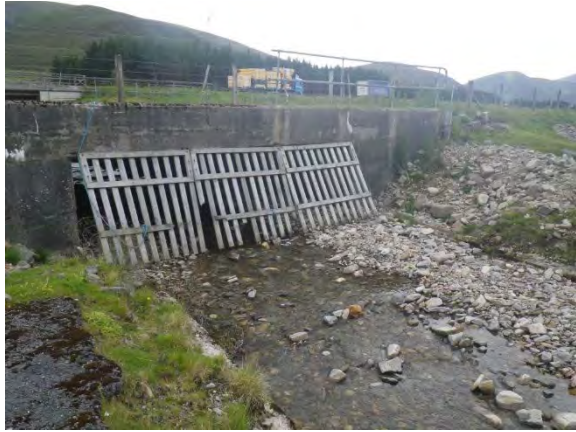
Photograph 11.4.3.5- Downstream to crossing

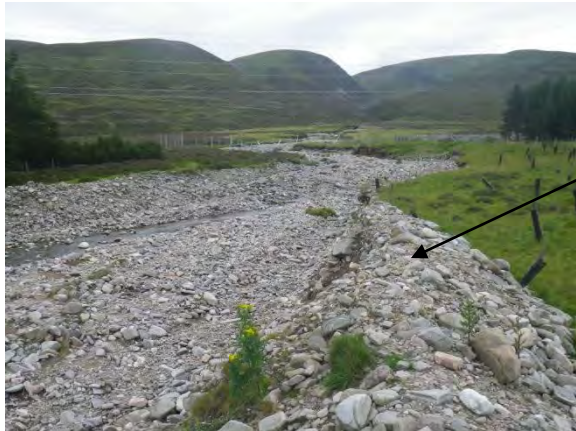
Photograph 11.4.3.7- Deposition upstream of crossing

Embankment

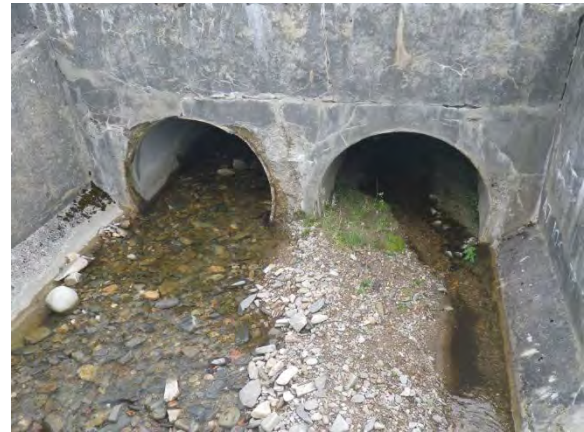
Photograph 11.4.3.12- Deposition in both pipes downstream of crossing

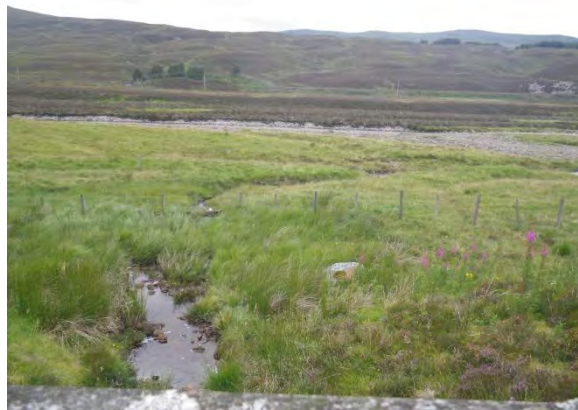
Photograph 11.4.3.28 - Low gradient channel  
downstream of crossing

Gravel and  
boulders in bed

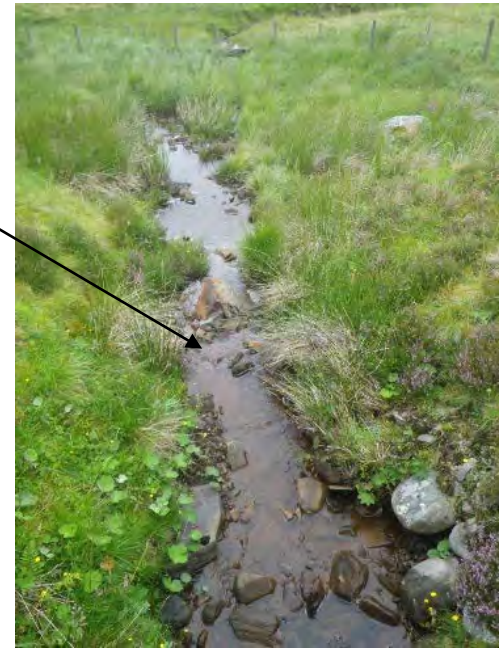
Photograph 11.4.3.29 - Downstream of  
crossing

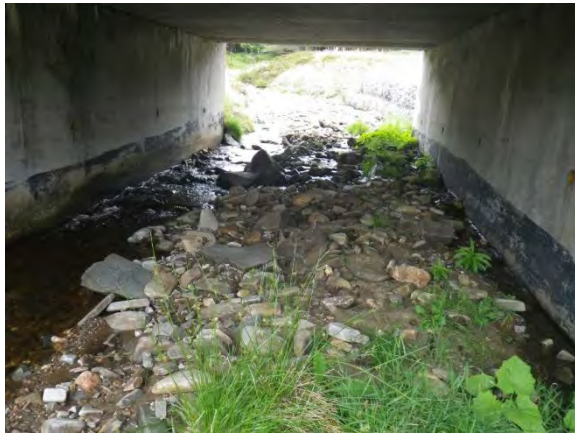
Photograph 11.4.3.33 - Deposition in A9 crossing, creating low flow channel

Deposition

Erosion protection

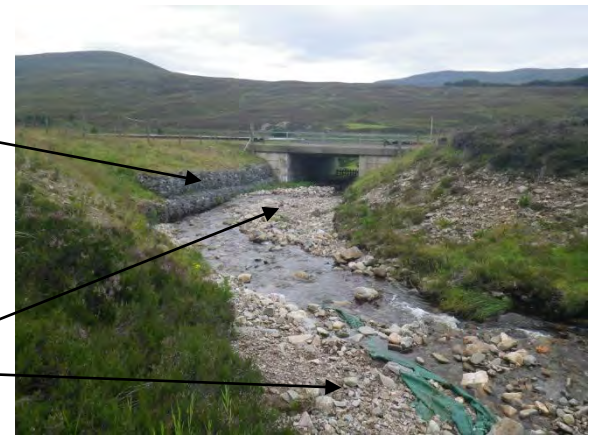
Photograph 11.4.3.37 - Downstream to crossing
