Appendix 11.4

Hydromorphology Assessment Part 4

Annex 11.4.3 - Hydromorphological Catchment Assessment - 94

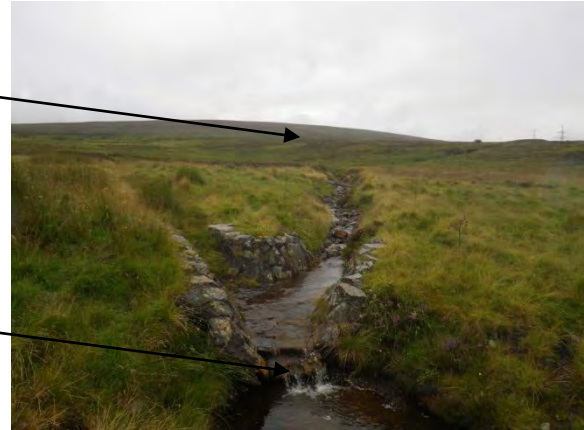
Photograph 11.4.3.66- Upstream to channel
realignment creating a step in bed

Gently sloping
catchment

Potential for
nick point
migration

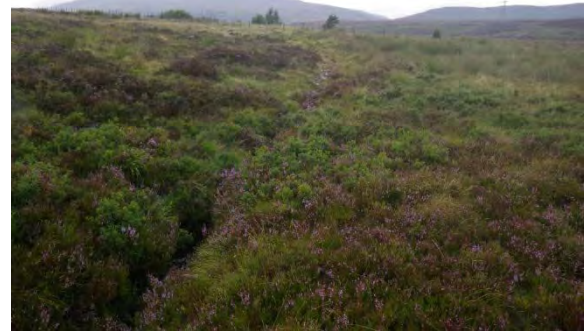
Photograph 11.4.3.68 - Looking upstream to
poorly defined channel

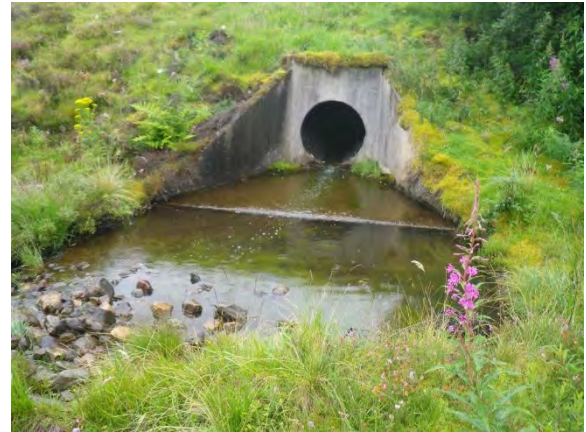
Photograph 11.4.3.72 - Crossing exit- Over wide, shallow channel

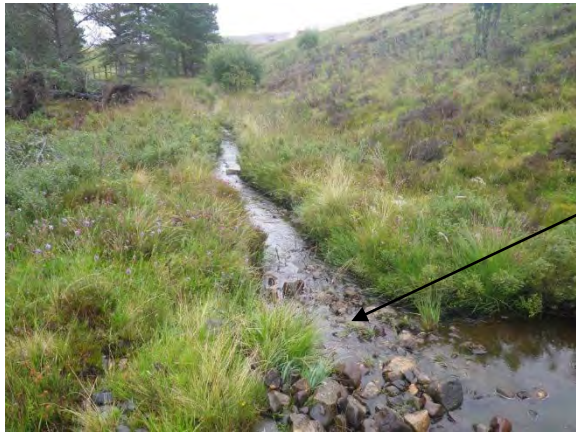
Photograph 11.4.3.73- Downstream of diverted channel

Gravel and
cobble bed

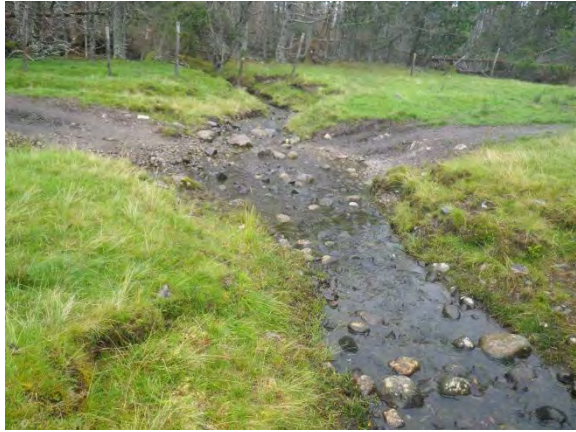
Photograph 11.4.3.76- Downstream channel
with cobble and gravel bed

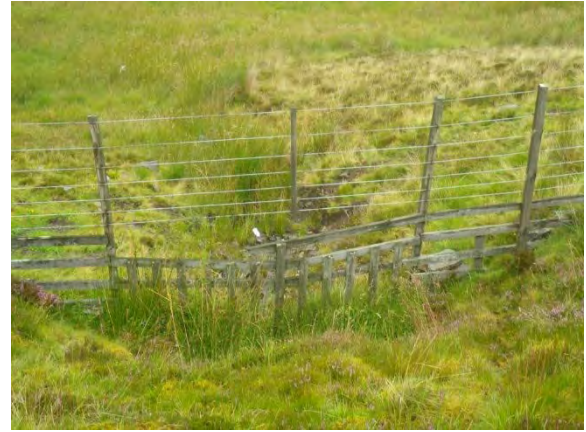
Photograph 11.4.3.90 -Downstream crossing exit

Morphology and Process- Reach downstream of crossing	Channel morphology	Engineered	
	Predominant sediment size	Fine	
	Unvegetated bars	No	
	Vertical incision	Medium	Some scour at outflow from road culvert
	Deposition	Low	Fines
	Lateral migration/bank erosion	Low	Immediately d/s of outflow, due to scour - see above
	Presence and nature of infrastructure (Map 1d)	Yes	Railway (on embankment)
	Infrastructure type (see Drawing 11.4.3.1 d, Catchment 106)	Yes	Impoundment of 104 at high flows
Channel realignment	Yes	Cut drain, straight	
Summary behaviour	<p>U/s of the road, a cut drain collects natural hillslope drainage from small channels. This descends to the road culvert on a principally intact cascade. D/s of the road culvert, there is a small amount of scour, before the drain crosses the flood plain/alluvial fan, close to its edge. At the railway embankment, flow goes through a railway crossing which appears oversized for channel 106. A large scour pool is also present on the d/s side of the railway crossing, which also appears very large for the limited flow that is likely to occur through crossing 106. Closer inspection of the LiDAR and aerial photographs indicate that this scour pool has likely been created when impounded high flows from channel 104 have drained through this railway crossing. These are more likely to have the energy to create the scour pool than the flow from channel 106 alone.</p>

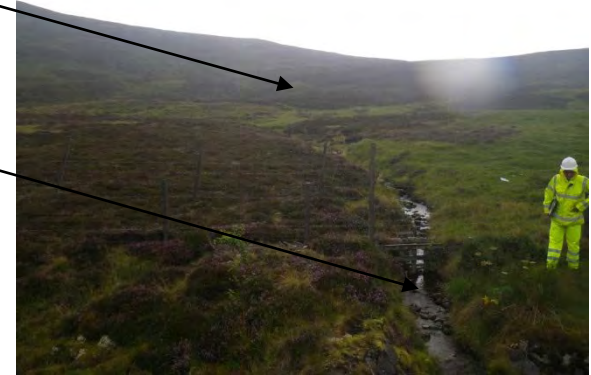
Photograph 11.4.3.102 – Upstream of crossing

Steep upper catchment

Crossing on lower gradient area
