# Appendix 11.4

## Hydromorphology Assessment Part 2

## Annex 11.4.4 Hydromorphology Catchment Baselines

**Annex 11.4.3 - Hydromorphological Catchment Assessment - -3**

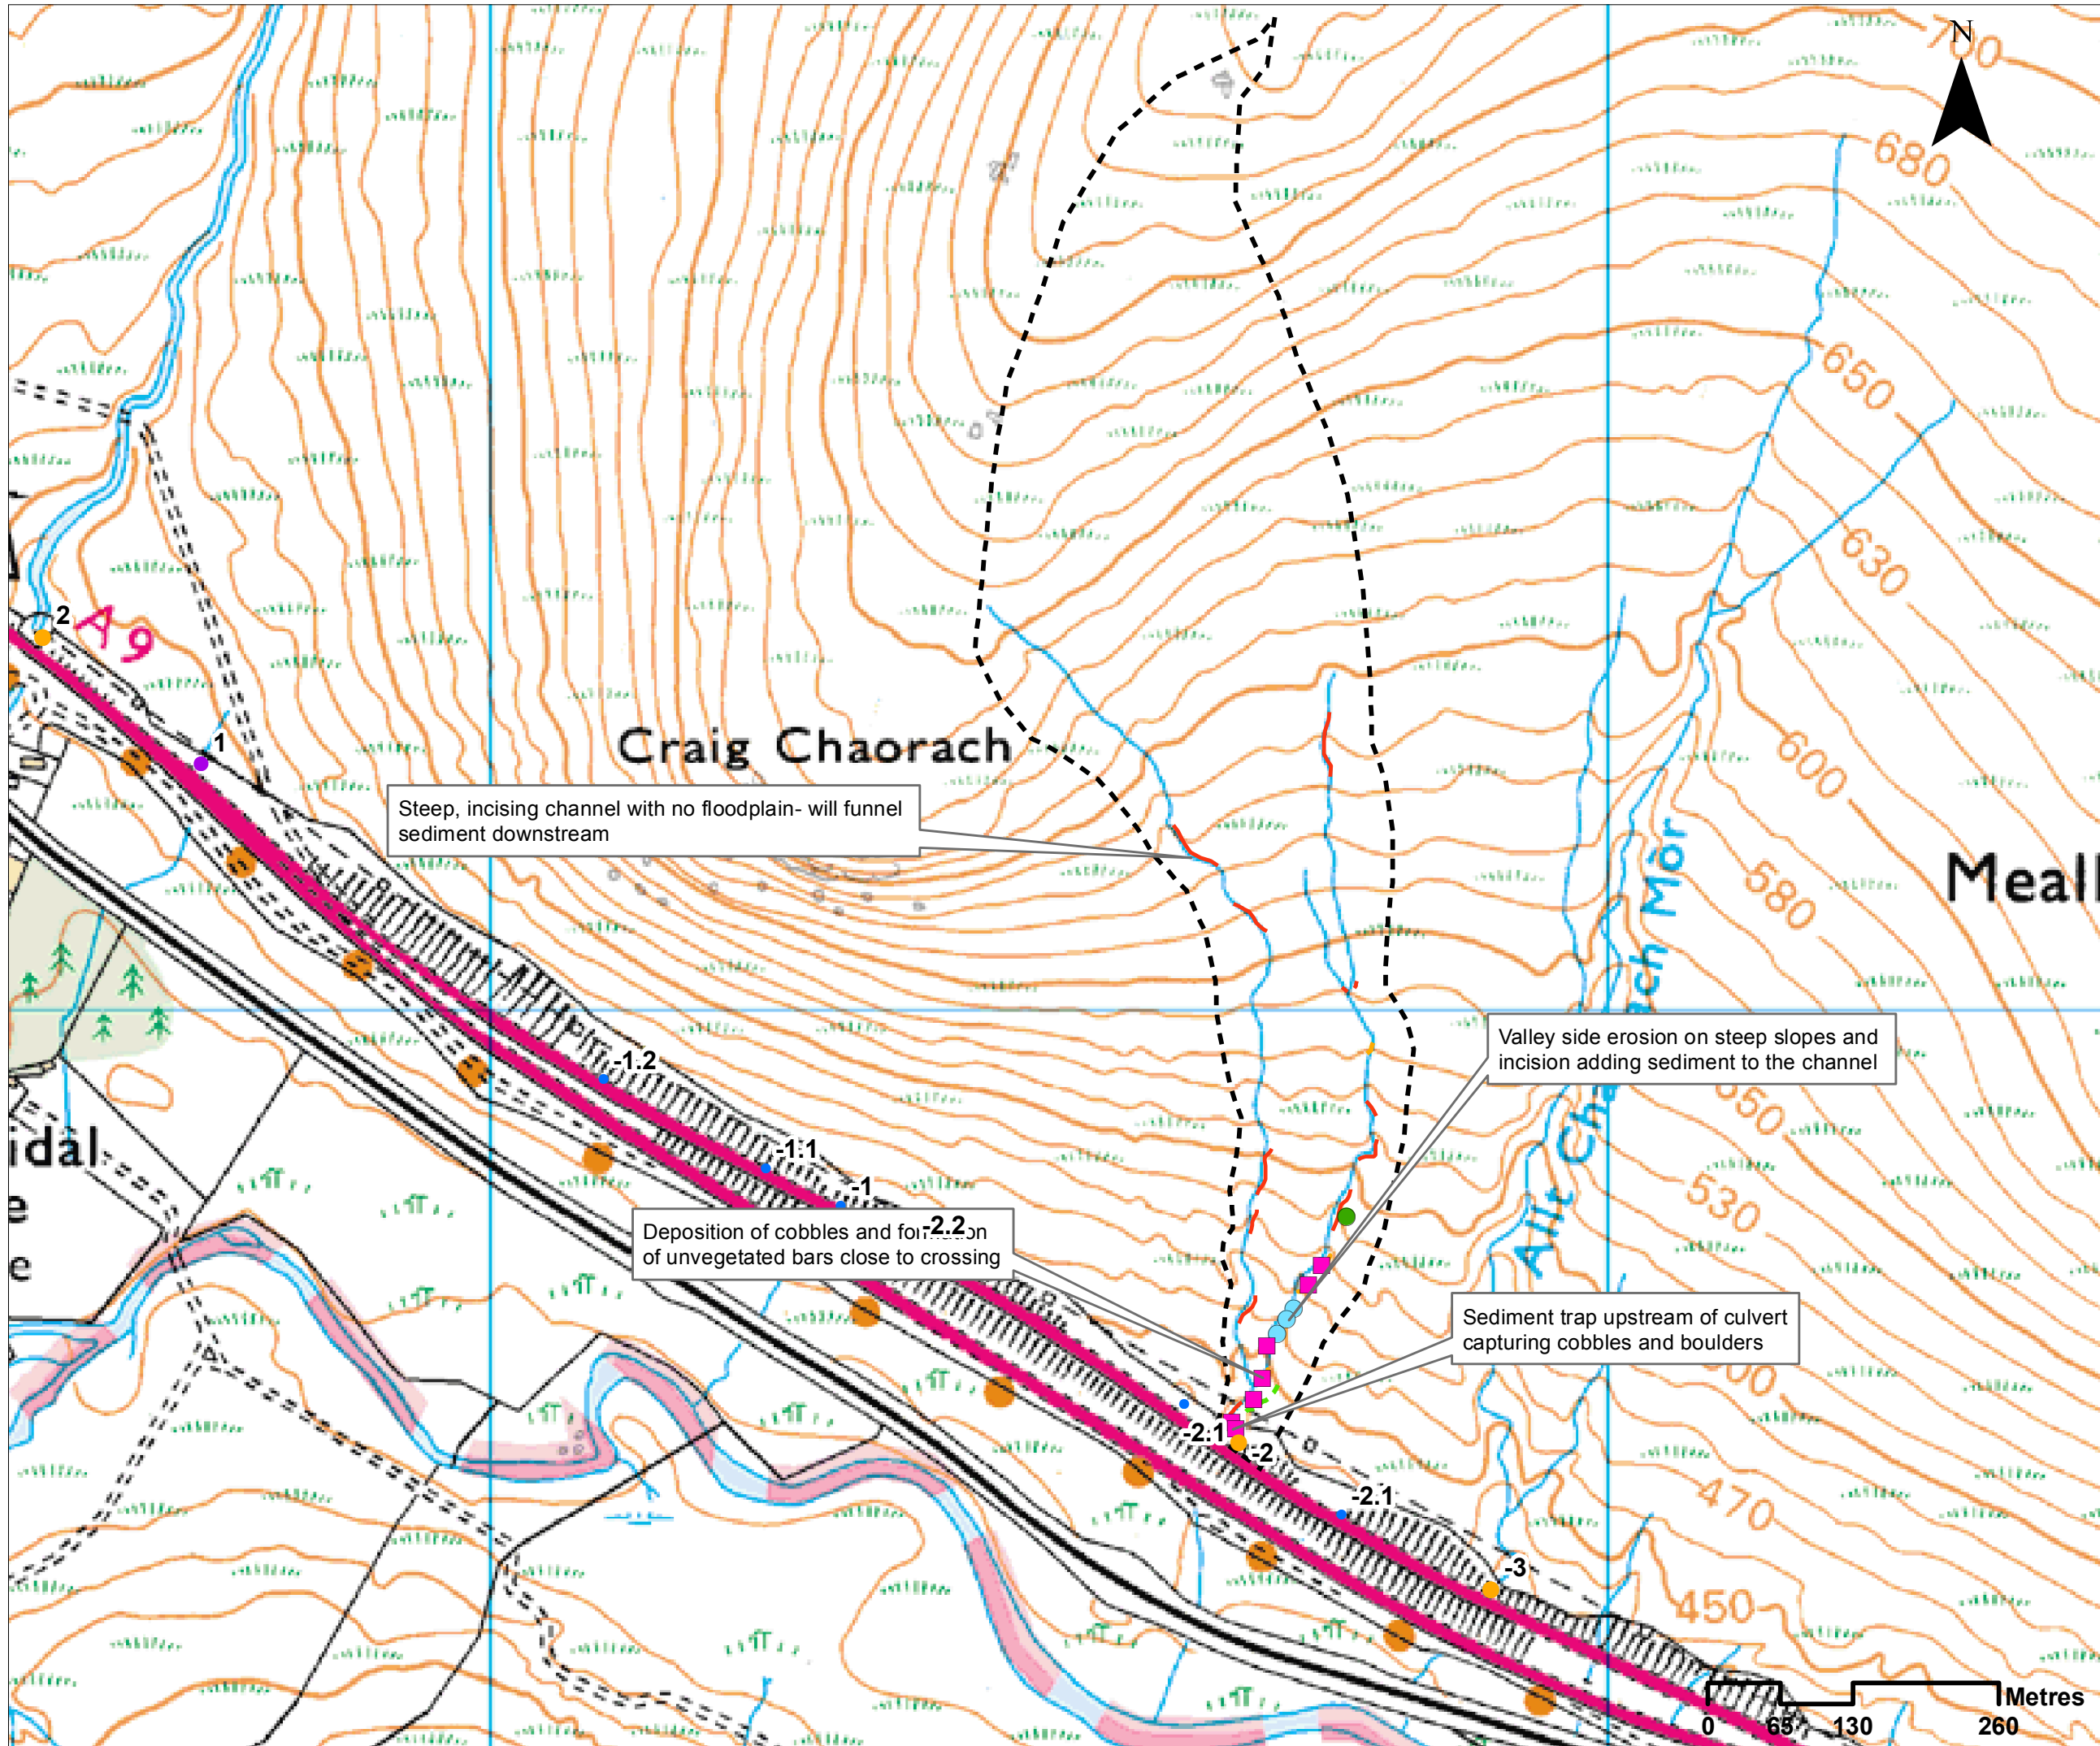
**PROJECT 7 GLEN GARRY TO DALWHINNIE EIA**  
**DRAWING 11.4.3.2. Catchment -2 Baseline Assessment**

Infrastructure type (see Drawing 11.4.3.1 d, Catchment -2)	Railway crossing NMV crossing (bridge), footbridge, drainage pipe	
	Impact of infrastructure	Fixing bank positions, potential higher discharge downstream of pipe	
Channel realignment	Yes	Straightened downstream of culvert	
<b>Summary behaviour</b>	High sediment supply from catchment by valley erosion and vertical incision. The catchment is steep and confined, funnelling sediment downstream, depositing in bars where slope reduces. This currently leaves unvegetated bars close to the crossing with the potential to be mobilised downstream during high flows. Deposition appears greatest both just upstream of the crossing and downstream of the crossing near the HML railway bridge. Bars increase potential of lateral and vertical movement downstream. Sediment appears trapped at the large upstream step in the channel in which there is a rectangular notch, leaving the road crossing culvert entrance generally clear of sediment. There is a high supply of sediment as much of the channel flows through highly erodible hummocky glacial deposits into which the channel has incised. The culvert crossing and armouring appear stable.

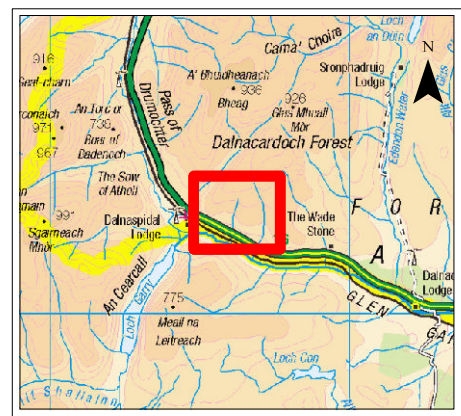
**PROJECT 7 GLEN GARRY TO DALWHINNIE EIA**  
**DRAWING 11.4.3.2. Catchment -3 Baseline Assessment**

Steep, incising channel through erodible hummocky glacial deposits. No floodplain, will funnel sediment downstream

Hillslope failure on steep slopes adding much sediment to the channel

Deposition of cobbles and formation of unvegetated bars close to crossing

Reduction in slope and high deposition downstream of crossing

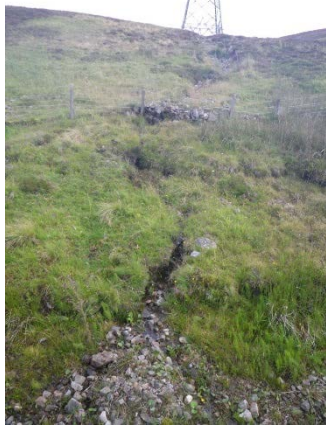
Photograph 11.4.3.14 -Small debris flow
