Project **FORTH REPLACEMENT CROSSING**

AIR QUALITY MONITORING REPORT
JULY 2012

Document number
REP-00041-00

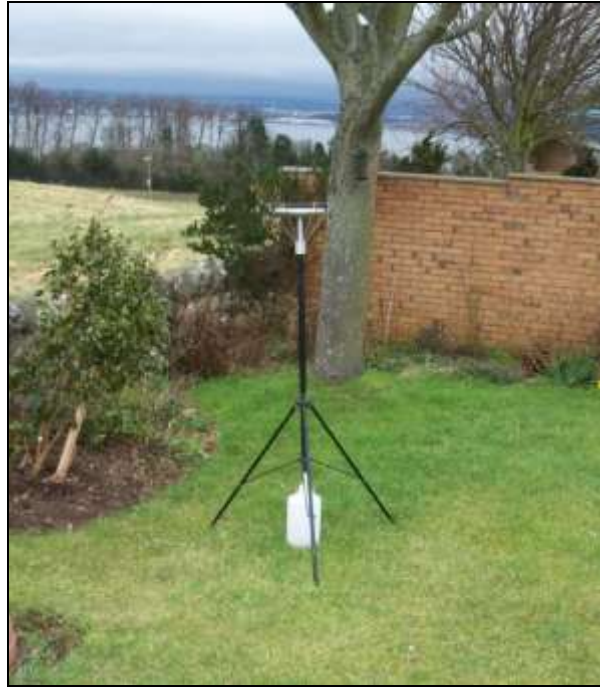
Figure 1: Example of an Installed Frisbee Gauge Meters

2.1. Air quality is being monitored on site using both automatic light scatter dust meters and Frisbee gauge dust deposition monitoring. Thirteen Frisbee gauges are set up at sensitive locations across the site to measure dust deposition rates (Figure 1). Seven automatic light scatter meters have also been installed at various sensitive locations to measure real time particulate matter (PM₁₀) concentrations and the Total Suspended Particle (TSP) concentrations (Figure 2). Table 1 lists the air quality monitoring equipment present at each monitoring location. The installation of the air quality monitoring equipment has not been simultaneous across the site, thus installation dates are also given in Table 1.
