Project **FORTH REPLACEMENT CROSSING**

**AIR QUALITY MONITORING REPORT  
OCTOBER 2018**

**REP-00361**

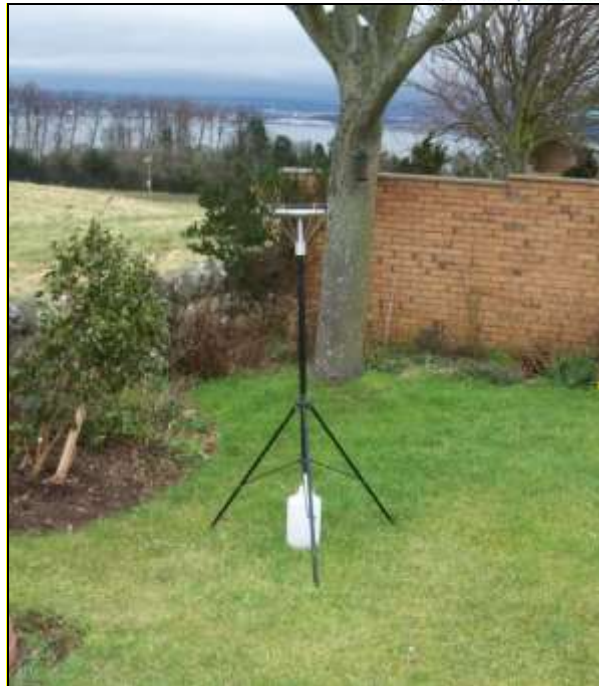
**Figure 1: Example of an Installed Frisbee Gauge Meter**

**2.1.** Air quality is being monitored on site using Frisbee gauge dust deposition monitoring. Four Frisbee gauges are currently set up at sensitive locations across the site to measure dust deposition rates (Figure 1). Table 1 lists the air quality monitoring equipment present at each monitoring location, including the date it was installed.

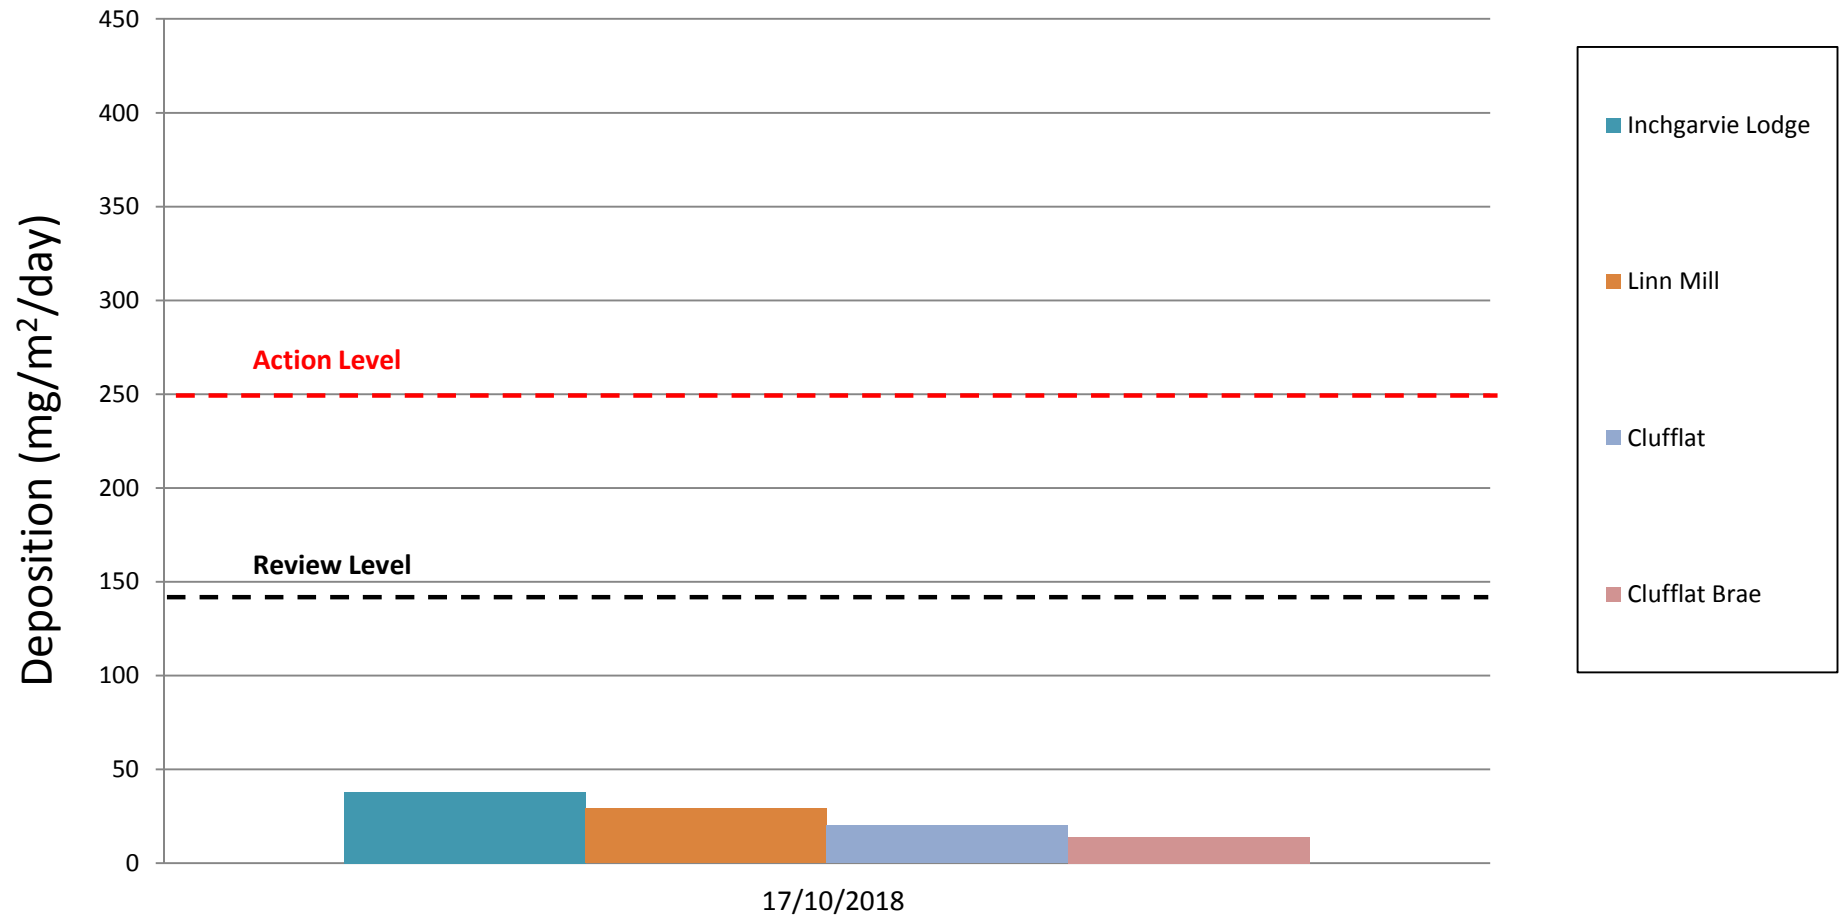
# Frisbee Dust Deposition Results: October 2018

- 3.1.1.** The Frisbee dust deposition results for October 2018 have been presented in a chart and can be found in Appendix A. One collection was made in October; this occurred on the 17<sup>th</sup> October.
- 3.1.2.** The site action level for the dust deposition rate has been set at 250 mg/m<sup>2</sup>/day. Exceedances of this level are treated as a potential incident and a review of the works in the vicinity of the site is instigated. A lower site review level has been set at 140 mg/m<sup>2</sup>/day. Where concentrations exceed the lower review threshold the site works are reviewed to ensure good practice is implemented; it is essentially a warning that additional controls may be required.
- 3.1.3.** During October there were no exceedances of either the site review or action levels.
