Project **FORTH REPLACEMENT CROSSING**

**AIR QUALITY MONITORING REPORT
NOVEMBER 2018**

Document number	Rev
REP-00362	00

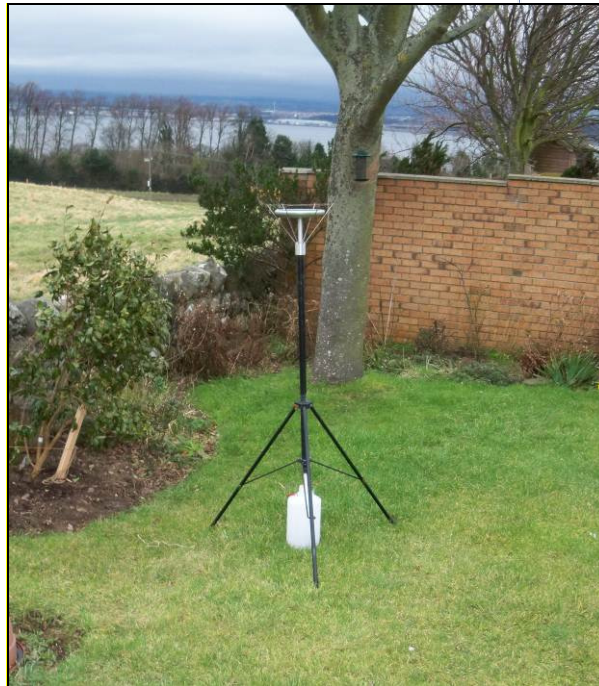
Figure 1: Example of an Installed Frisbee Gauge Meter

2.1. Air quality is being monitored on site using Frisbee gauge dust deposition monitoring. Four Frisbee gauges are currently set up at sensitive locations across the site to measure dust deposition rates (Figure 1). Table 1 lists the air quality monitoring equipment present at each monitoring location, including the date it was installed.
