Client: **TRANSPORT SCOTLAND**  
CONFIDENTIAL ALBA

Project: **ACCESS ARGYLL & BUTE [A83]**

Drawing title: **DMRB STAGE 1 ASSESSMENT  
FIGURE 9B  
GEOTECHNICAL CONSTRAINTS PLAN**

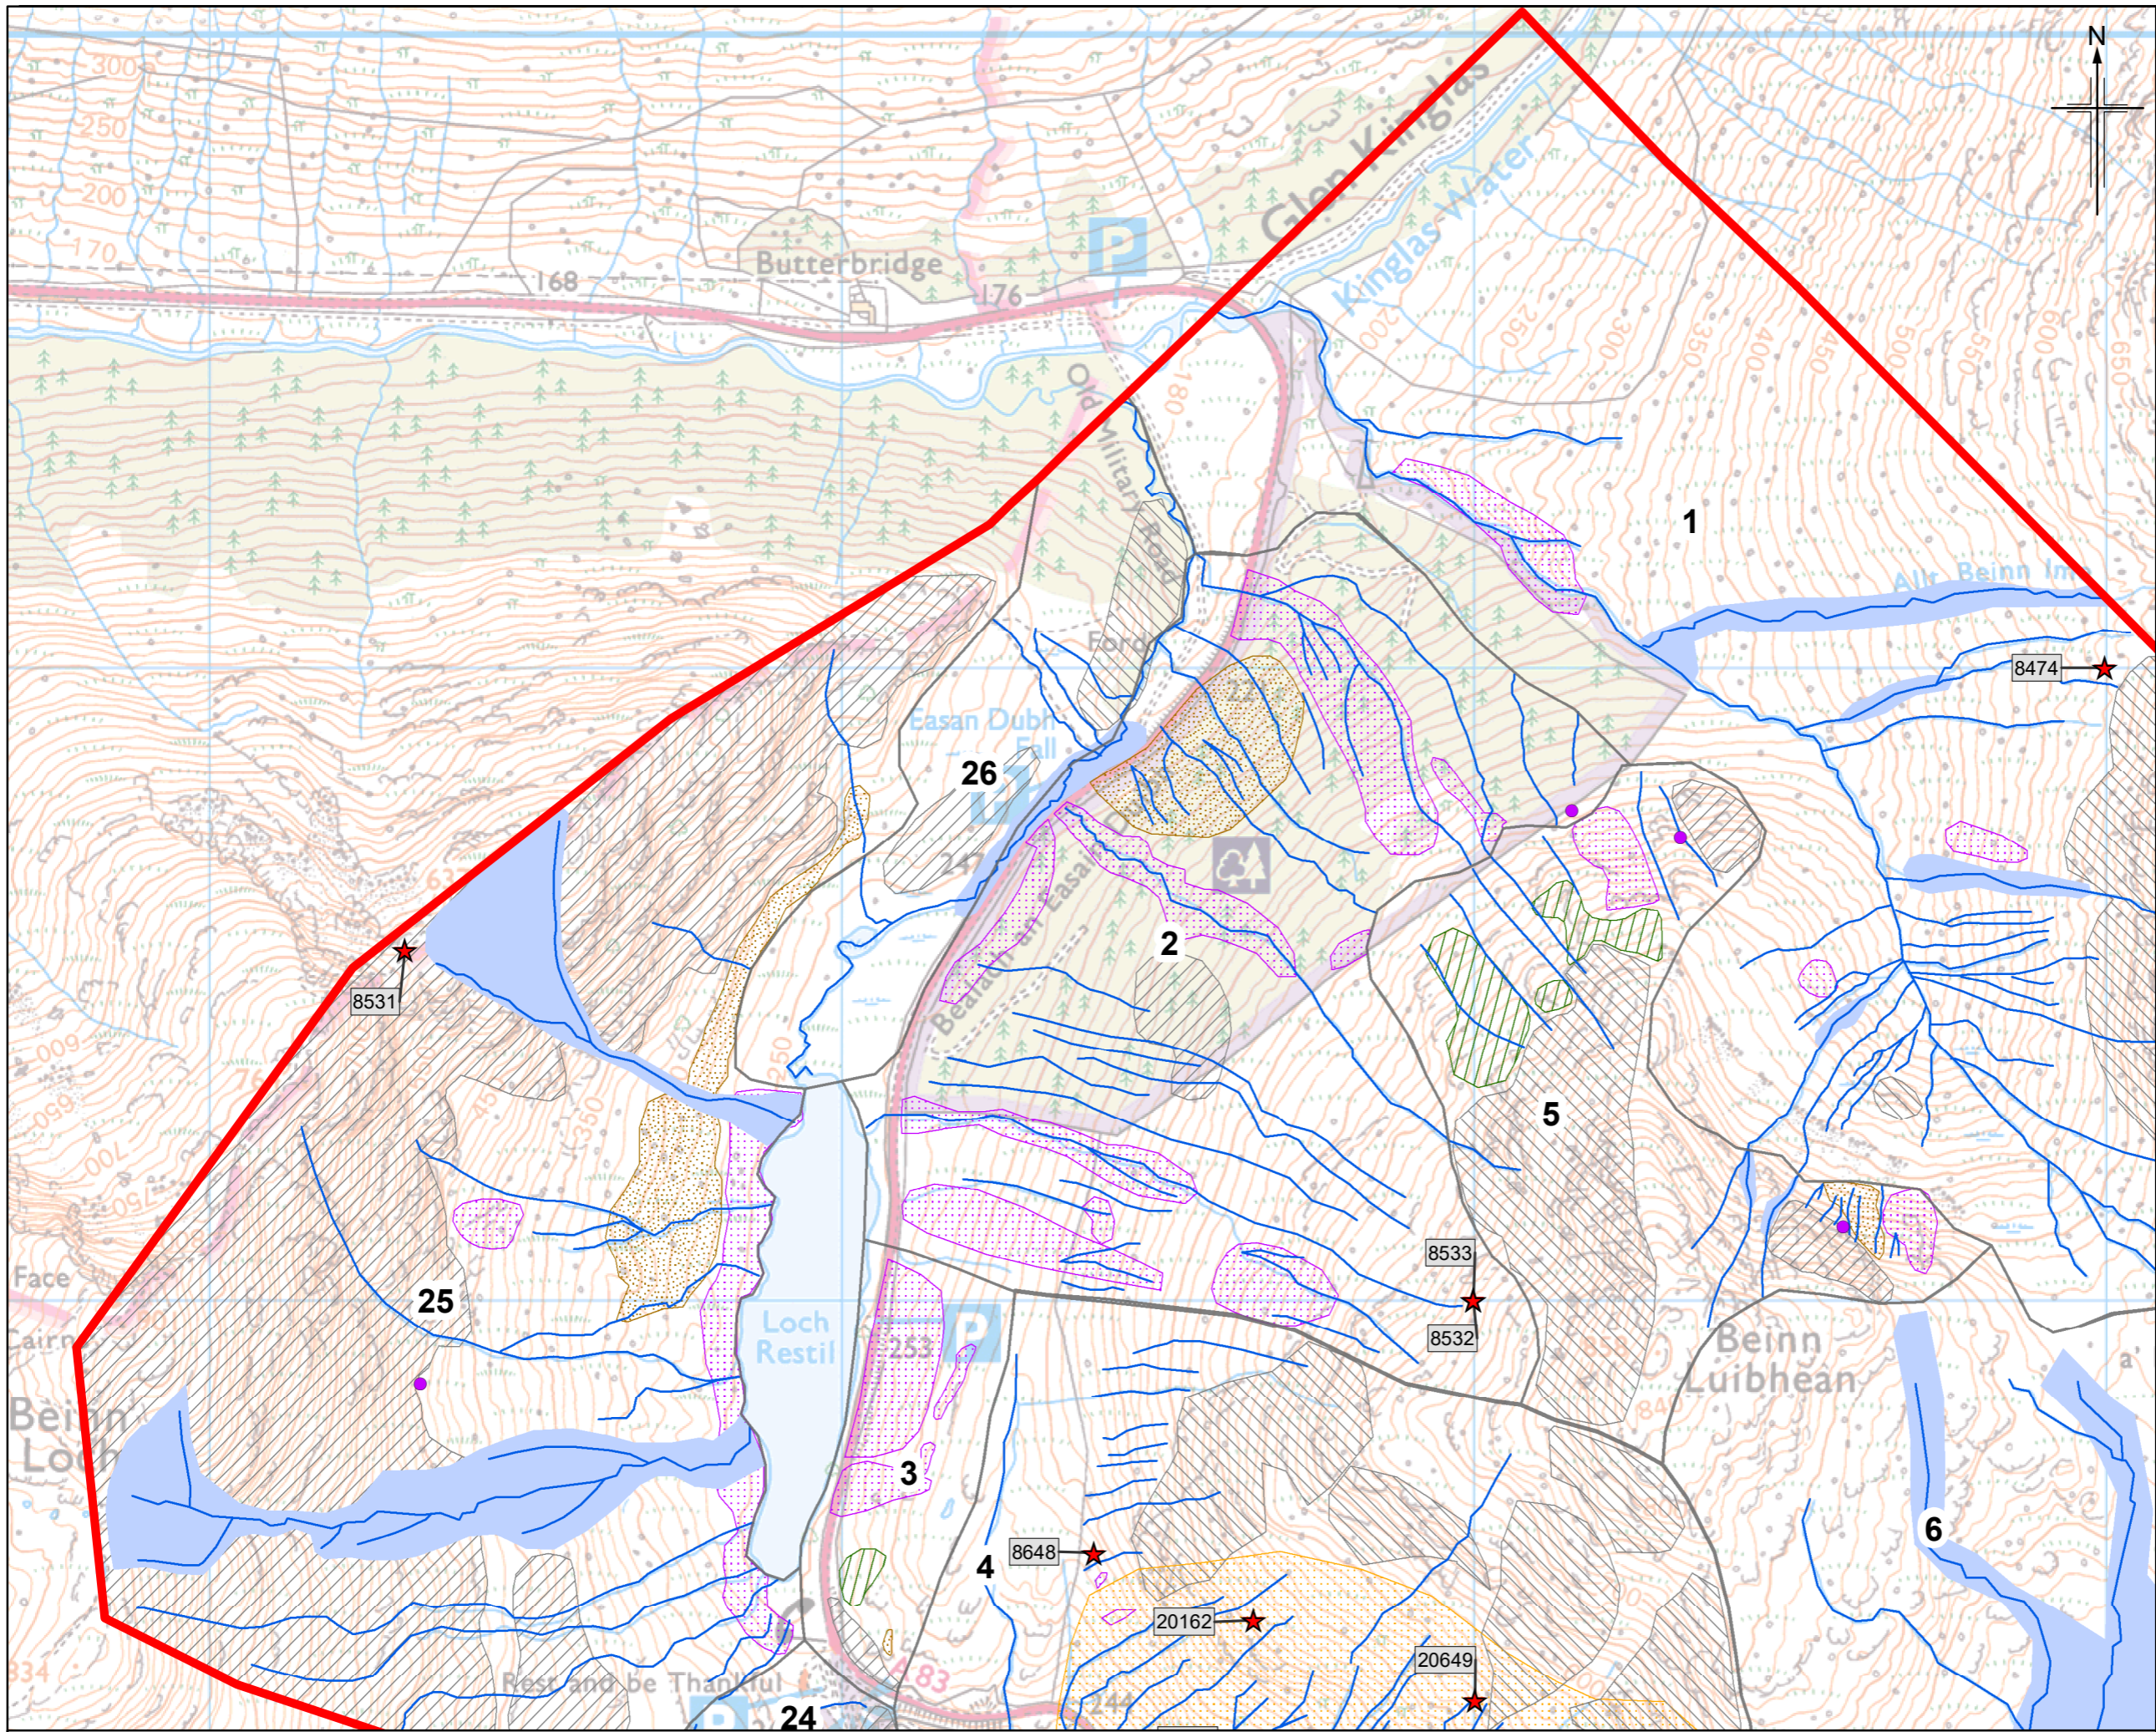
Client  
Project  
Drawing title  
**DMRB STAGE 1 ASSESSMENT  
FIGURE 9A  
GEOTECHNICAL CONSTRAINTS PLAN**
