FORTH REPLACEMENT CROSSING

CONSTRUCTION NOISE MONITORING REPORT: MARCH 2017

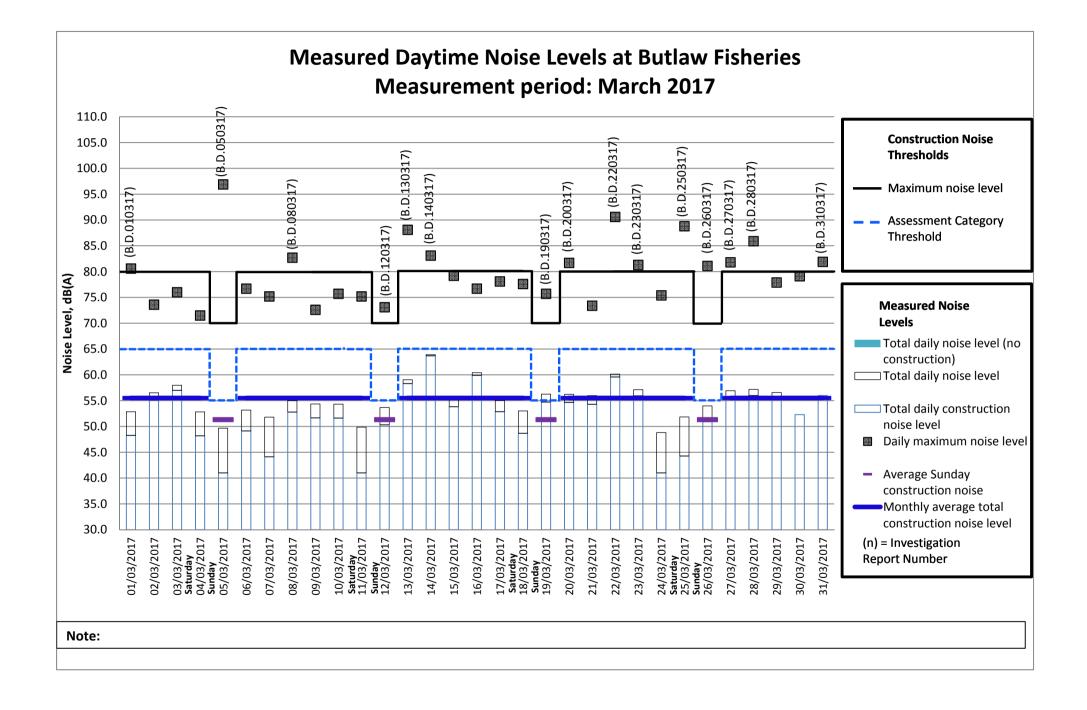
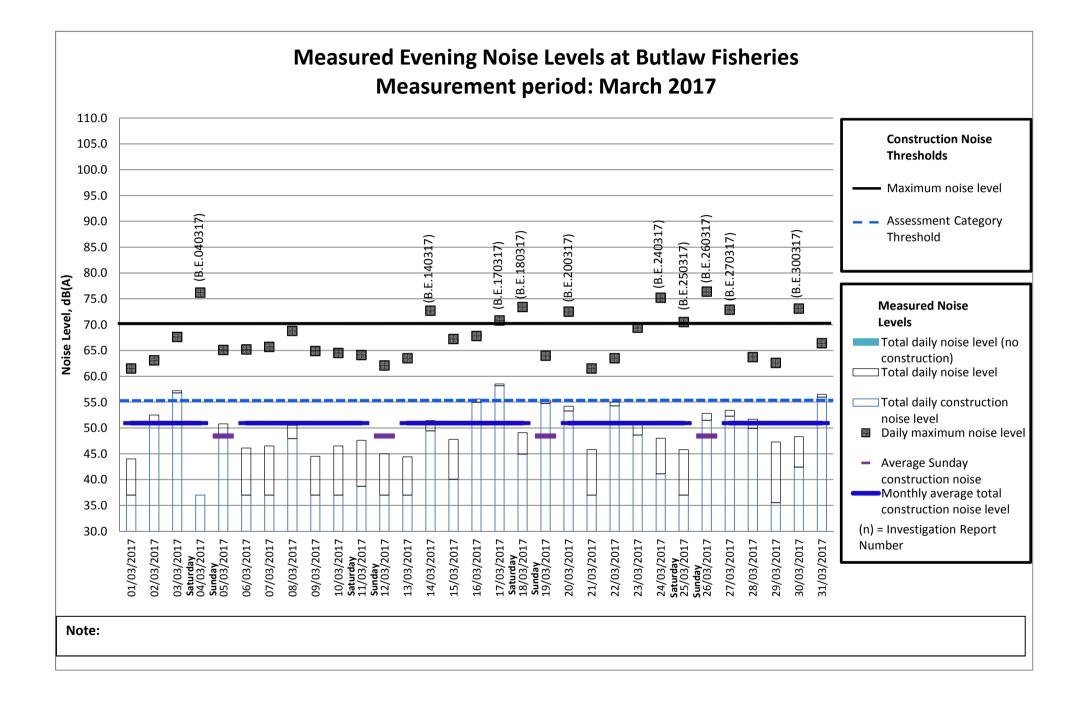
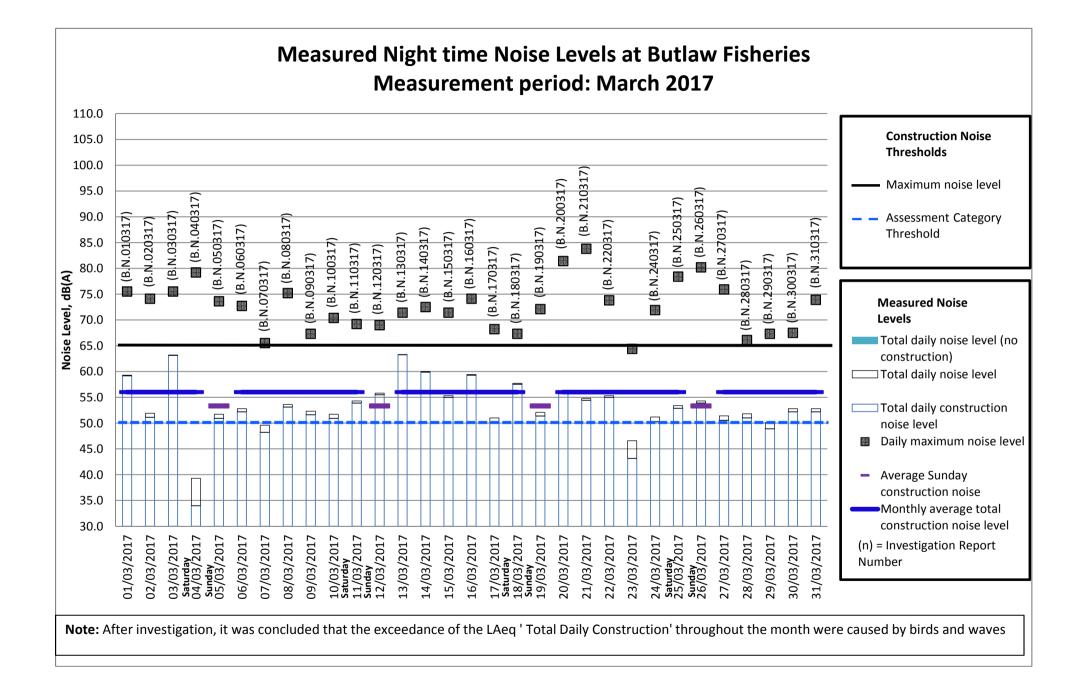
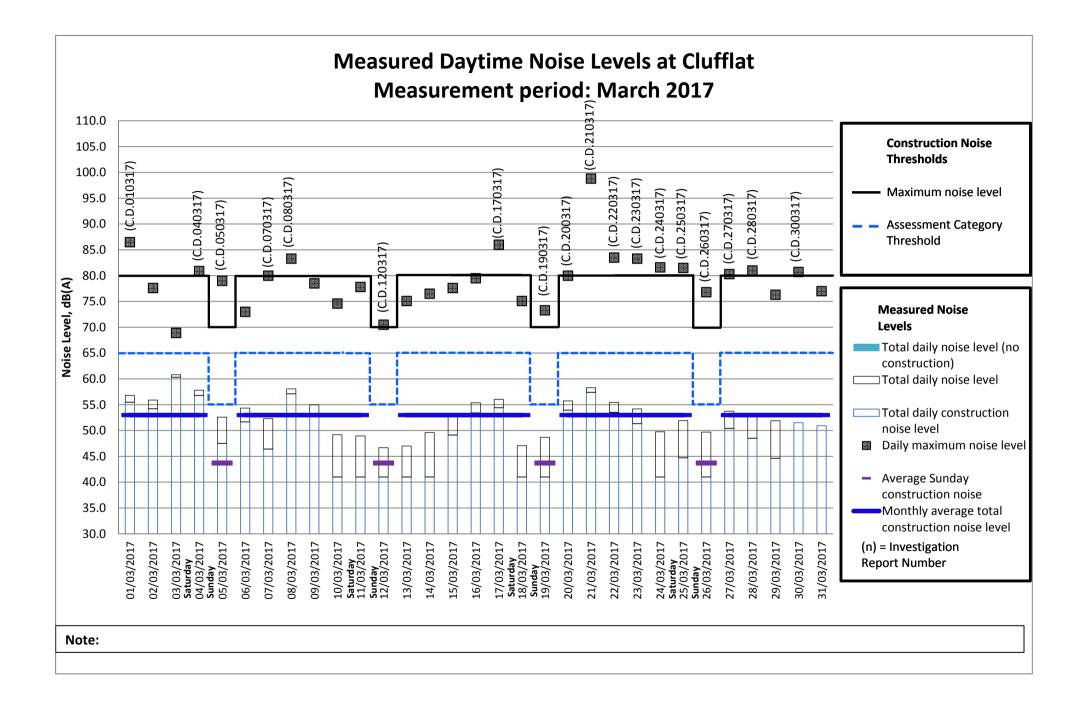
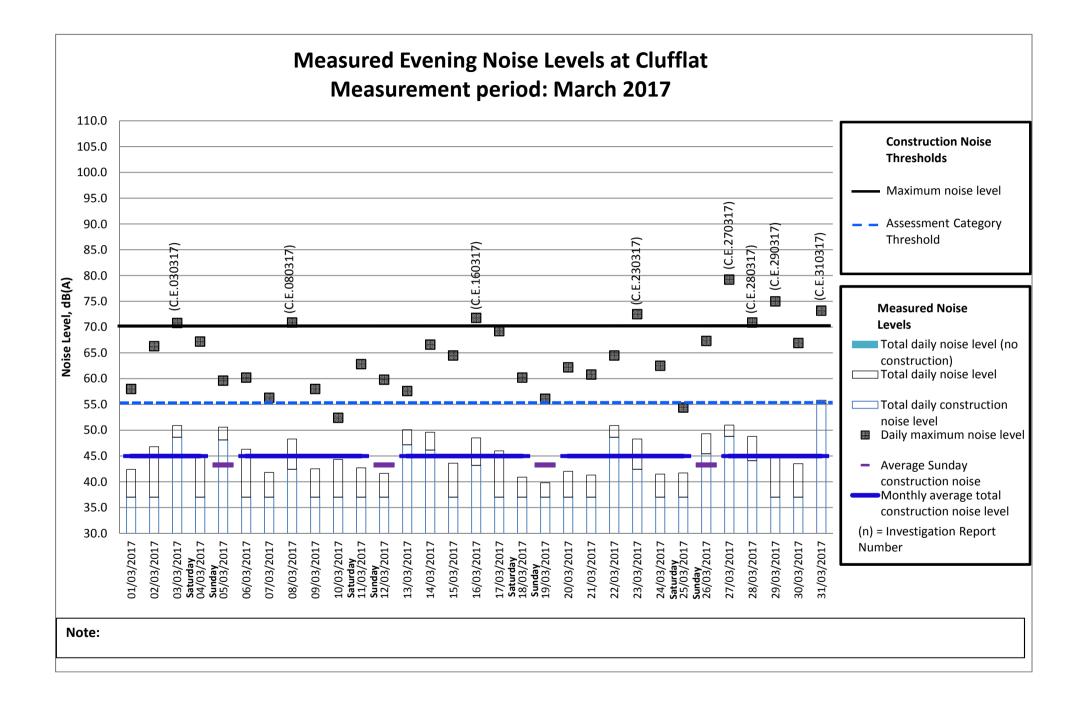
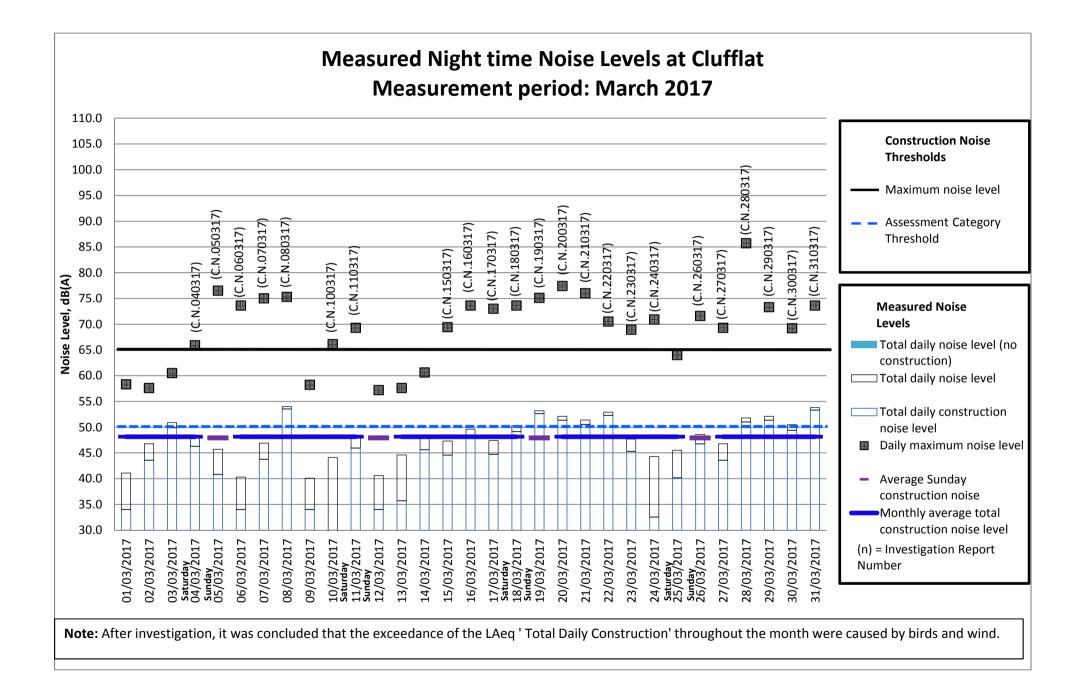
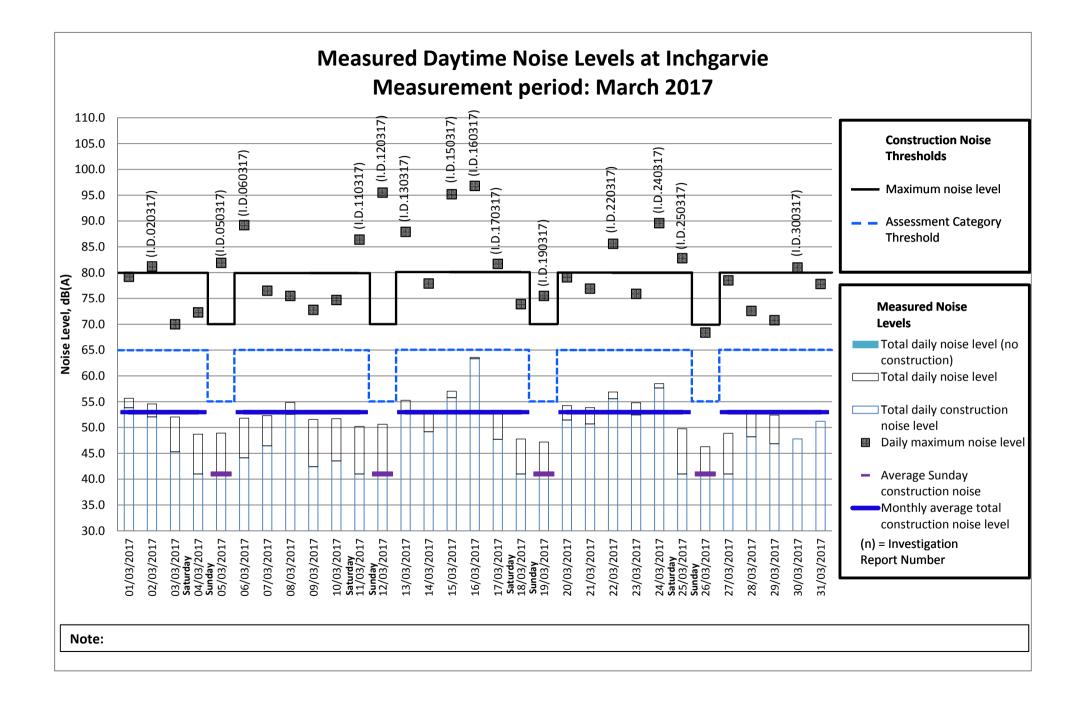
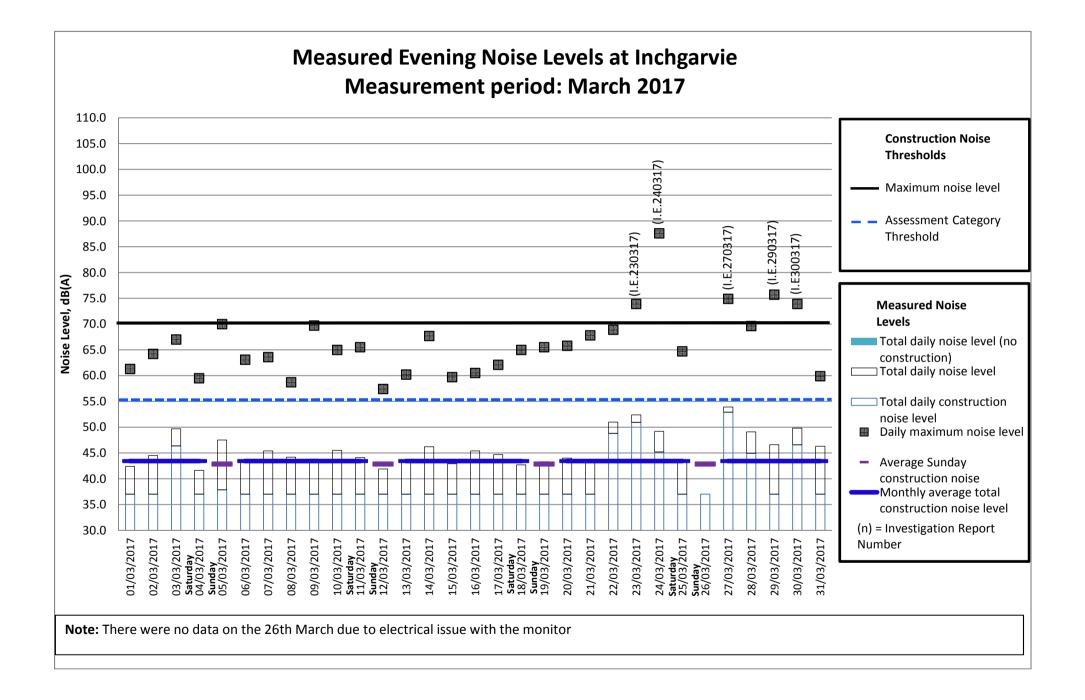
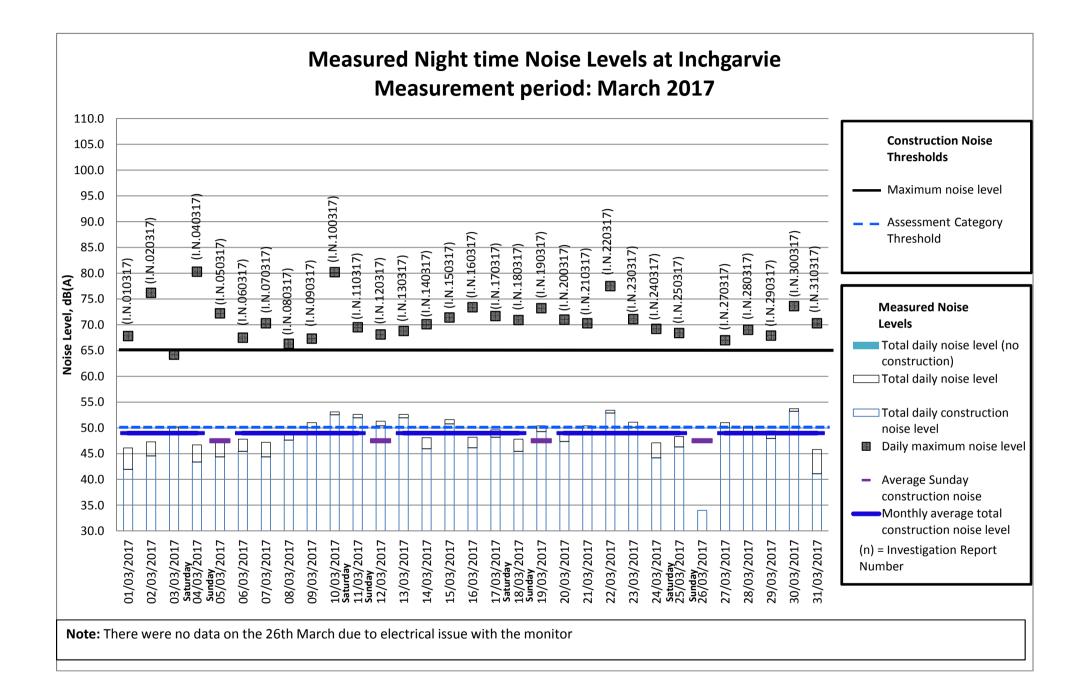
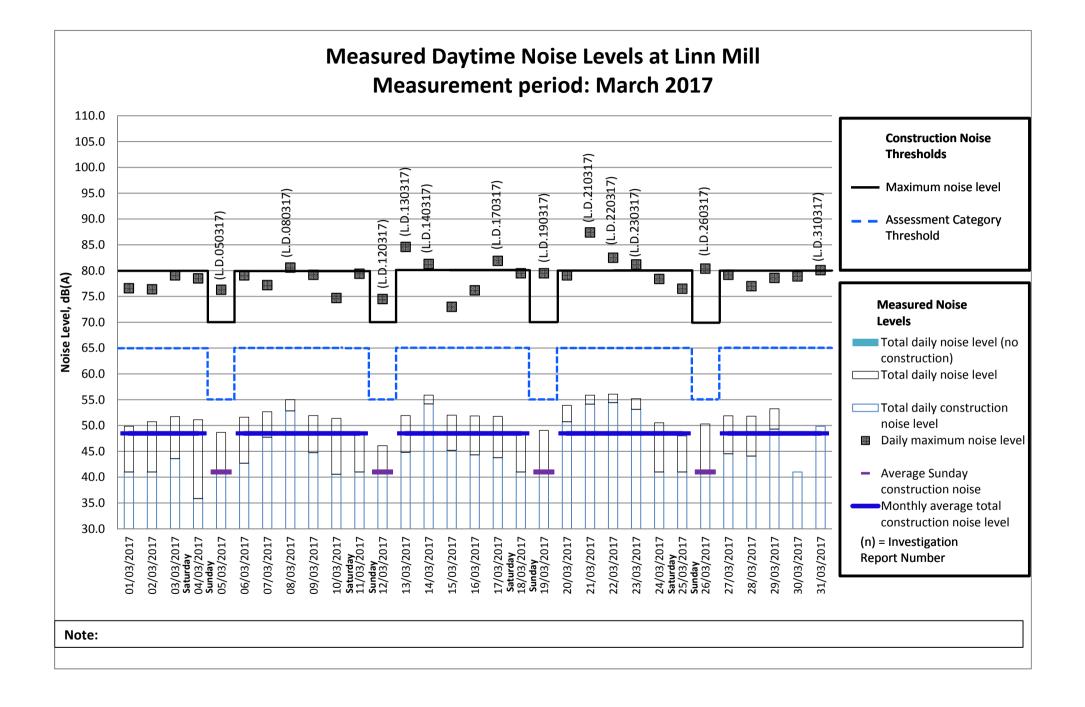
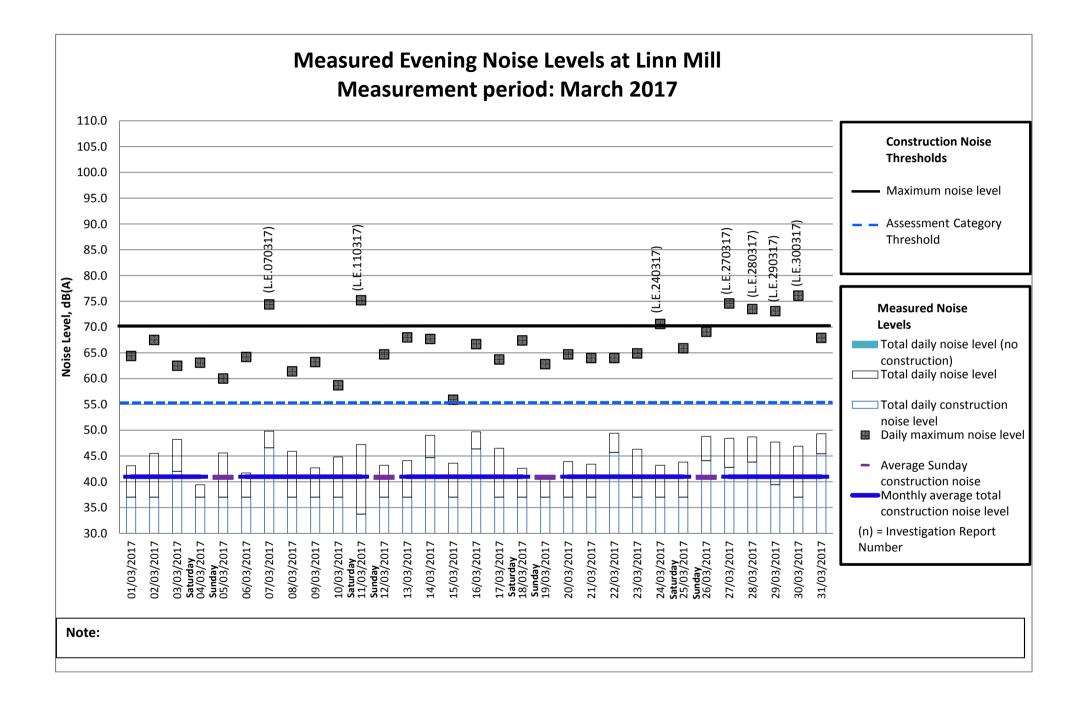
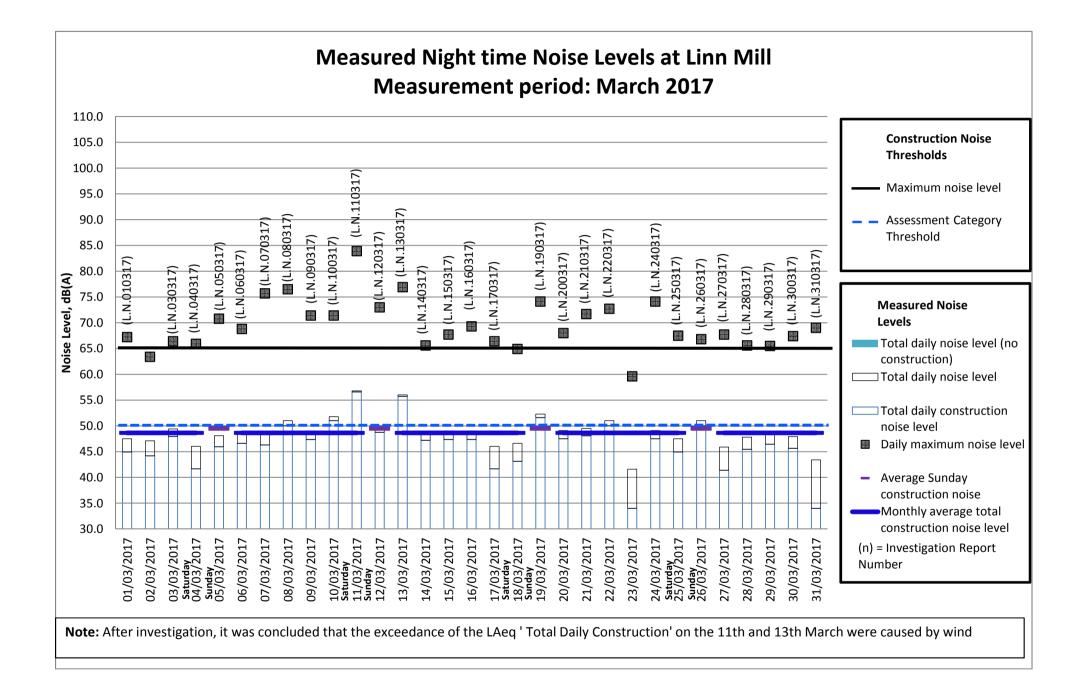
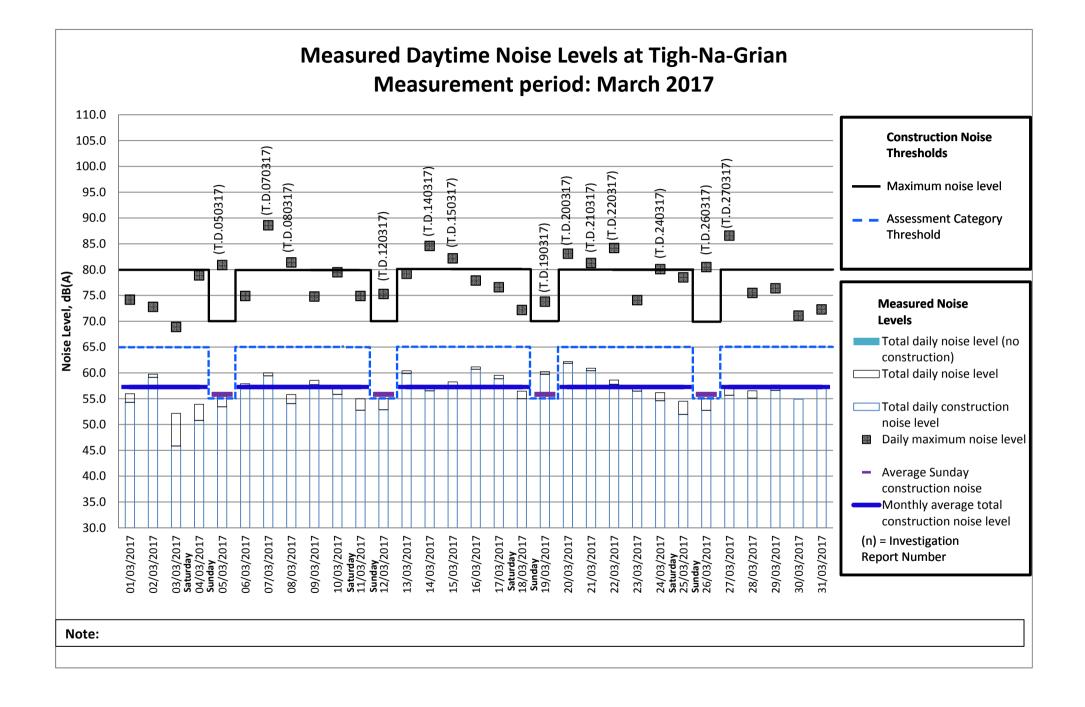
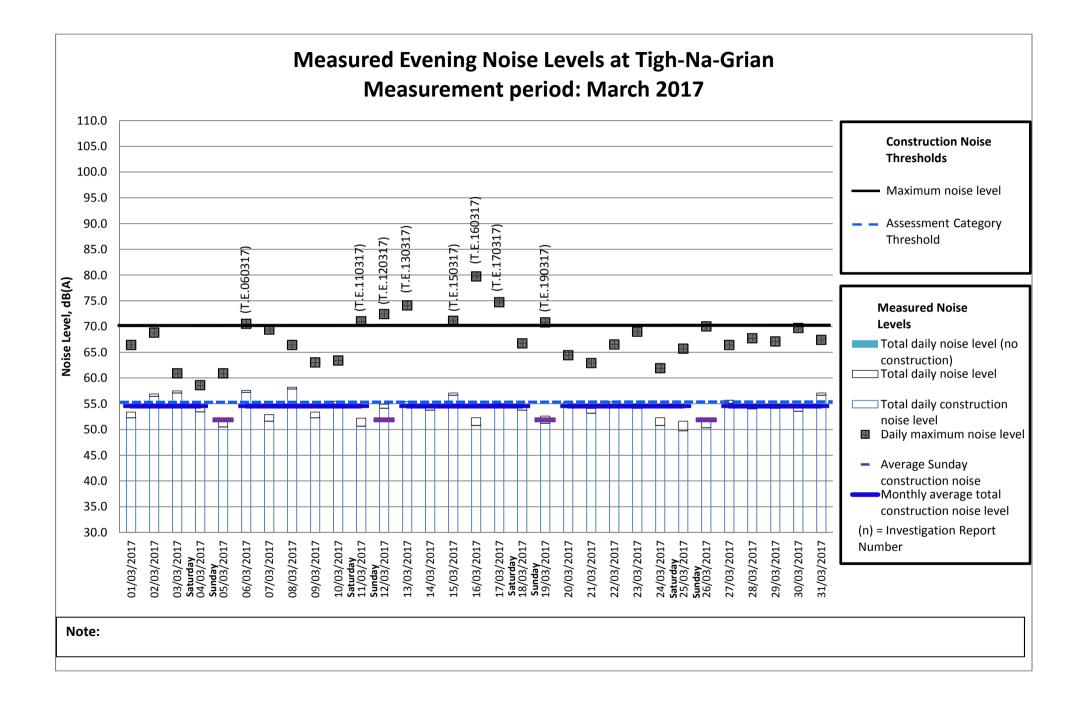
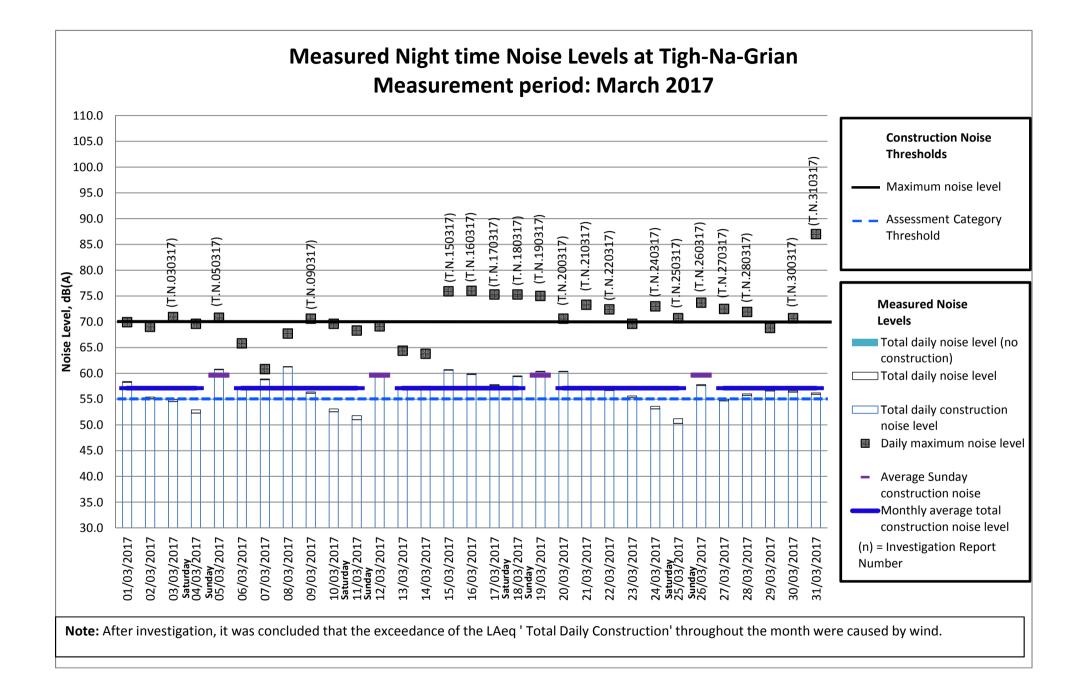
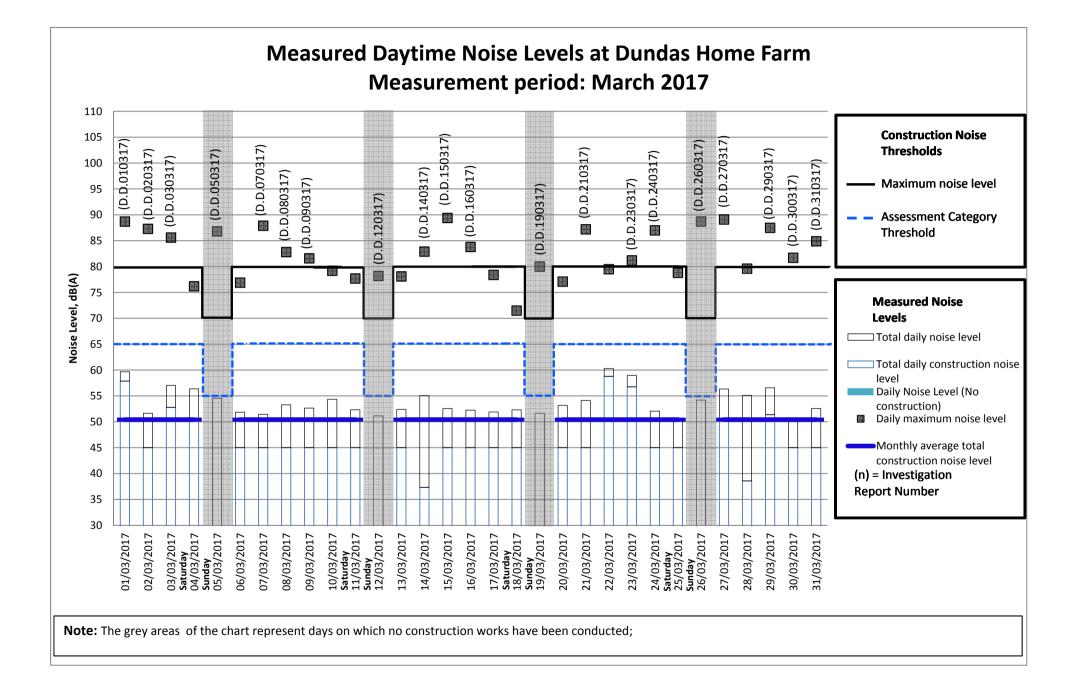
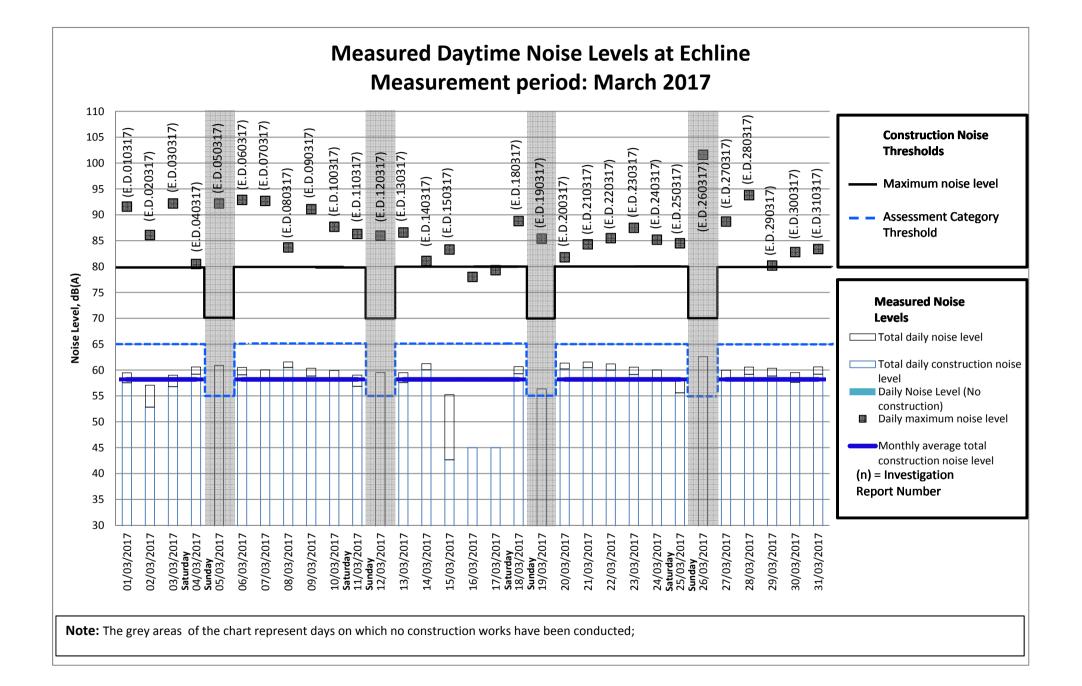
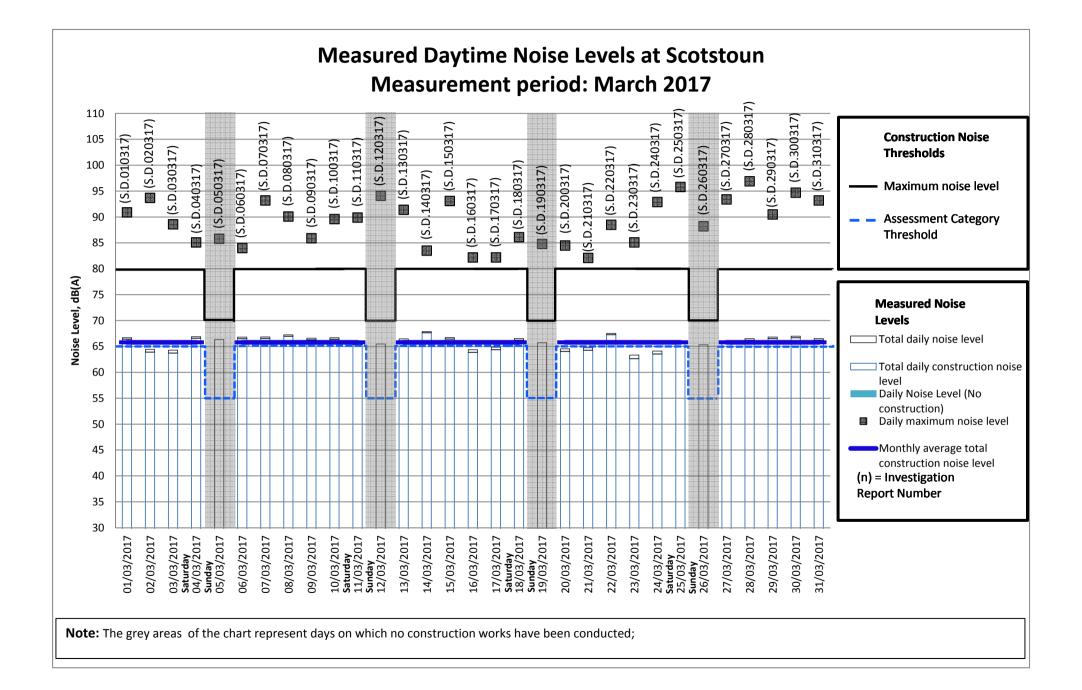
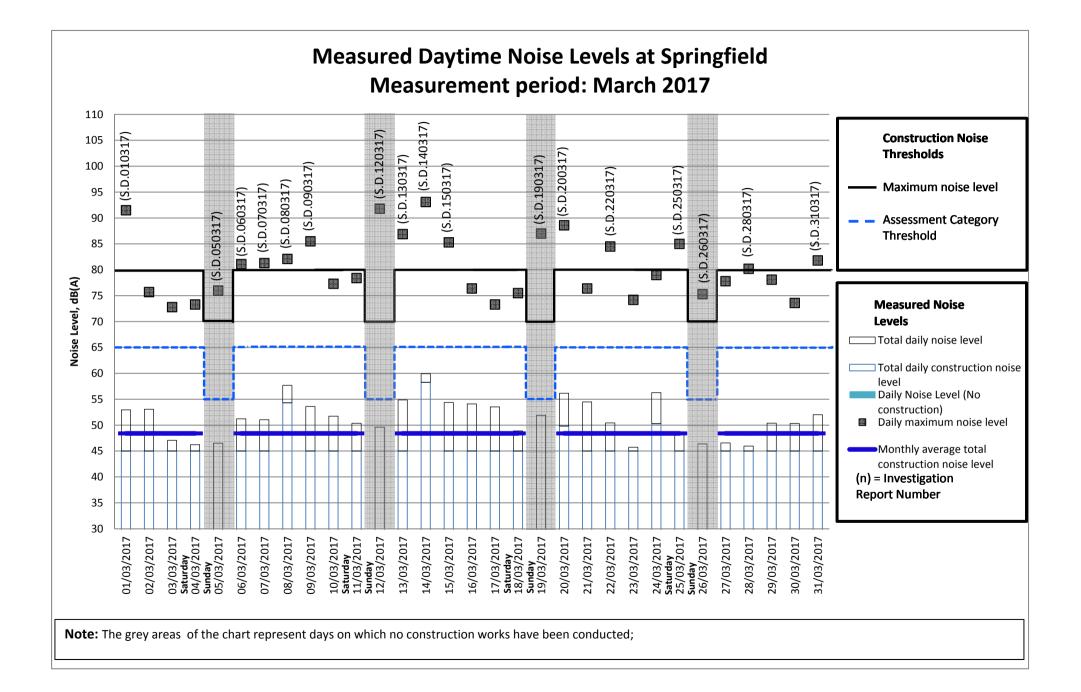
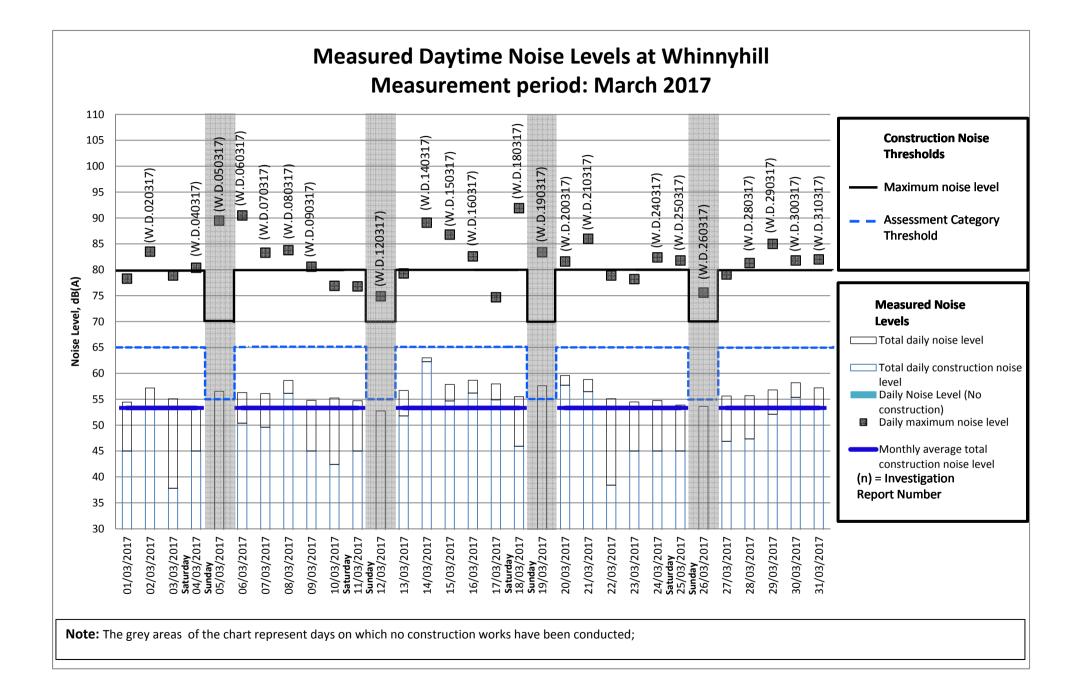
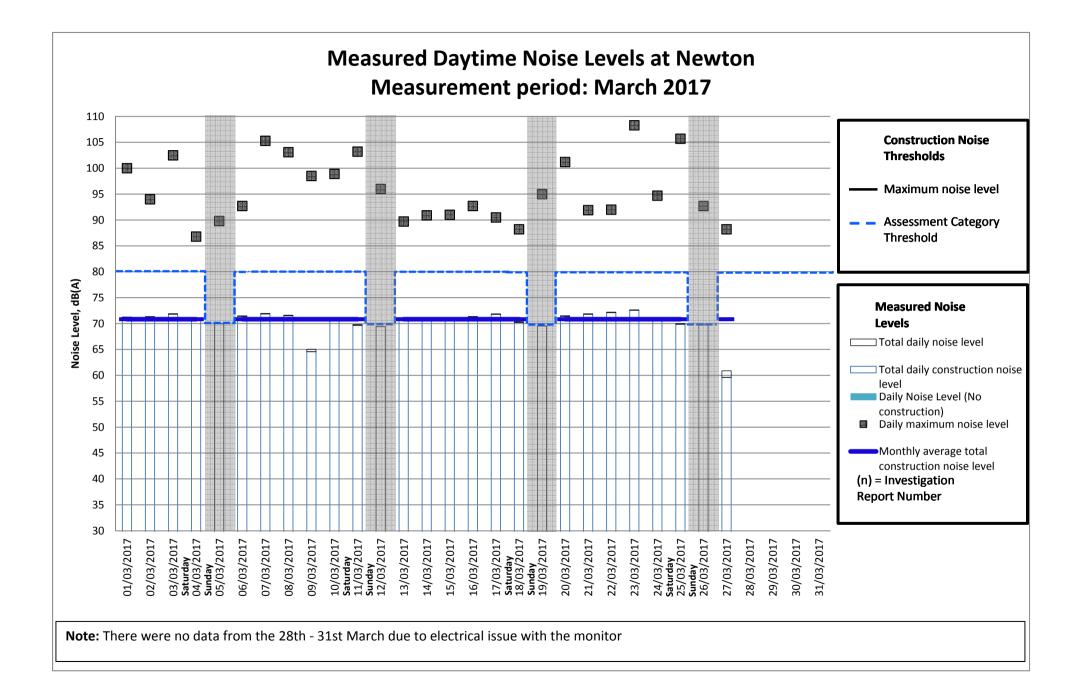
APPENDIX A

- 2.4 Noise monitoring results are presented in graphs (Appendix A) using the template provided in the *Construction Noise Monitoring Information Note* (www.transportscotland.gov.uk).

- 2.6 Results demonstrate that the monthly average total of construction noise results for daytime and evening are within the threshold levels for all monitoring locations during March 2017. For night time periods, there were exceedances of monthly average at Butlaw and Tigh-Na-Grian. There were also exceedances of Sunday average for Butlaw and Tigh-Na-Grian during the night.

- 2.7 Most exceedances noted were not caused by construction activities. Each exceedance was found to be influenced by increased noise levels due to periods of adverse weather, traffic, residential noise or birdsong. Audio recordings demonstrate that the increased levels were caused by sea waves and birdsong at Butlaw Fisheries and birdsong at Tigh-Na-Grian. With regard to the averages reported for night-time periods, it should be noted that these averages are based only on the highest LAeq levels for 1 hour periods which can affect the averages.
