Project **FORTH REPLACEMENT CROSSING**

**AIR QUALITY MONITORING REPORT  
JUNE 2017**

Made by Steven Westwater	Checked By: David Clark
Initials: SWR	Initials: David Clark
Document number <b>REP-00333</b>	Rev <b>00</b>

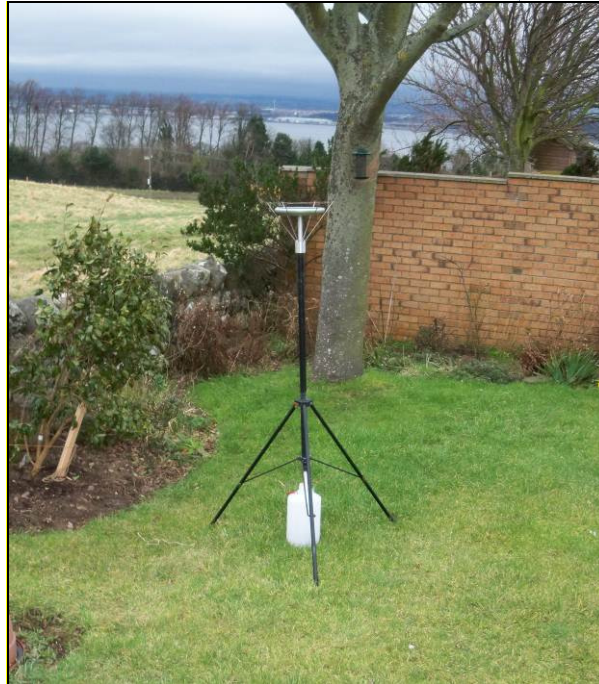
**Figure 1: Example of an Installed Frisbee Gauge Meter**

**2.1.** Air quality is being monitored on site using both automatic light scatter dust meters and Frisbee gauge dust deposition monitoring. Twelve Frisbee gauges are currently set up at sensitive locations across the site to measure dust deposition rates (Figure 1). Seven automatic light scatter meters have also been installed at various sensitive locations to measure real time particulate matter (PM<sub>10</sub>) concentrations and the Total Suspended Particle (TSP) concentrations (Figure 2). These meters are calibrated annually. Table 1 lists the air quality monitoring equipment present at each monitoring location, including the date it was installed.

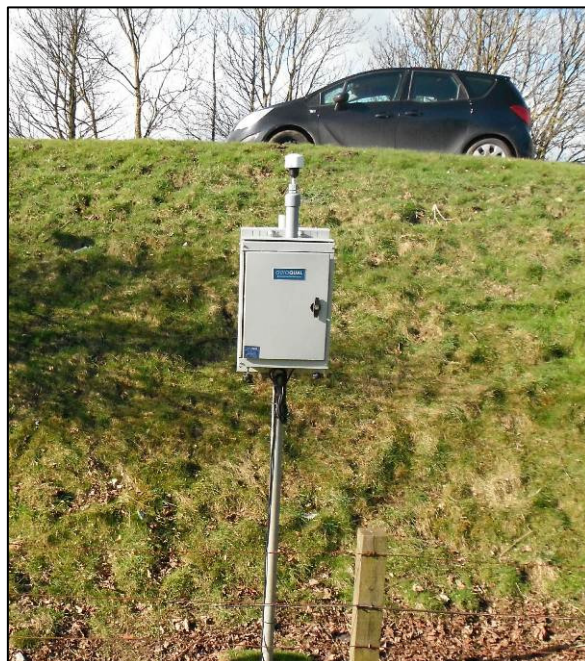
**Figure 2: Example of an installed Automatic Light Scatter Dust Meter**

**2.2.** Light scatter type monitoring equipment have been selected as a site monitoring tool to create a live network which assesses the levels of fugitive particulate matter, principally airborne dust. These monitors require less space, maintenance and power than other real time monitors such as a Tapered Element Oscillating Microbalance (TEOM) which is used and designed to measure particulate levels to exceedingly high standards, including measuring long-term compliance to statutory limits. Light scatter meters are more practicable to deploy. However, the meters do generally record levels higher than those measured by the TEOM. The meters can also be affected by atmospheric moisture content which further increases reported levels. Accordingly, any elevations of statutory limits should be treated as precautionary exceedances. The monitors are reliable for on-site monitoring and the establishment of action thresholds to ensure unforeseen activities generating significant dust are identified and suitably controlled. Light scatter meters are becoming the construction and waste industries norm for particulate dust monitoring.
