# Appendix A11.1

## Hydromorphology Assessment

1.1.1. This report forms a technical appendix to the A9 Dualling Tomatin to Moy – Stage 3 Environmental Statement, Chapter 11 (Road Drainage and the Water Environment) in Volume 1.

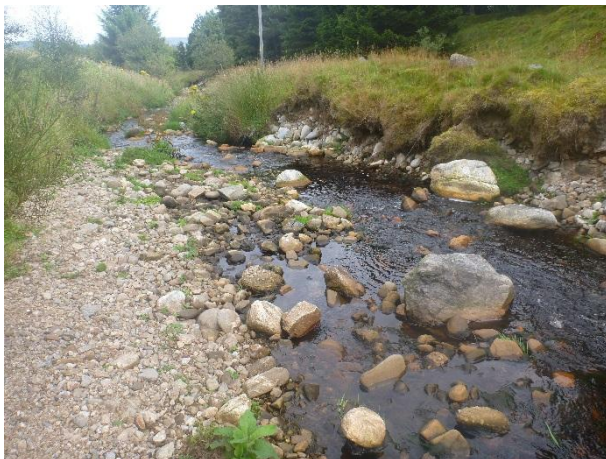
The banks comprised sandy soils with large amounts of gravels and cobbles. The bed substrates were dominated by coarse material from gravels through to boulders, forming step-pools. Sand and other fine gravels were present at the margins and at the bottom of pools. The system also possessed a dynamic and diverse range of flows typical of upland streams, including step-pool sequences. At low flows the system was primarily a stable transfer system, however large gravel bars and regular (albeit not extensive) erosion suggested an exchange process with potential for lateral adjustment at higher flows.

P1030760 – View downstream illustrating gravel/cobble bar opposite bank erosion (NGR NH 793 297)

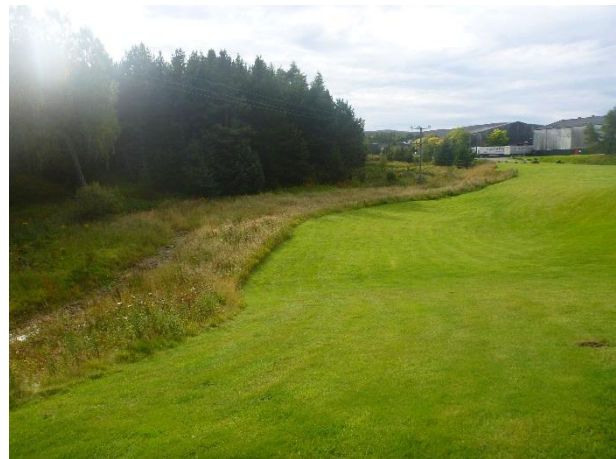
P1030774 – View upstream on Allt na Frithe. Tomatin distillery on the right hand side of the image (NGR NH 795 298)

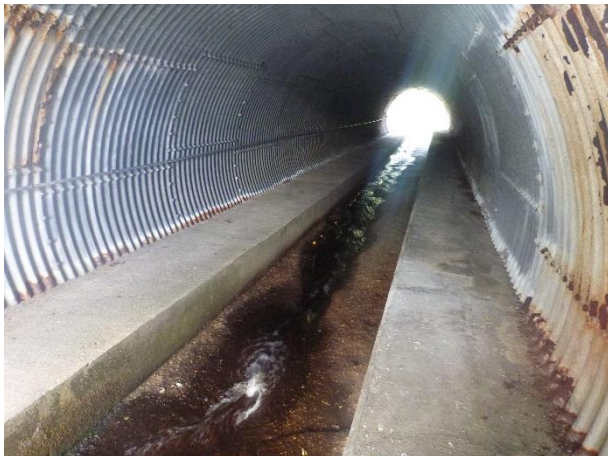
A short remaining section of watercourse flowed downstream of the existing A9 crossing and into the River Findhorn. The channel was artificially protected with concrete bed and banks through the culvert and immediately at its exit. There was evidence of some failure of the bed and a sudden drop at the end of the concrete apron. The channel then ran through a narrow wooded valley with an informal, dirt access track situated on the right hand bank. The gradient briefly steepened again at this point and step-pools were still common.

P1030789 – View downstream through existing A9 culvert showing concrete bed and banks (NGR NH 797 300)

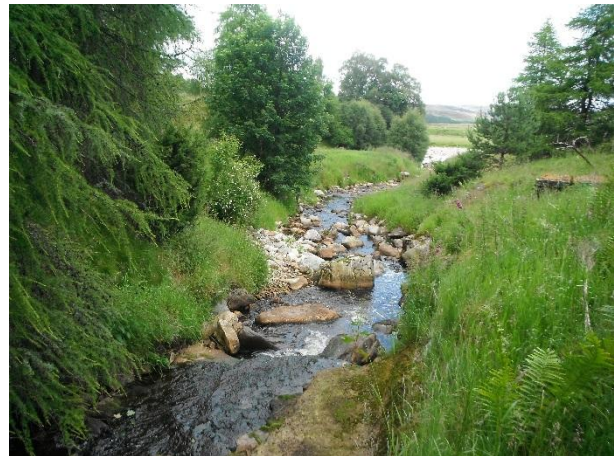
DCSF3950 – View downstream from culvert exit; the concrete apron has failed at the end of the culvert; limited gravel deposits on the left hand bank (NGR NH 797 300)

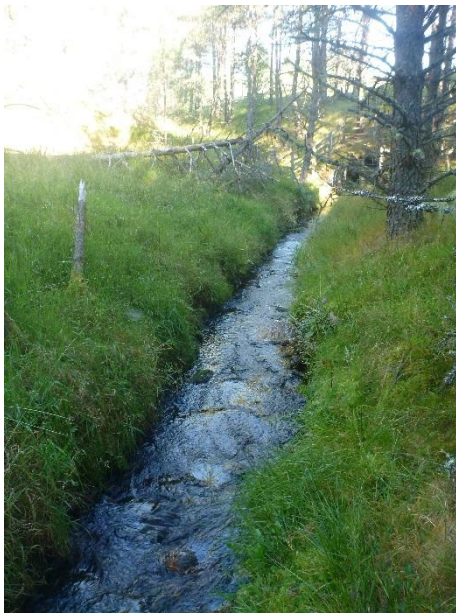
Prior to the straightening, gravel bars were present on the margins and some bank erosion hinted at the potential for active morphological processes upstream and some availability of coarse substrate. Overall the flows observed were uniform and the channel had been restrained leading into the culvert. The watercourse (in the vicinity of the crossing) was representative of a stable transfer system.

P1040023 – View towards the existing A9 culvert (upstream of the A9); the channel has been artificially straightened and bank/bed protected throughout (NGR NH 793 305)

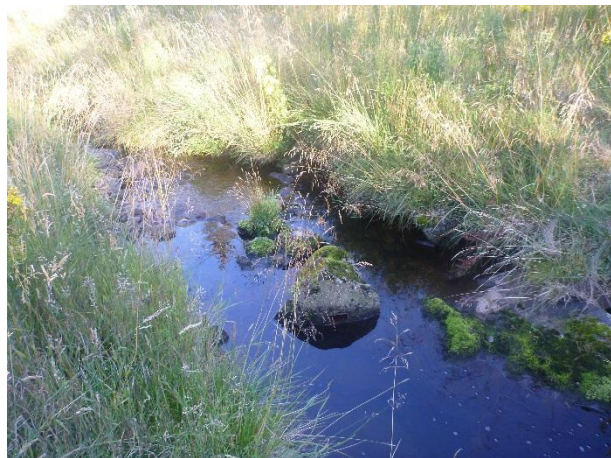
P1040041 – Downstream of the culvert a series of step-pools have developed and the channel returns to a more natural profile and planform (NGR NH 794 305)

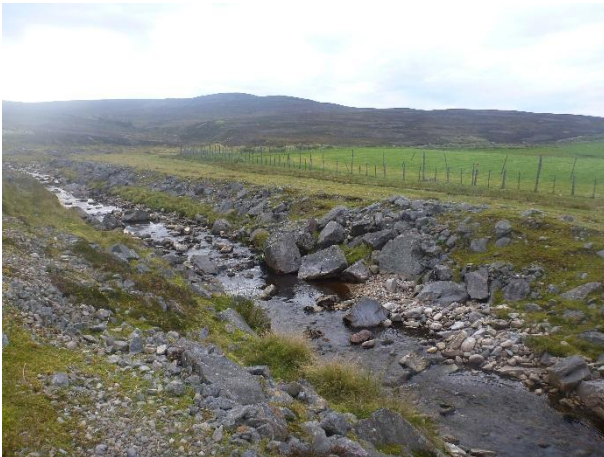
The bed comprised cobble and boulder material, with some sands at the margins and in pools. Although protected, the banks were mainly sandy soils. The channel displayed a good range of flows associated with step-pool sequences. There was little bank erosion present and few notable deposits beyond the scattering of boulders on the bed, suggesting a stable transfer system.

P1030800 – View upstream showing embankment on the left hand bank and stone protection throughout (NGR NH 784 321)

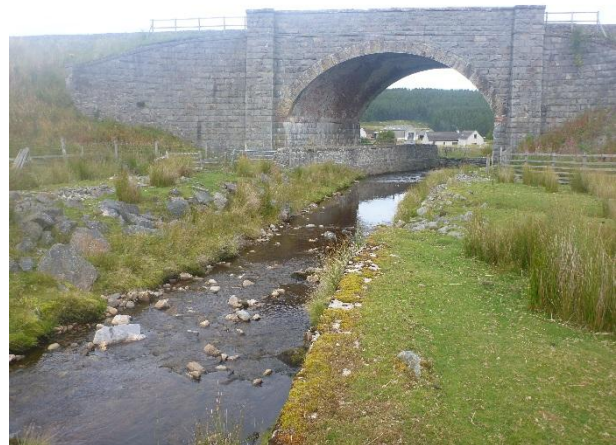
P1030804 – View downstream underneath railway bridge (NGR NH 786 322)

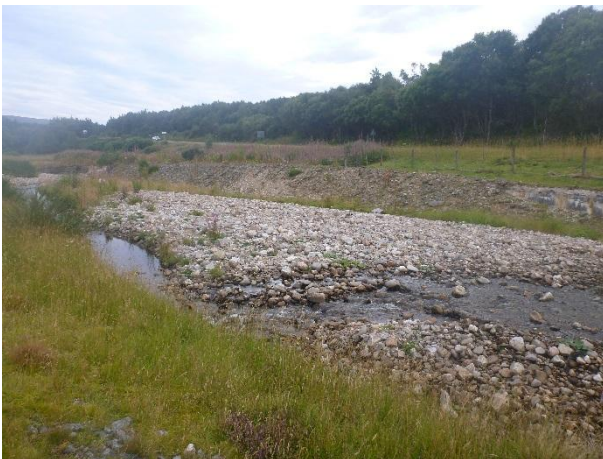
The left hand bank was still embanked, however the stone protection appeared to be absent. Large mobile gravel bars which were situated immediately downstream of the road crossing suggest a lowering of the gradient and there was some limited bank erosion on the right hand bank. Faster and more energetic flows were associated around a number of steps and cascades flowing in between the bar features. Further downstream as the tree cover dominates, there was an increase in fine sediment and algae growth as the gradient and flow energy decreases. There were still some occasional gravel bars and riffles suggesting potential for large sediment movements downstream. Immediately before the confluence with the Funtack Burn the channel was very straight and continued to be embanked and constrained.

P1030810 – View downstream of large gravel deposit; Current A9 alignment on the right hand side of image (NGR NH 788 322)

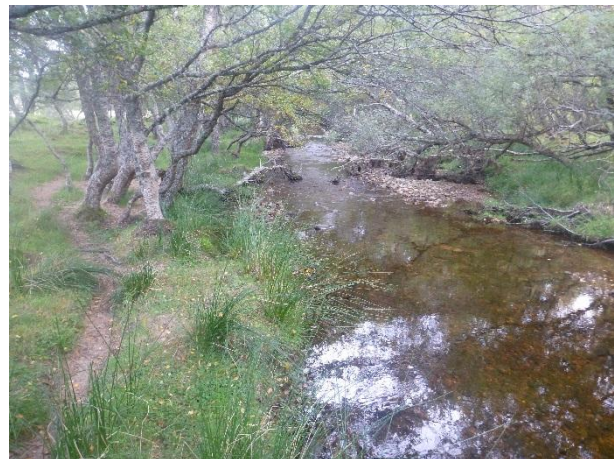
The frequency of gravel bars and fine sediment on the bed suggested a tendency for deposition, but the channel was mostly geomorphologically stable.

P1030823 – View downstream through wooded section, some evidence of fine sediment and algae growth on bed suggesting low energy flows for long periods (NGR NH 792 320)

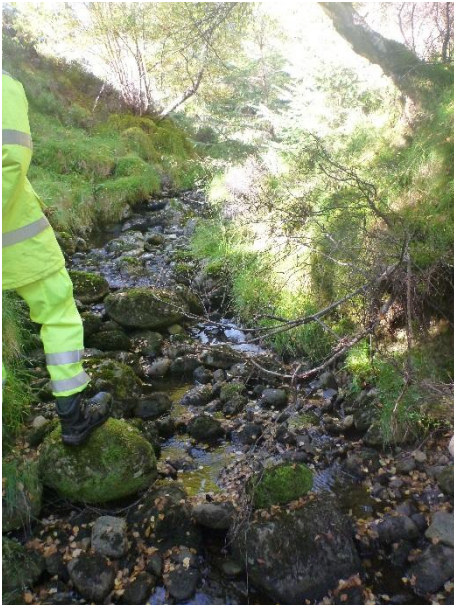
P1040010 – View upstream of existing crossing; wide boulder bed with regular steps (NGR NH 771 339)

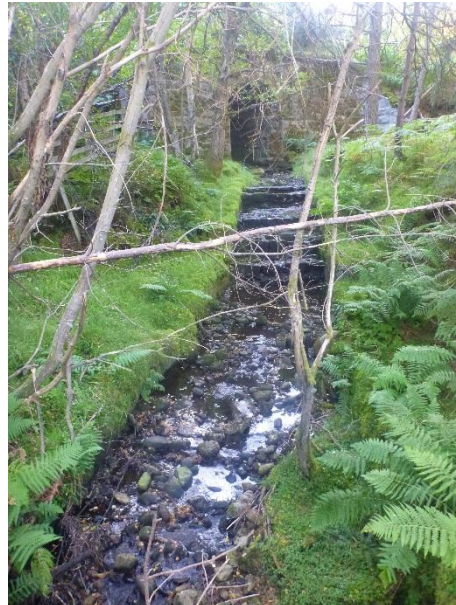
P1040028 – View from downstream towards existing railway bridge with heavily modified bed and banks (NGR NH 772 340)

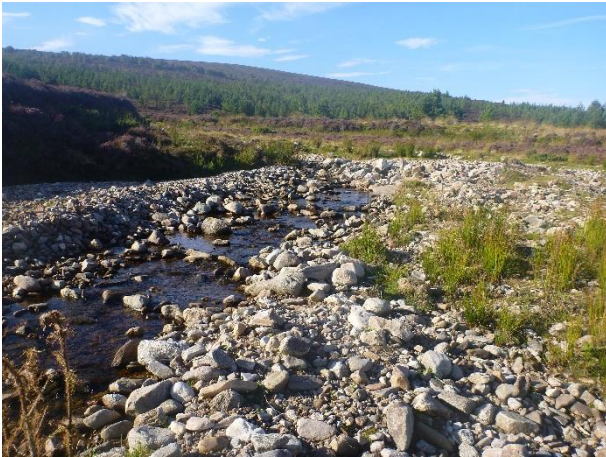
P1030849 – View upstream; large gravel bars present throughout the upper sections (NGR NH 759 341)

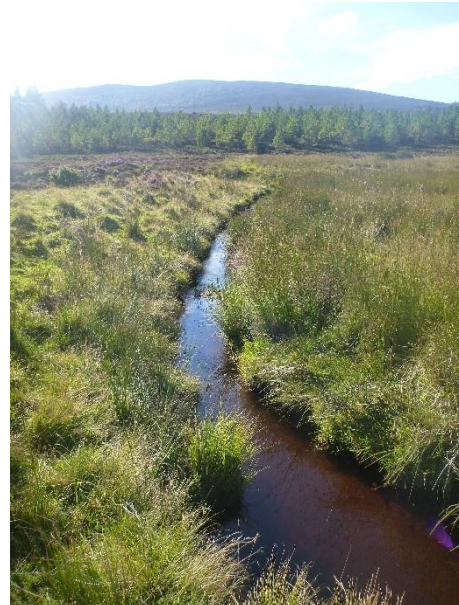
P1030869 – Further downstream the channel shows signs of impacts from historic abstraction from a now derelict reservoir (NGR NH 762 342)

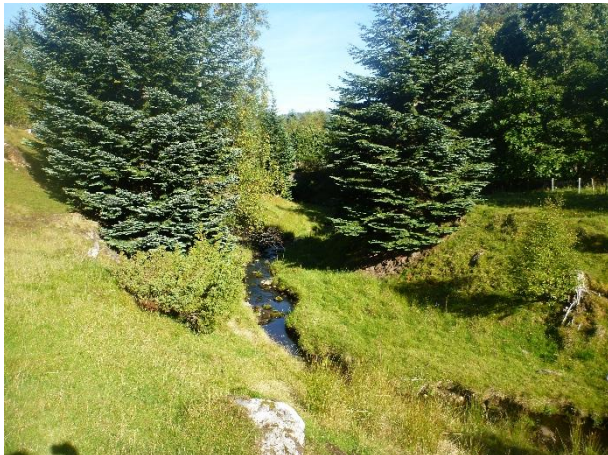
P1030897 - View downstream down Allt na Loinne Mòire showing steep valley sides and step-pools (NGR NH 764 344)

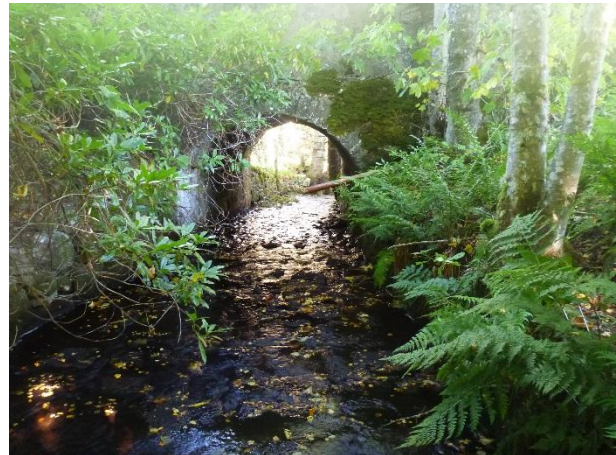
1030905 – View upstream of bank and bed protection underneath railway bridge (NGR NH 765 345)

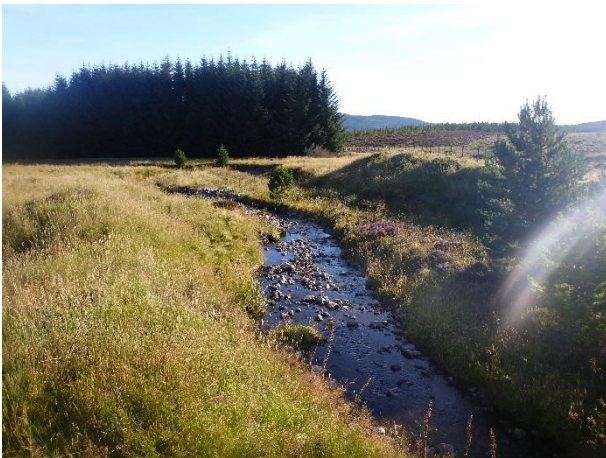
These observations indicated an exchange of material within the reach and areas of active laterally migration, with erosion on the outer bends mirrored with point bars and side bars.

P1030958 – View downstream from start of surveyed section in open grassland, active erosion was observed throughout (NGR NH 747 342)

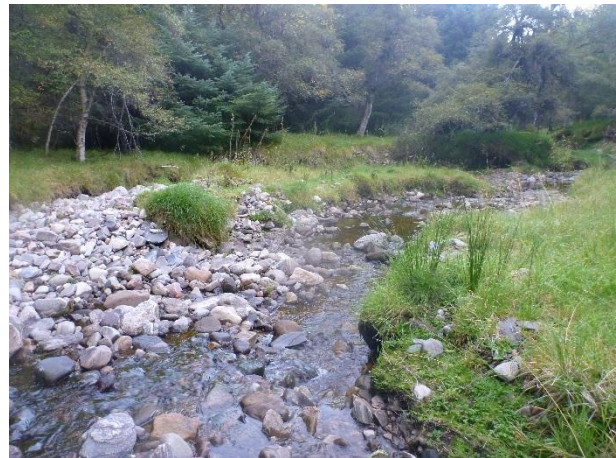
P1030977 – View through wooded section with large gravel bars forming a multiple stage channel profile (NGR NH 749 345)

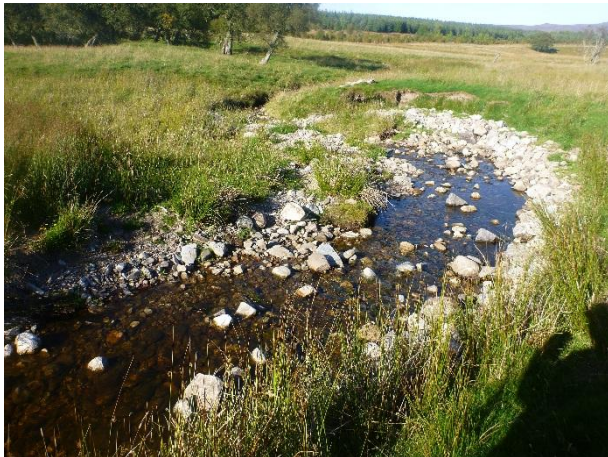
P1030909 – View immediately downstream of existing A9 culvert with unnaturally placed boulders on the outside bend (NGR NH 751 348)

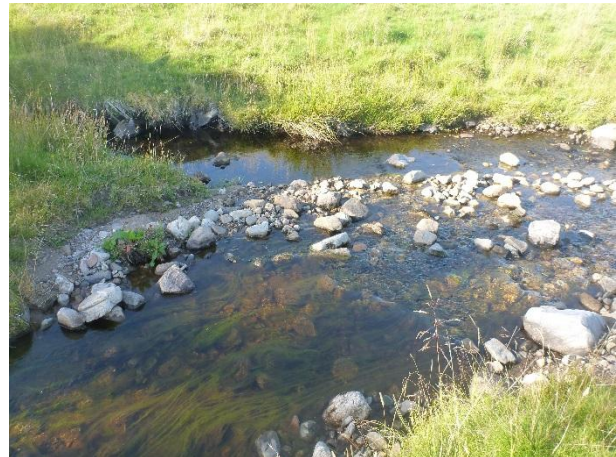
P1030915 – View of confluence with Allt Creag Bheithin; note the macrophytes situated within the channel (NGR NH 751 349)

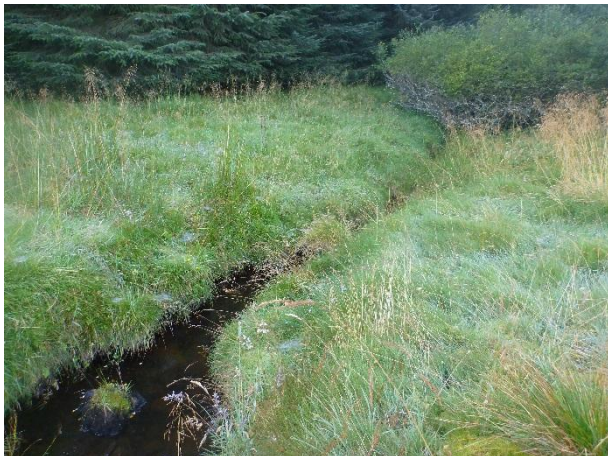
The channel showed few signs of erosion, but with the deposition of fine sediment it is likely to be a sink, which is nominally aggrading, although it is primarily stable.

P1030991 – View upstream towards woodland; channel in this location is ponded and fines deposited on top of gravels (NGR NH 749 347)

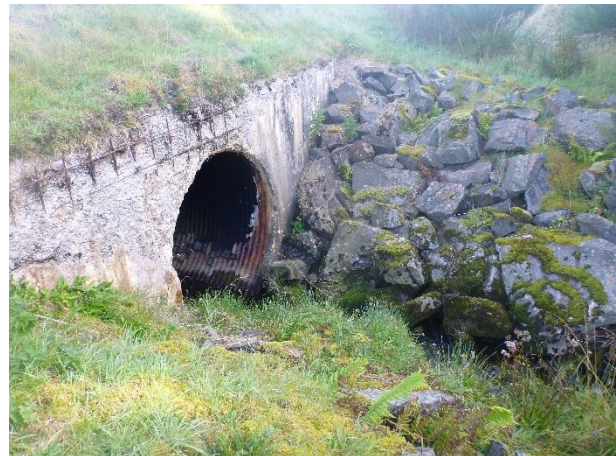
The banks, although tree lined further upstream, were mainly grass covered comprising sandy soils. Closer to the culvert the banks were protected with stone and concrete. The bed was mainly fine material over coarse gravel and cobbles. Pondered flow leading up to the culvert has led to the preferential deposition fine material over the coarse substrate, exacerbated by a low level obstruction (weir) across the channel.

P1030994 – View of culvert underneath existing A9 (NGR NH 749 347)

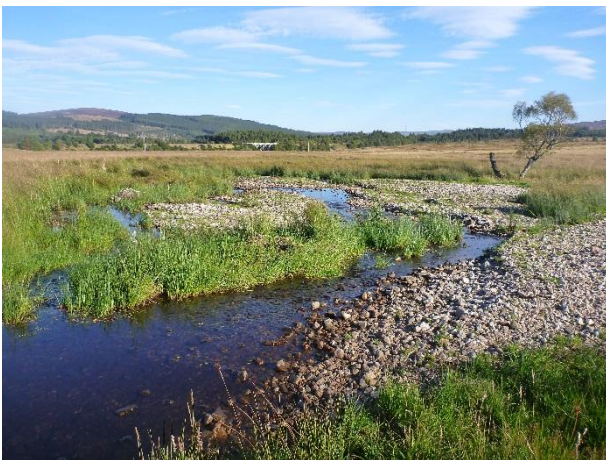
The high energy flows and reduction in gradient have resulted in the transportation and formation of large gravel bars, suggesting a reliable supply of gravels from upstream and the surrounding landscape. As the planform straightened out into the wetter, boggy area the gravel bars were less common (as the gravels having dropped out earlier) and the flow was more uniform. Fine sediment arriving from upstream and adjacent floodplain has been deposited over the gravel substrate.

P1030940 – View downstream just after the confluence with Allt na Slànaich demonstrating the large gravel bar deposits and dynamic flows (NGR NH 755 351)

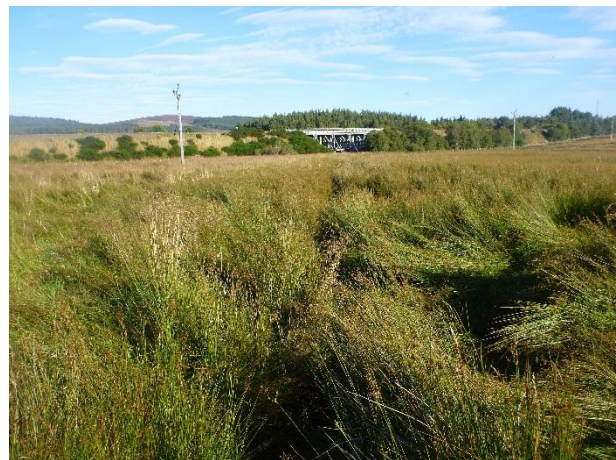
P1030950 – View downstream towards the railway bridge through the boggy area downstream of the A9; there are fewer gravel deposits through this section (NGR NH 759 350)
