# Appendix 11.4

## Hydromorphology Assessment Part 1

- 1.1.1 This appendix presents the detail of the hydromorphology assessment of the Proposed Scheme for Project 8 – Dalwhinnie to Crubenmore (Central Section) of the A9 Dualling Programme. It supports the summarised findings presented in **Chapter 11** of the Environmental Statement (ES). The Proposed Scheme that was assessed is described in **Chapter 5** of the ES.

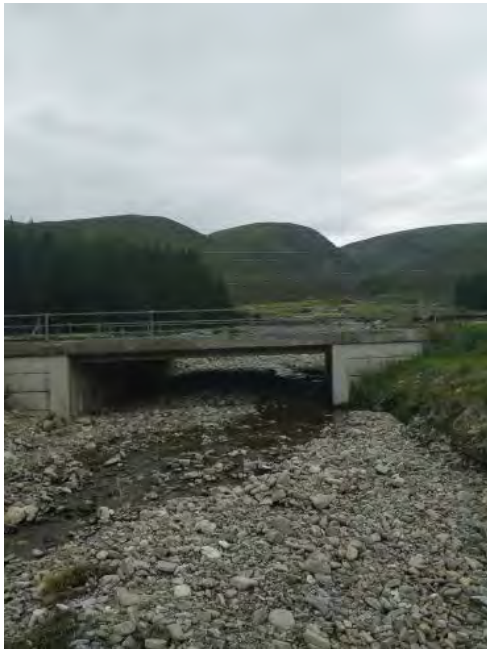
Photograph 11.4.3.3 -Steep  
catchment upstream

Deposition

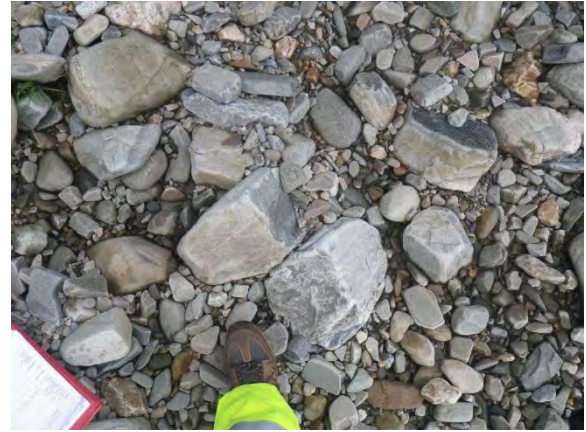
Photograph 11.4.3.6- Bed sediment (Cobbles and boulders)

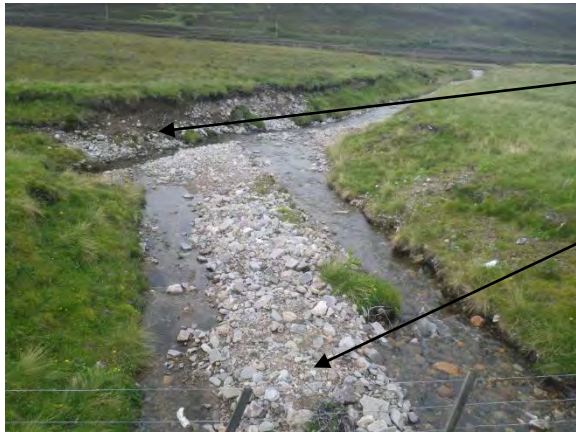
Erosion at confluence with 63

Deposition

Photograph 11.4.3.11- Downstream of crossing

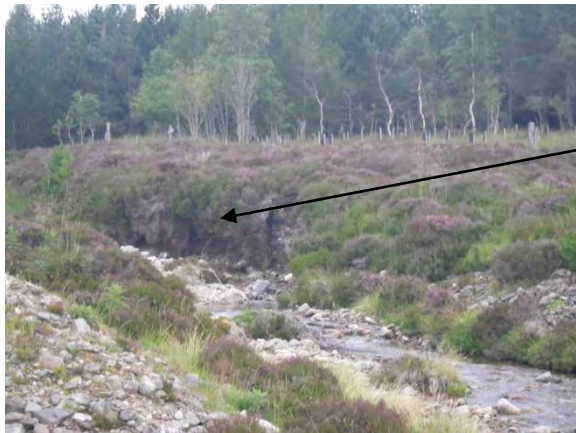
Bank Erosion

11.4.3.13 Upstream of crossing

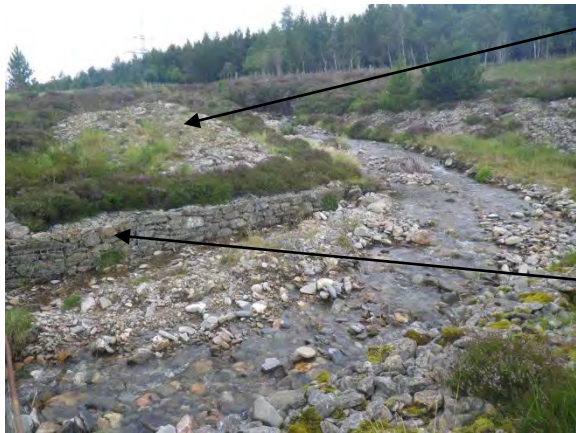
Arising's from dredging

Bank protection

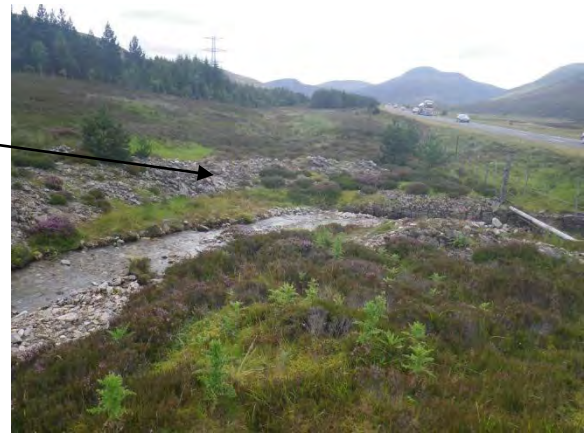
Photograph 11.4.3.15-Upstream bank protection

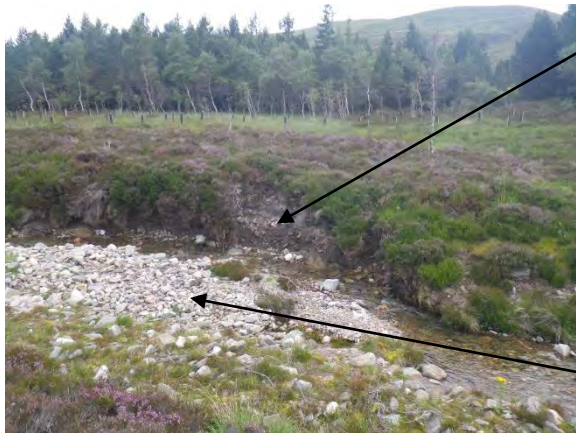
Arising's from dredging

Photograph 11.4.3.16-Looking South

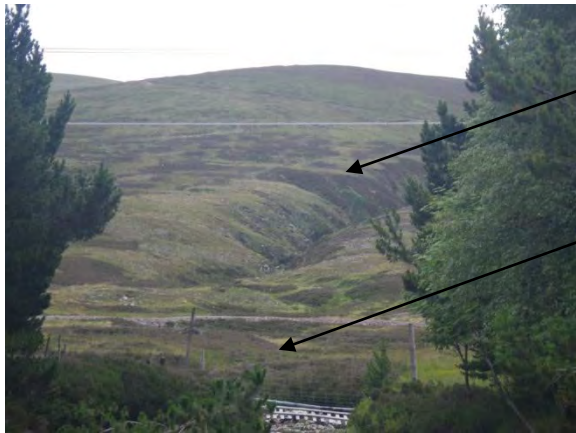
Photograph 11.4.3.18- Sediment rich channel

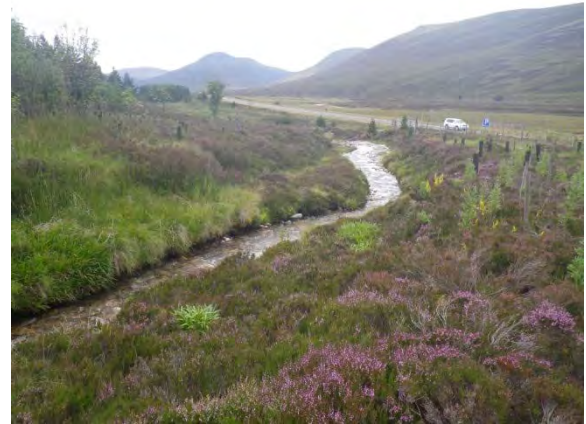
Steep upper  
catchment

Flatter mid slopes

Photograph 11.4.3.19-Catchment upstream of crossing showing confined channel

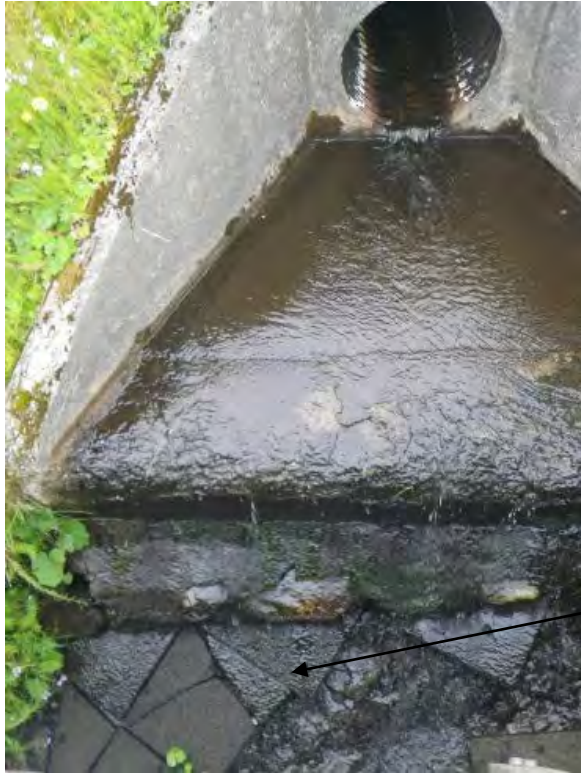
Photograph 11.4.3.24 - Crossing exit

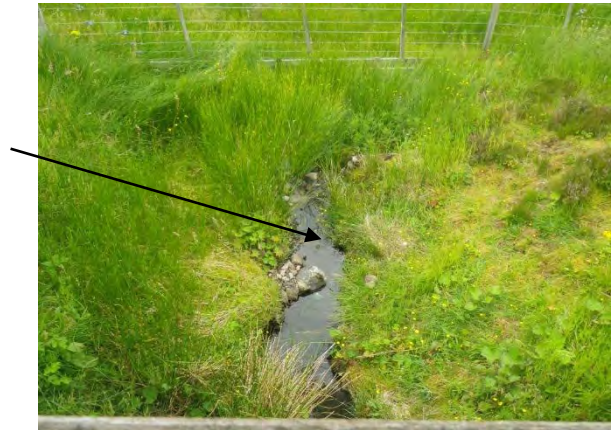
Low gradient channel

Photograph 11.4.3.25 - Downstream of crossing-  
Small channel

Some damage to apron from high energy flows

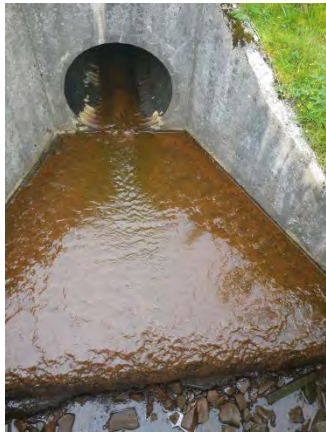
Photograph 11.4.3.27 -  
Crossing exit

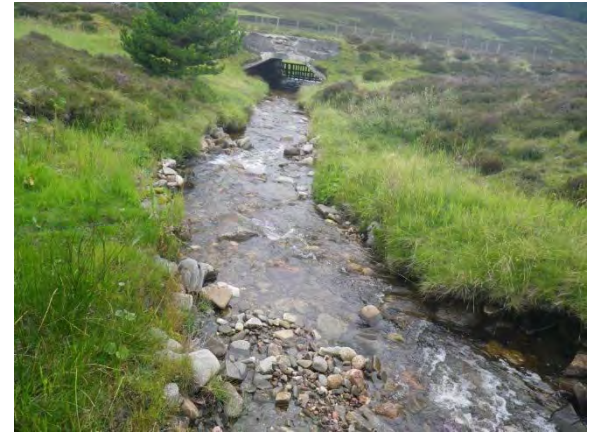
Photograph 11.4.3.32- Downstream to cycle crossing-Cobbel bed

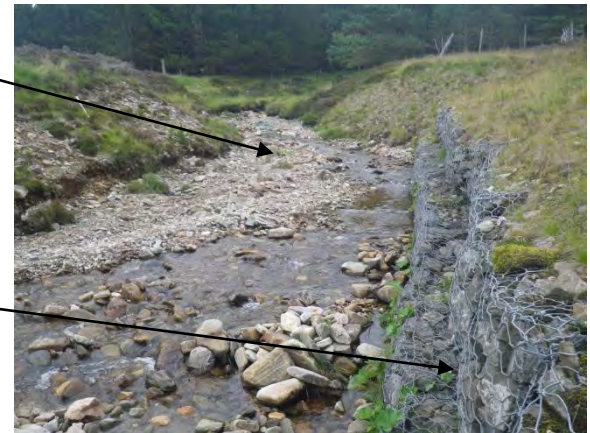
Photograph 11.4.3.34 - Upstream from crossing, confined channel

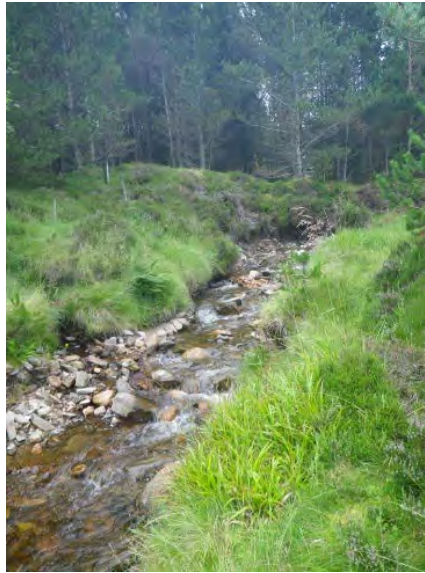
Photograph 11.4.3.35 - Upstream, Cascade morphology

Bank erosion

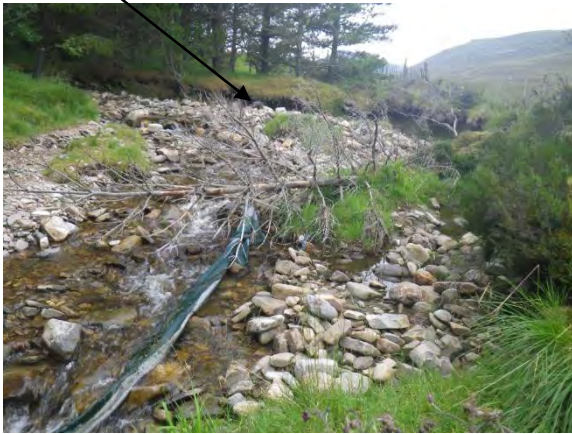
Photograph 11.4.3.36 - Deposition and woody debris upstream of crossing

Meander development halted by gabions

Lateral bars
