Appendix 11.4

Hydromorphology Assessment Part 4

Annex 11.4.3 - Hydromorphological Catchment Assessment - 94

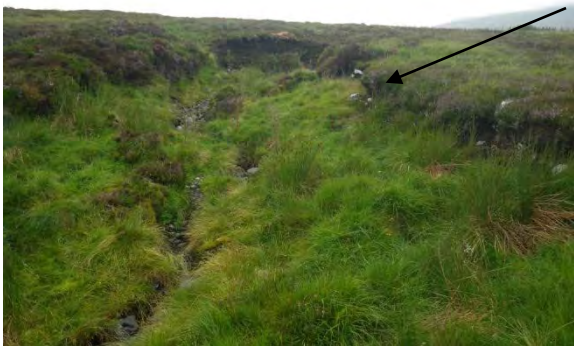
Photograph 11.4.3.67- Upstream to channel in
peat

Erosion in peat

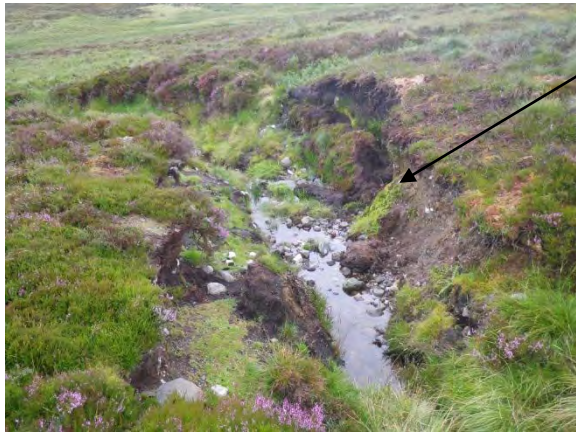
Photograph 11.4.3.69- Downstream

Incision in peat

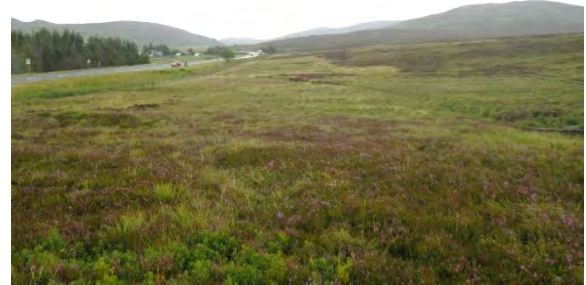
Photograph 11.4.3.70 – Low lying catchment

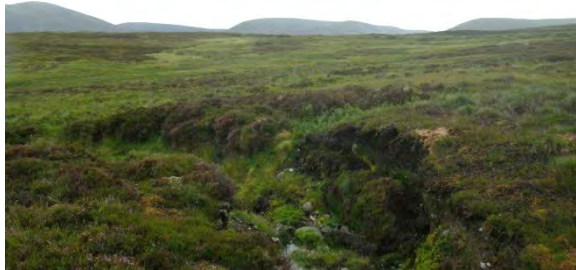
Photograph 11.4.3.71 - Low lying catchment

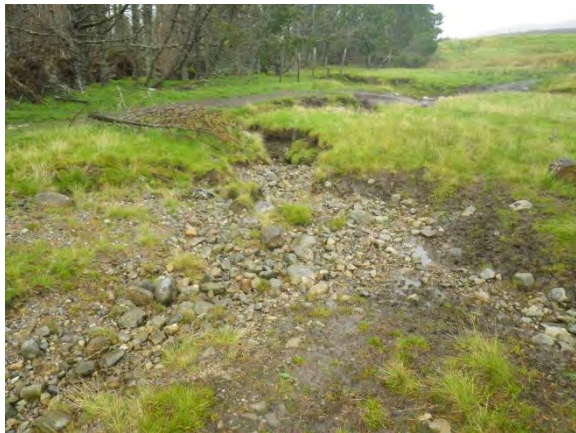
Photograph 11.4.3.75- Floodplain erosion

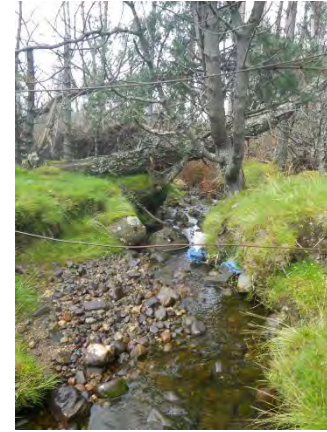
Photograph 11.4.3.77-
Downstream to wooded
section- Gravel bed and
influence of woody debris

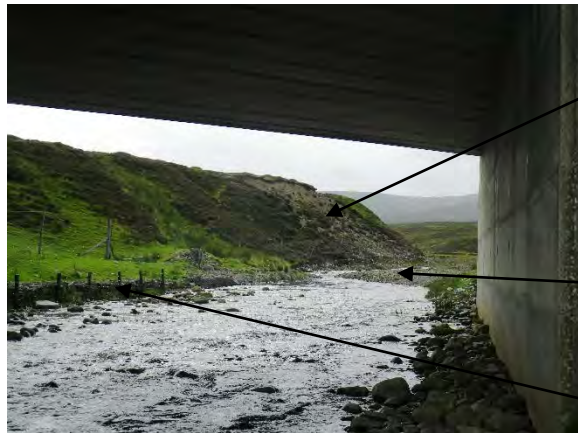
Photograph 11.4.3.79- Upstream

Some deposition

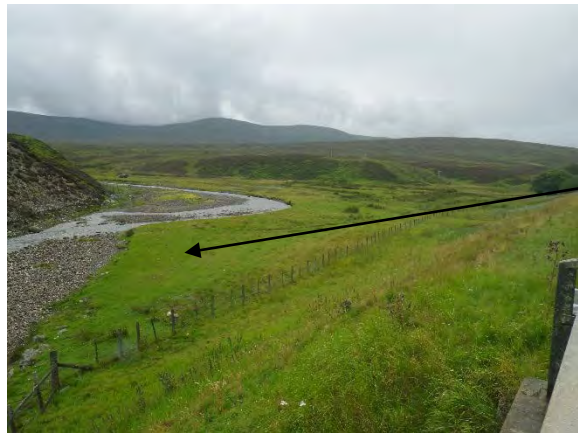
Photograph 11.4.3.82- Upstream

Flow deflection to keep flow under bridge

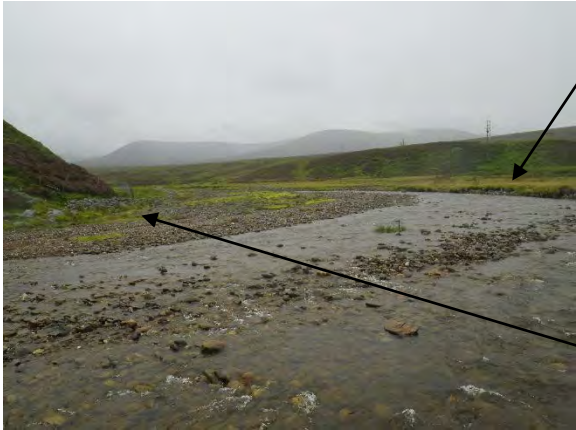
Photograph 11.4.3.84- Upstream

Erosion on outside of bend

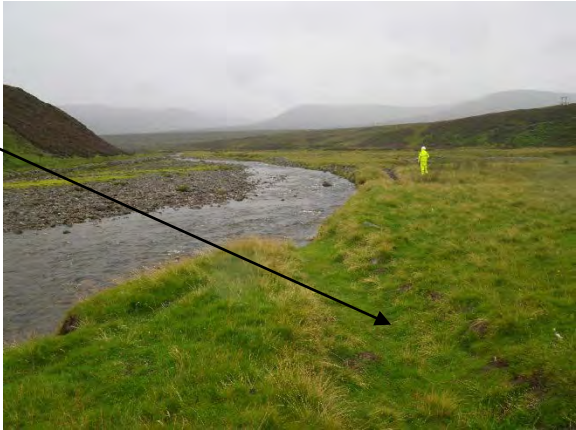
Photograph 11.4.3.85

Bank erosion

Bars formed due to local sediment supply

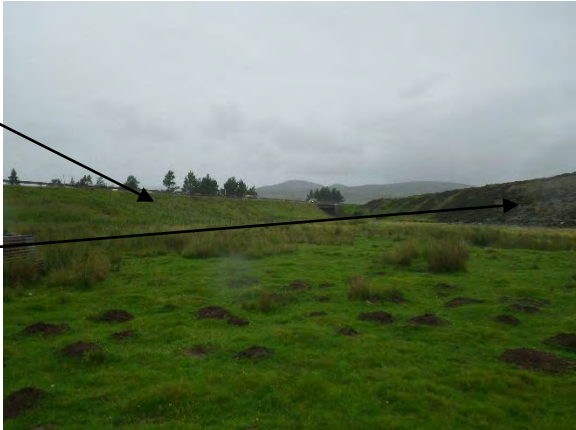
Photograph 11.4.3.87 - Paelochannel visible on the floodplain

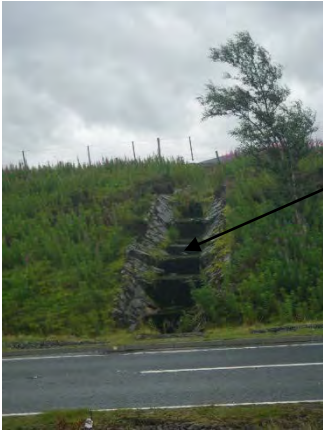
Photograph 11.4.3.89

Step cascade

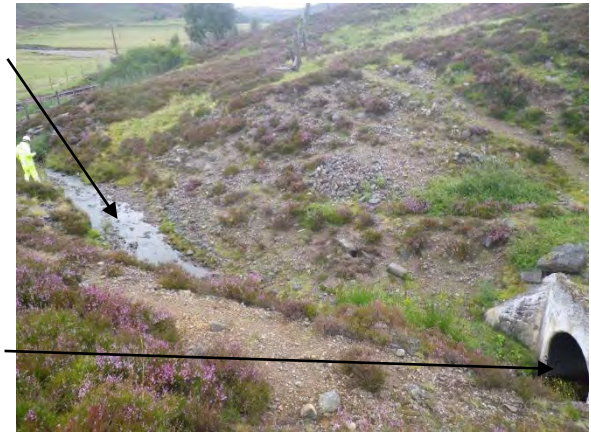
Channel confined by valley sides

Crossing exit

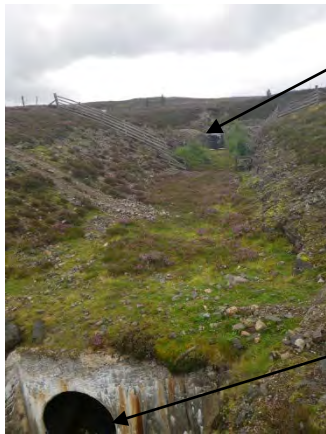
Cascade upstream of road

Crossing exit- Steep channel gradient

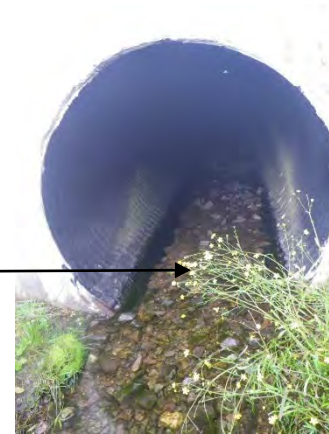
Some deposition in culvert

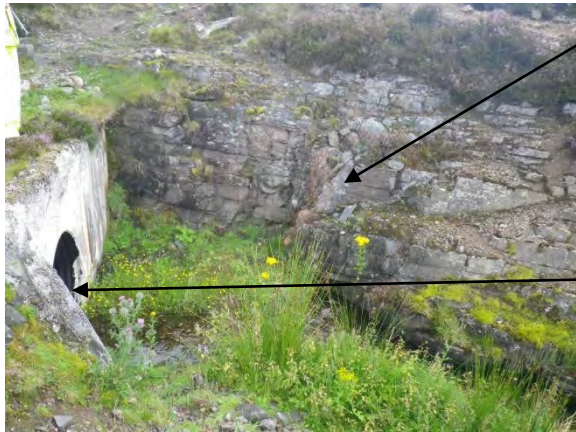
Channel cut into bedrock

Crossing exit

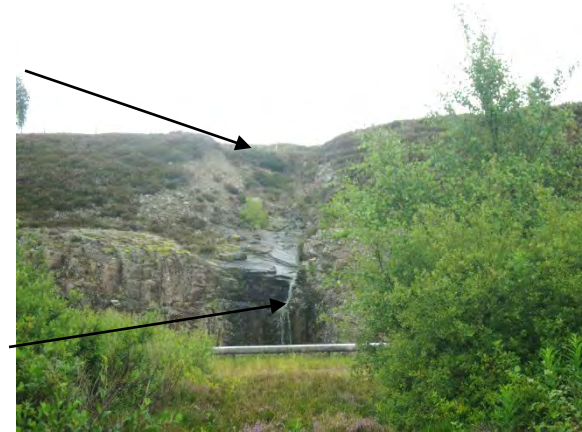
Photograph 11.4.3.96 -Upstream

Channel incision upstream

Upstream cascade in bedrock

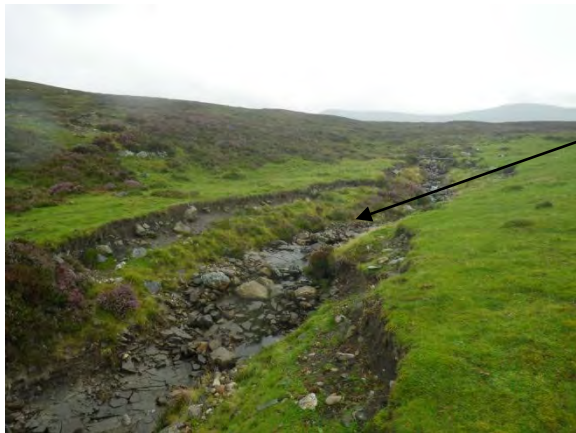
Photograph 11.4.3.97 –Upstream of crossing, looking upstream

Channel incision upstream as bed level adjusts to crossing realignment

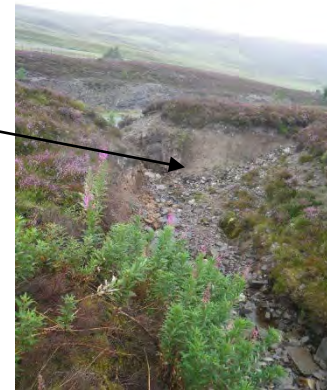
Photograph 11.4.3.98-Downstream to cascade

Channel incision at drain

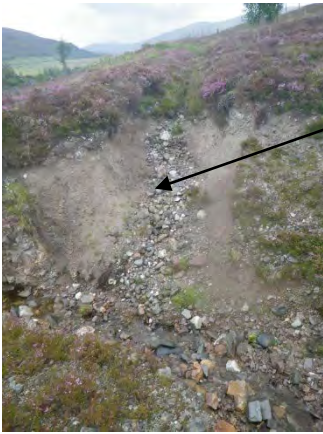
Photograph 11.4.3.99-
Upstream of cascade

Incision of
drain entering
crossing

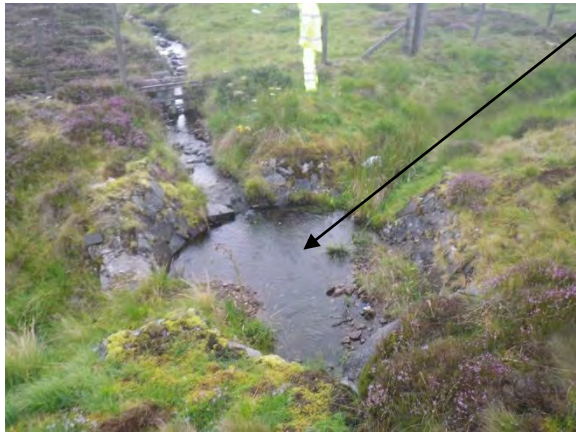
Photograph 11.4.3.101 – Upstream of crossing

Gravel in pool

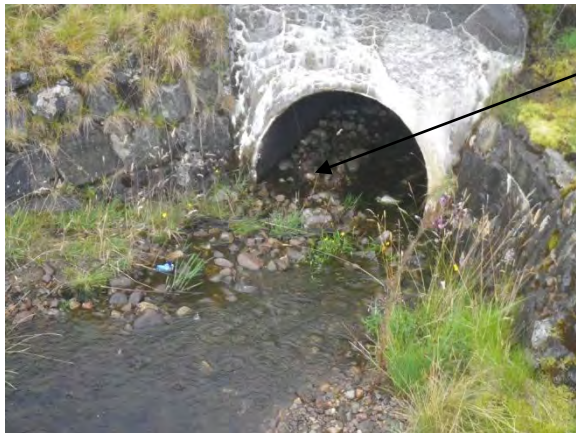
Photograph 11.4.3.103- Entrance to crossing

Gravel deposition in culvert
